3.0 Physical Evidence

The physical survey of Point Peron "K" Battery site has been prepared with reference to the available documentary evidence and on an assessment of the existing fabric at the site. The objectives of the survey are to assess the extent of extant fabric and its condition and to determine the extent of conservation works required to safeguard these structures from further deterioration.

3.3 Description of the Surviving fabric

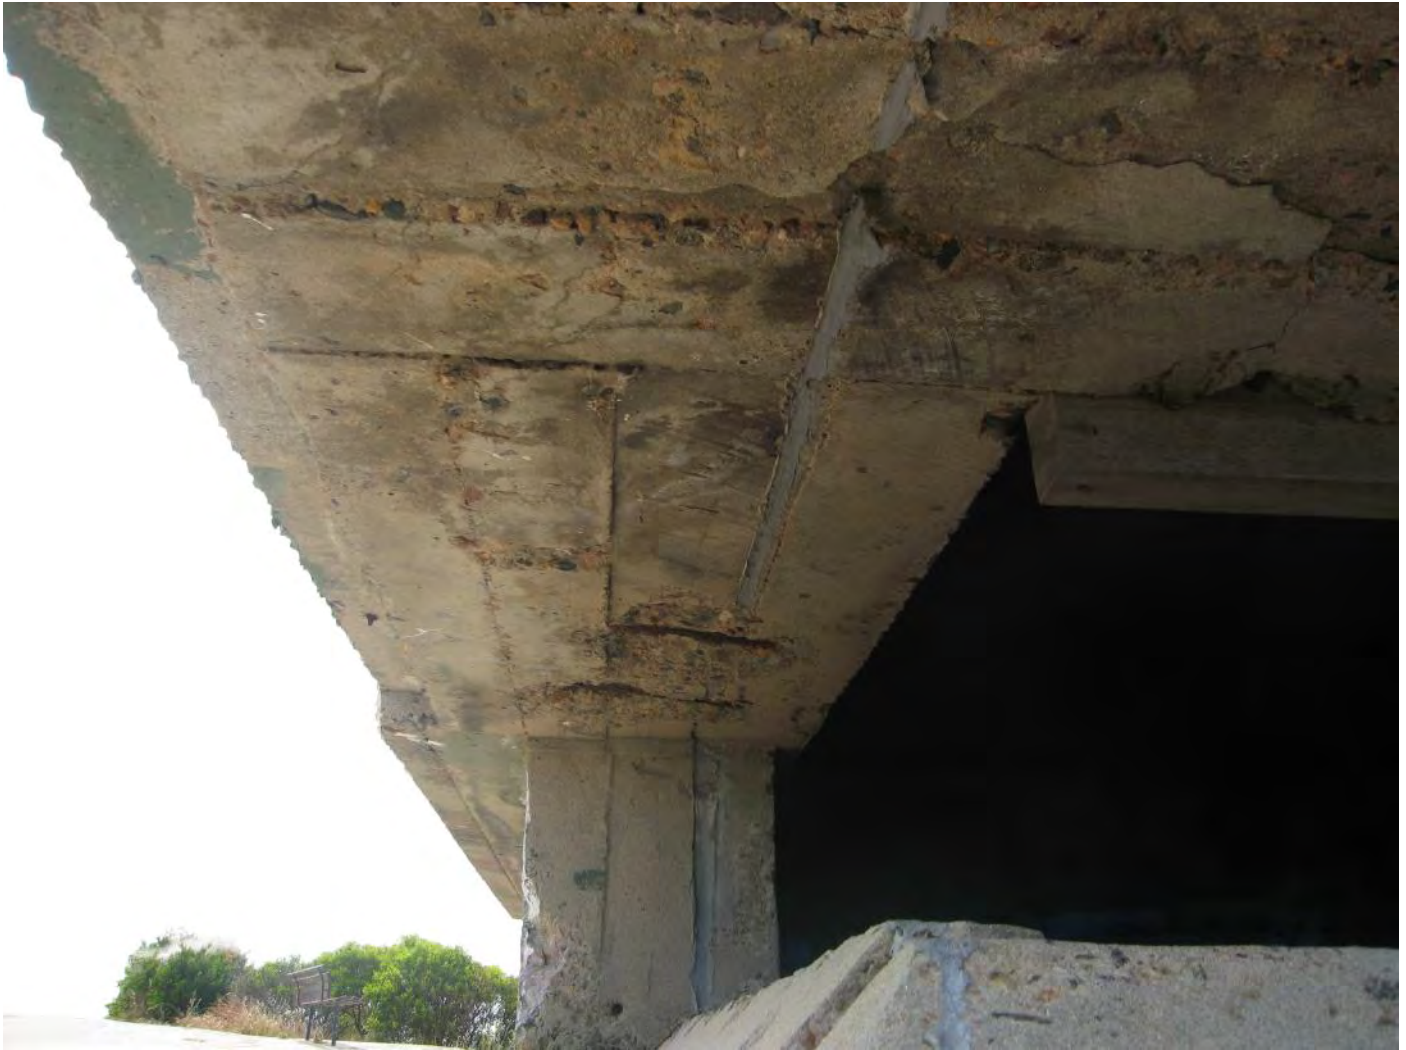
Research has shown that in similar structures, the ground level often came up to the bottom of these projection or slightly above providing support. Over time the ground level has eroded or has been manually removed to provide a flat walking surface around the structure which has removed all support for the projecting element. As a consequence, the weight of the projecting storage area is pulling the wall away from the rest of the structure which is evident in the cracking seen along the brick joints.

Figure 61: **Underside of Concrete Overhang to Observation Opening**

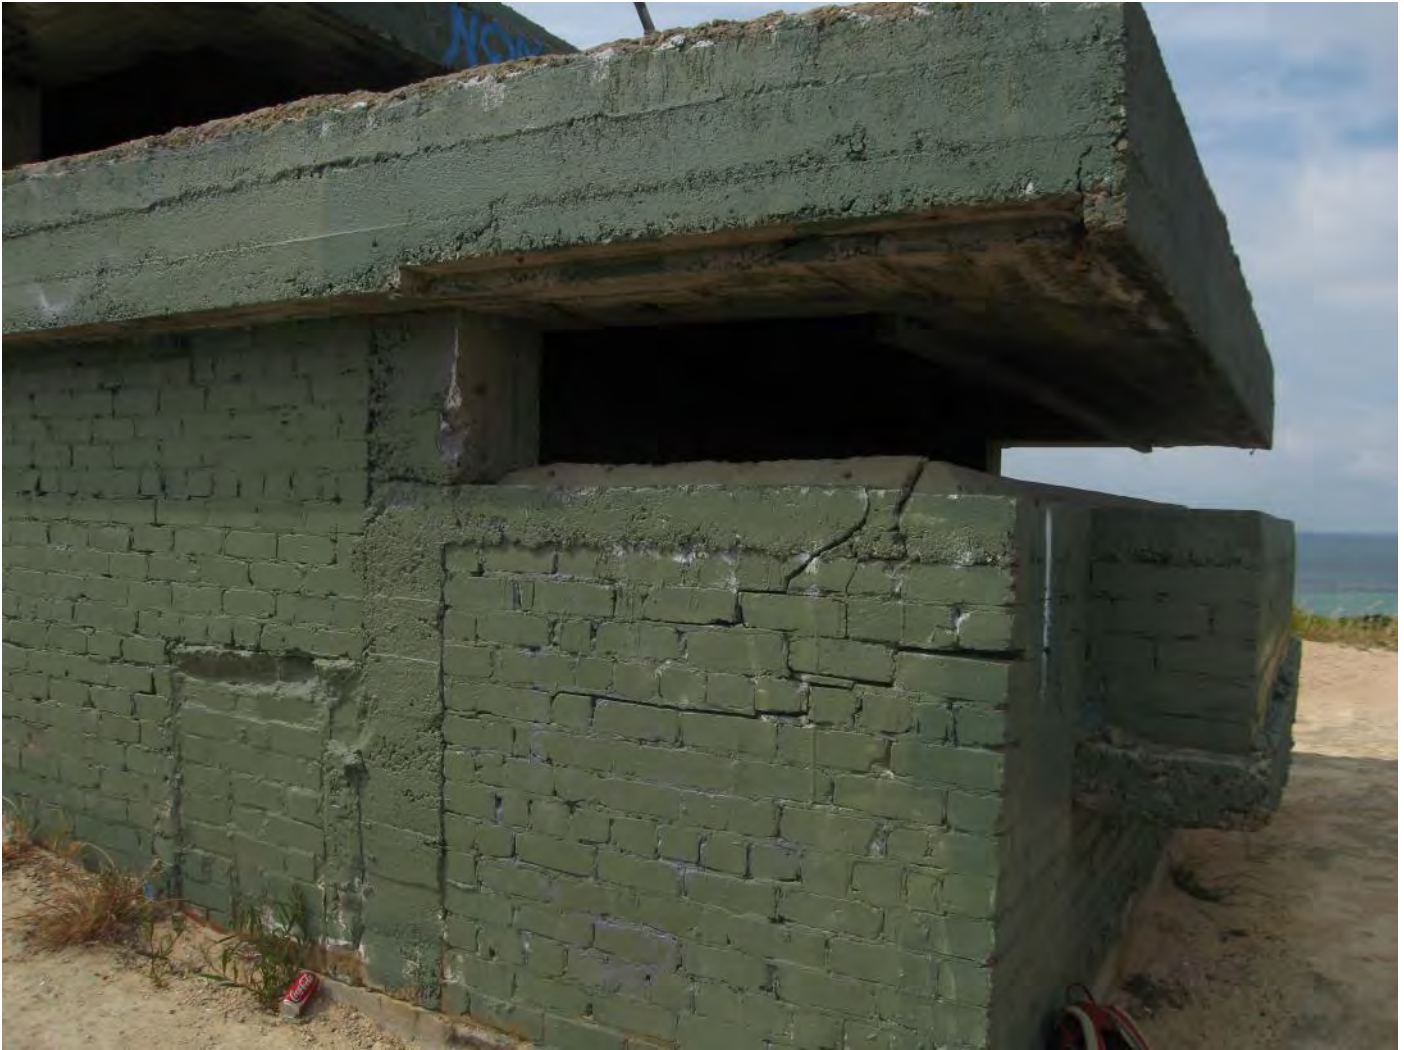
Figure 63: North Elevation – western corner being pulled away from the main elevation

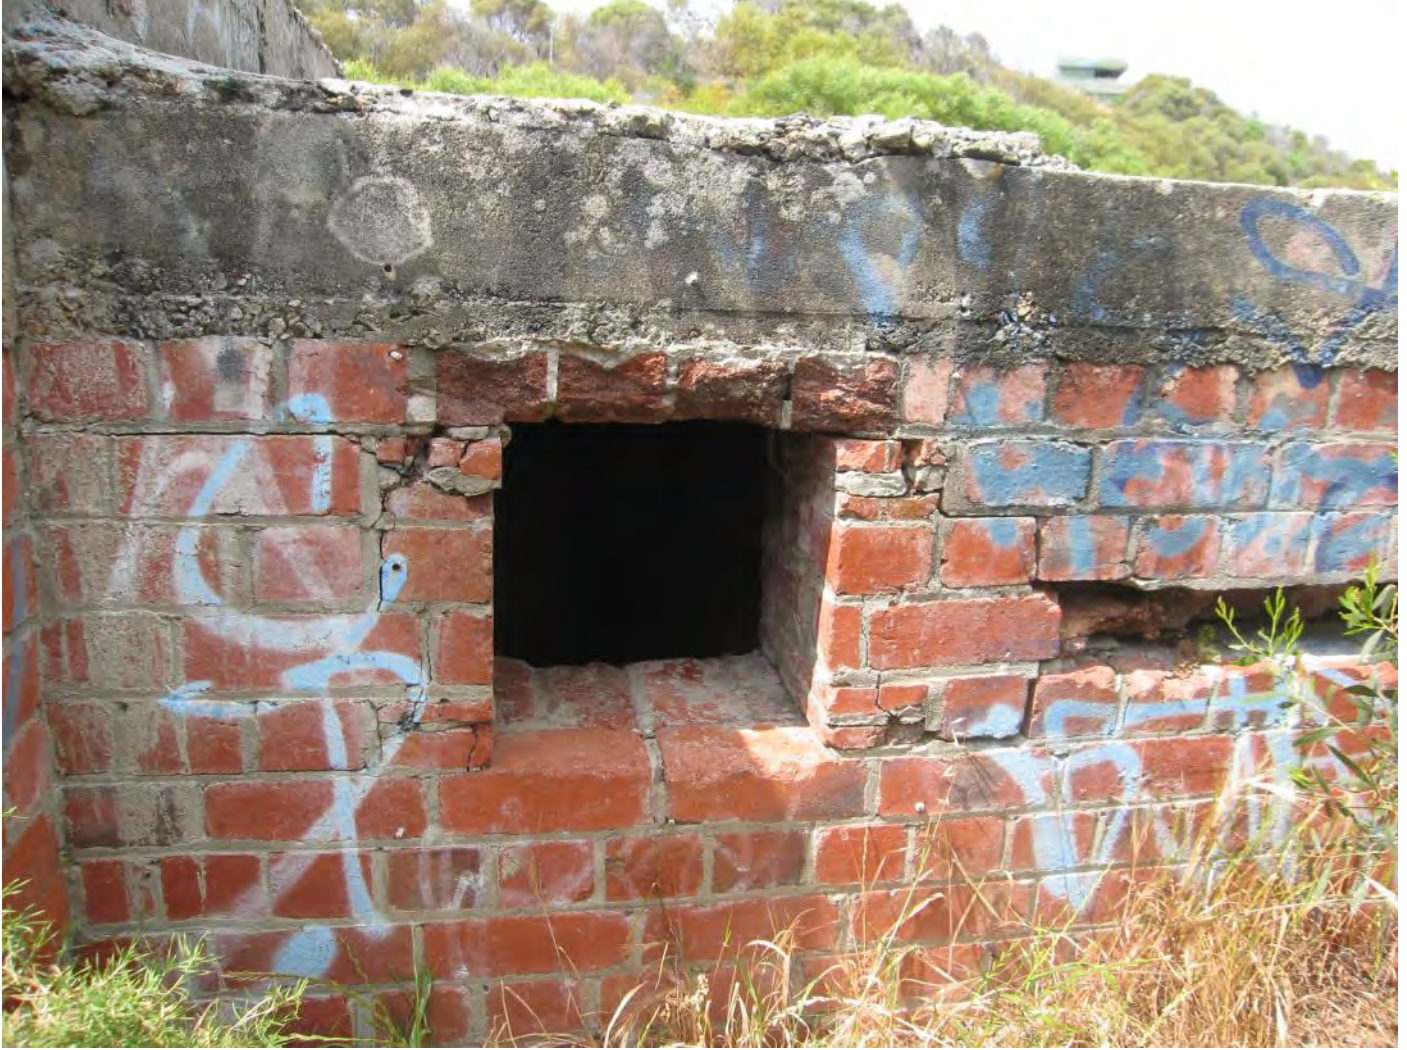
Figure 85: Operations Bunker – Openings in north wall

The brickwork immediately to the west of the opening, closest to the west elevation, is deteriorating. Bricks are missing with much of the damage being caused by the rusting and failing reinforcing steel. Previous repairs have been carried out with some evidence of localised repointing.

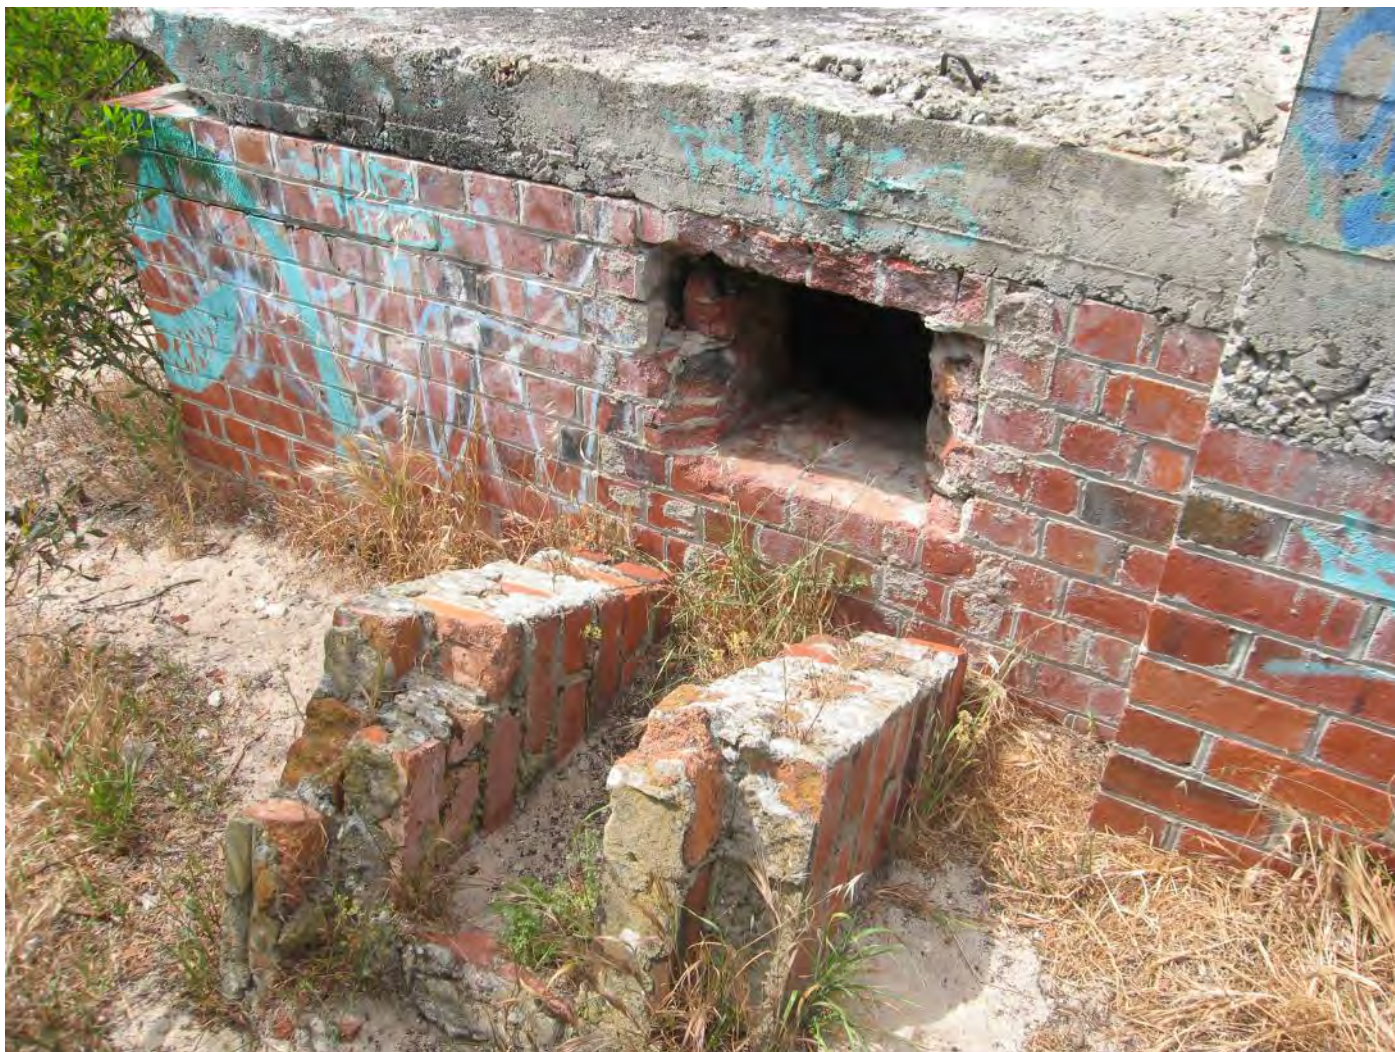
Figure 86: Operations Bunker – Openings in north elevation and remnant fabric

A further opening of the same dimensions is located towards the eastern end of the north elevation with much of the brickwork around the opening being in poor condition, with the faces of the bricks having spalled and fallen off and large chunks of brick have broken off from the around the opening. A three-sided brick element is laying on the ground adjacent to the opening. This element was originally attached to the north elevation around the opening allowing for ventilation to enter the building. This element was not keyed into the main structure, and was only attached by mortar which has failed over time and eventually resulted in the brick flue falling off.

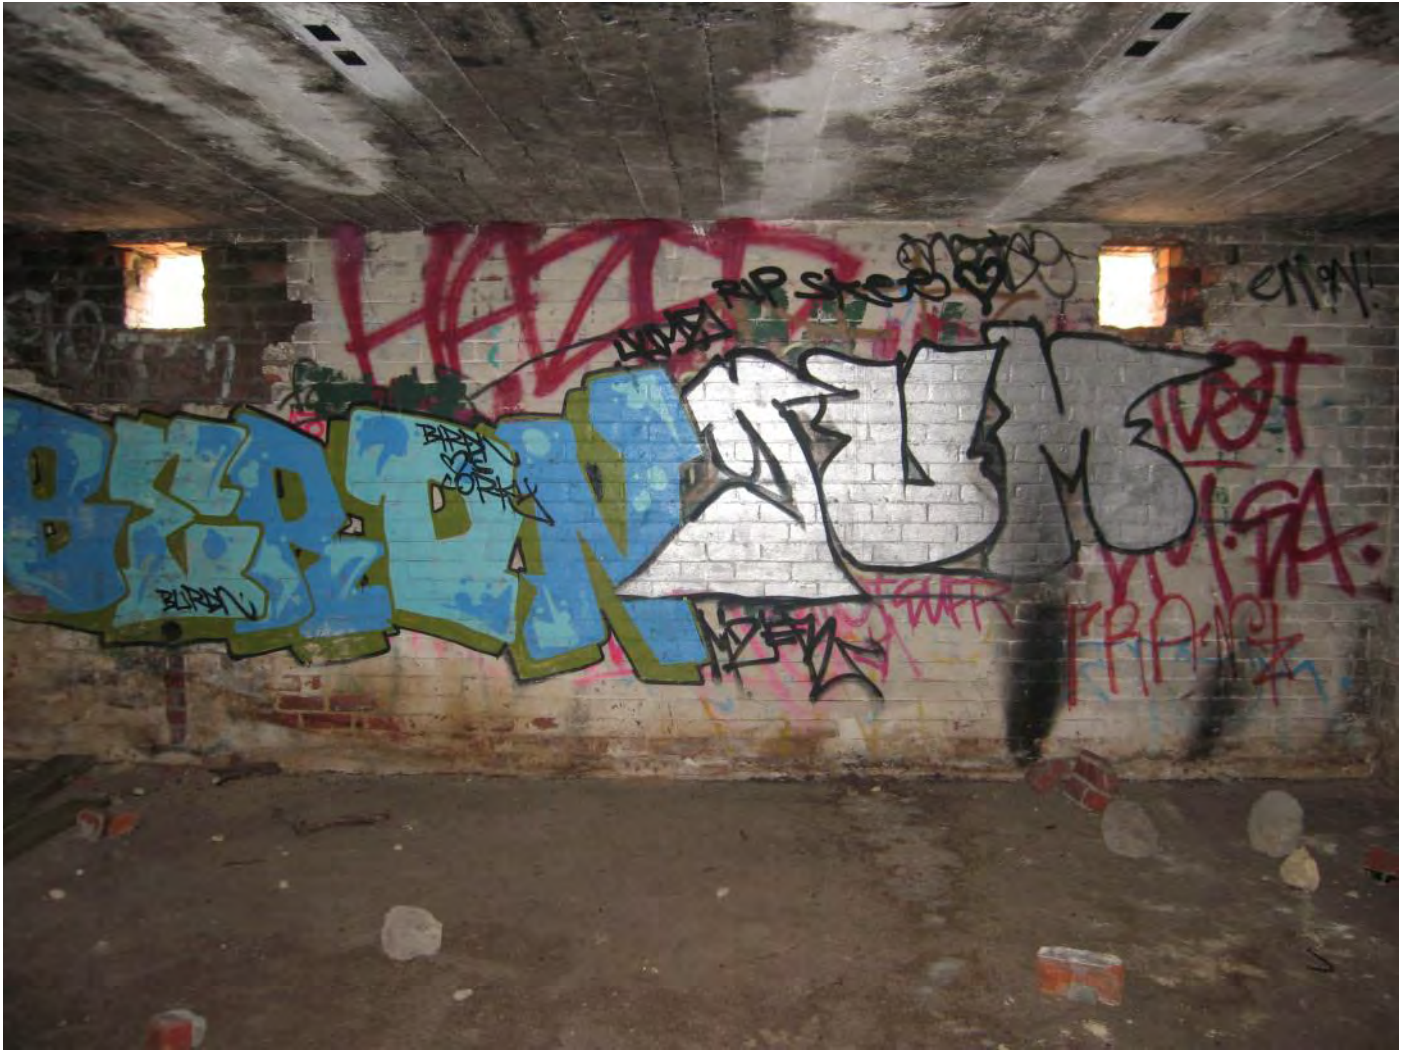
Figure 92: Operations Bunker – interior (north wall)

The bricks around the north west opening have become loose and fallen from the wall. This in part is due to the failure of the steel reinforcement in the brick wall but part of the damage can also be attributed to vandalism. The remainder of the wall around the opening appears to be in a stable condition.

The lower levels of the walls are showing some signs of damp, most of which is attributable to the build up of sand over the years and the inability of the fabric to breathe.

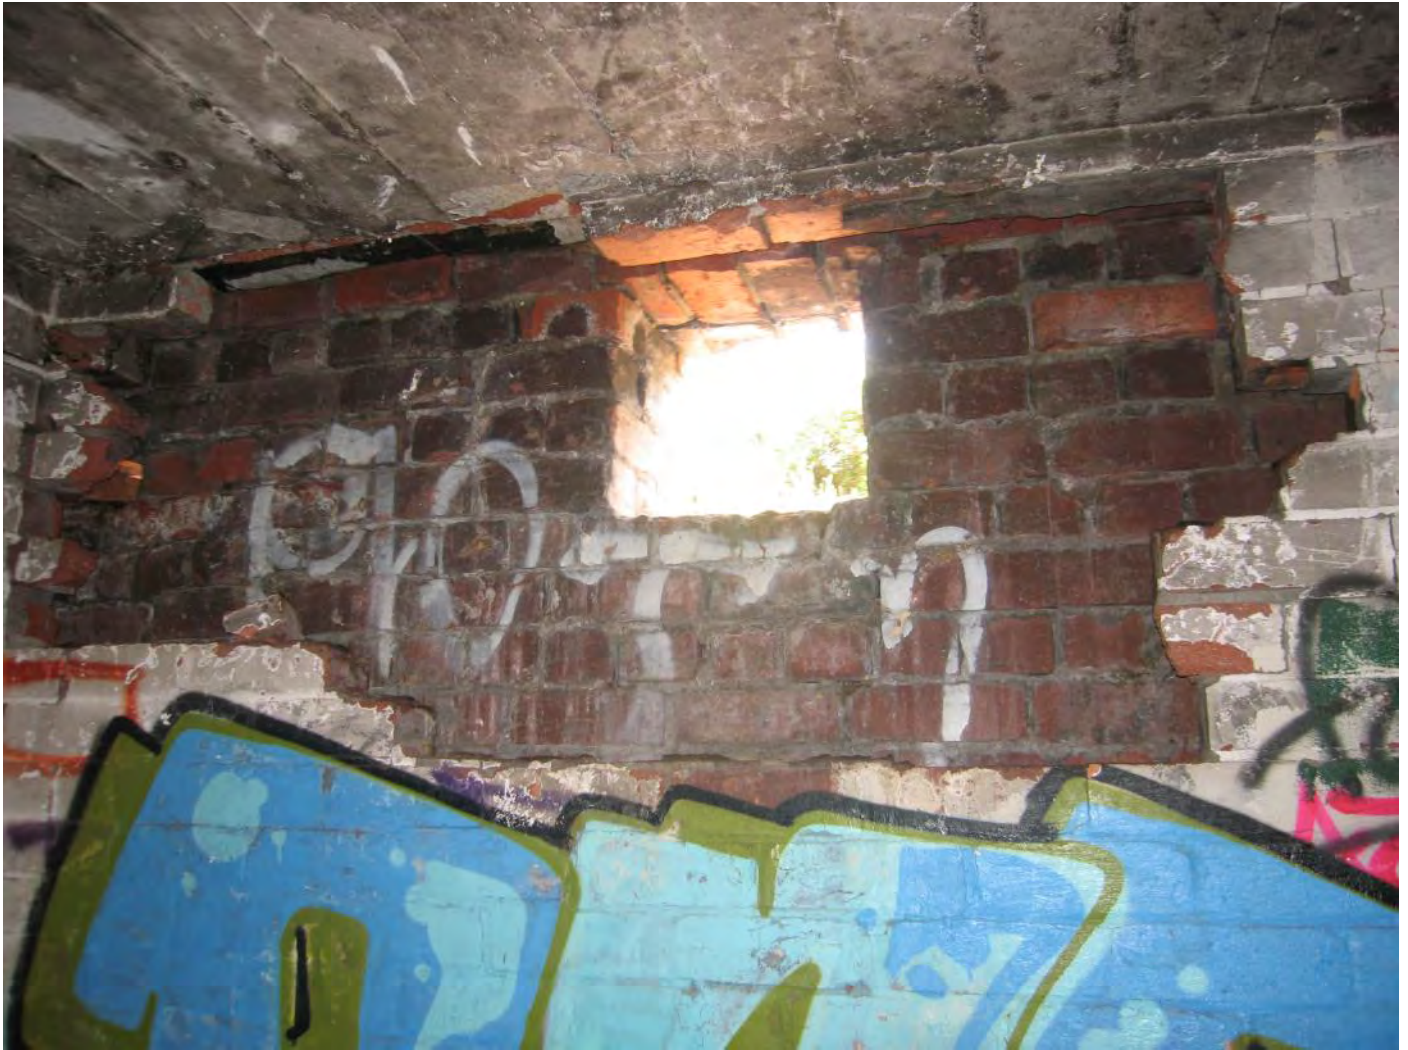
Figure 94: Operations Bunker – Small opening in north wall with damaged brickwork

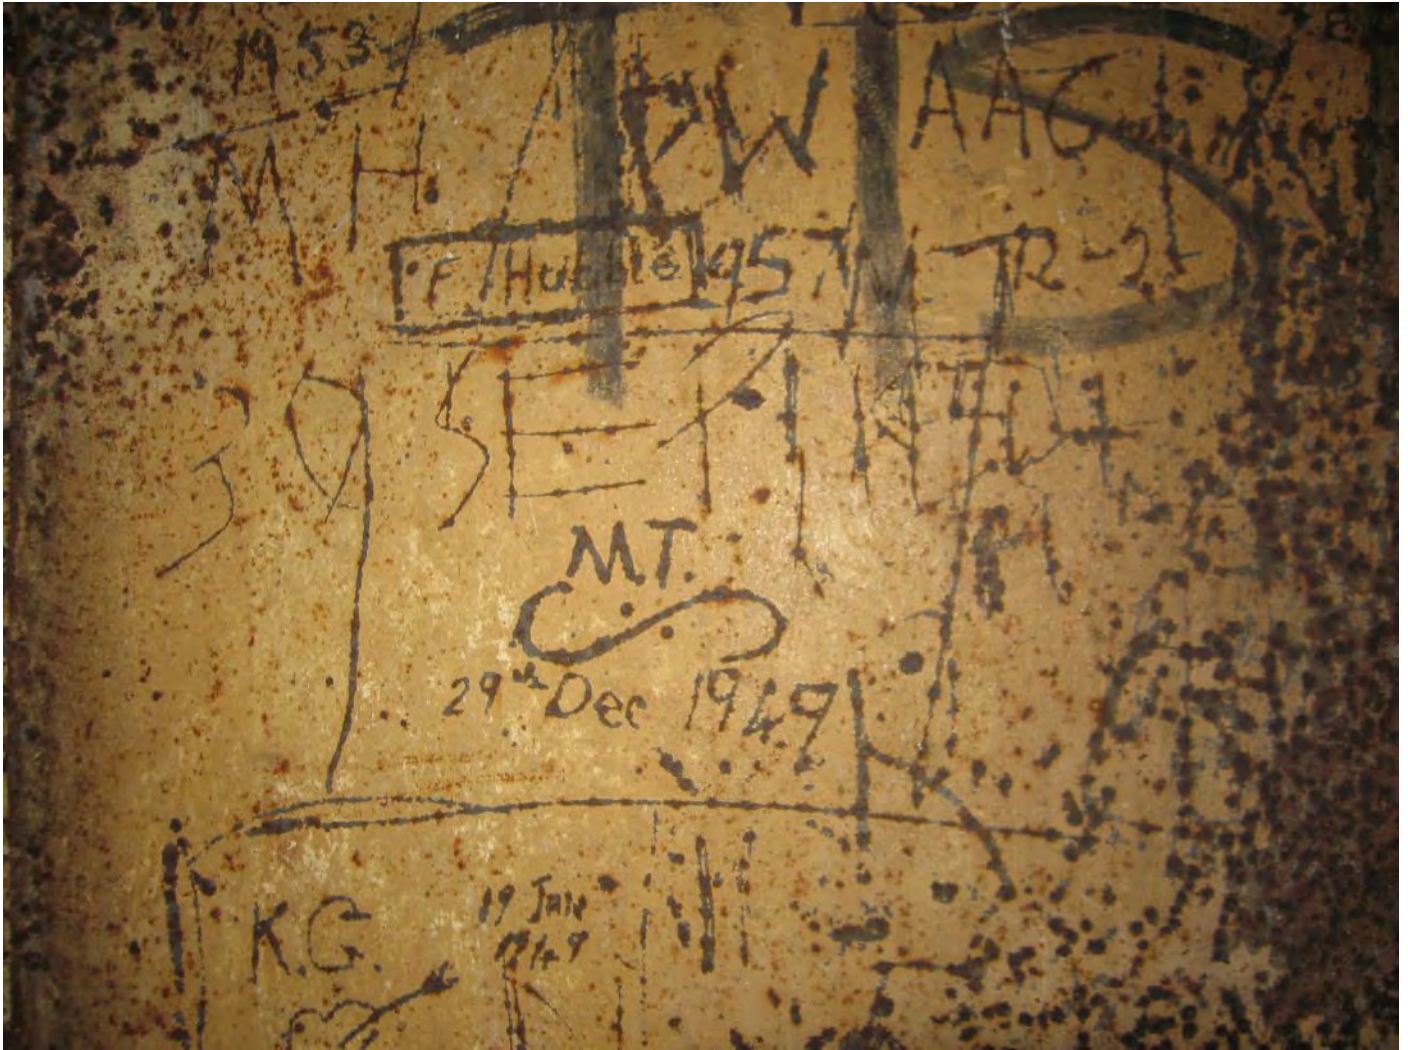
Figure 95: Operations Bunker – Graffiti scratched into entrance doors

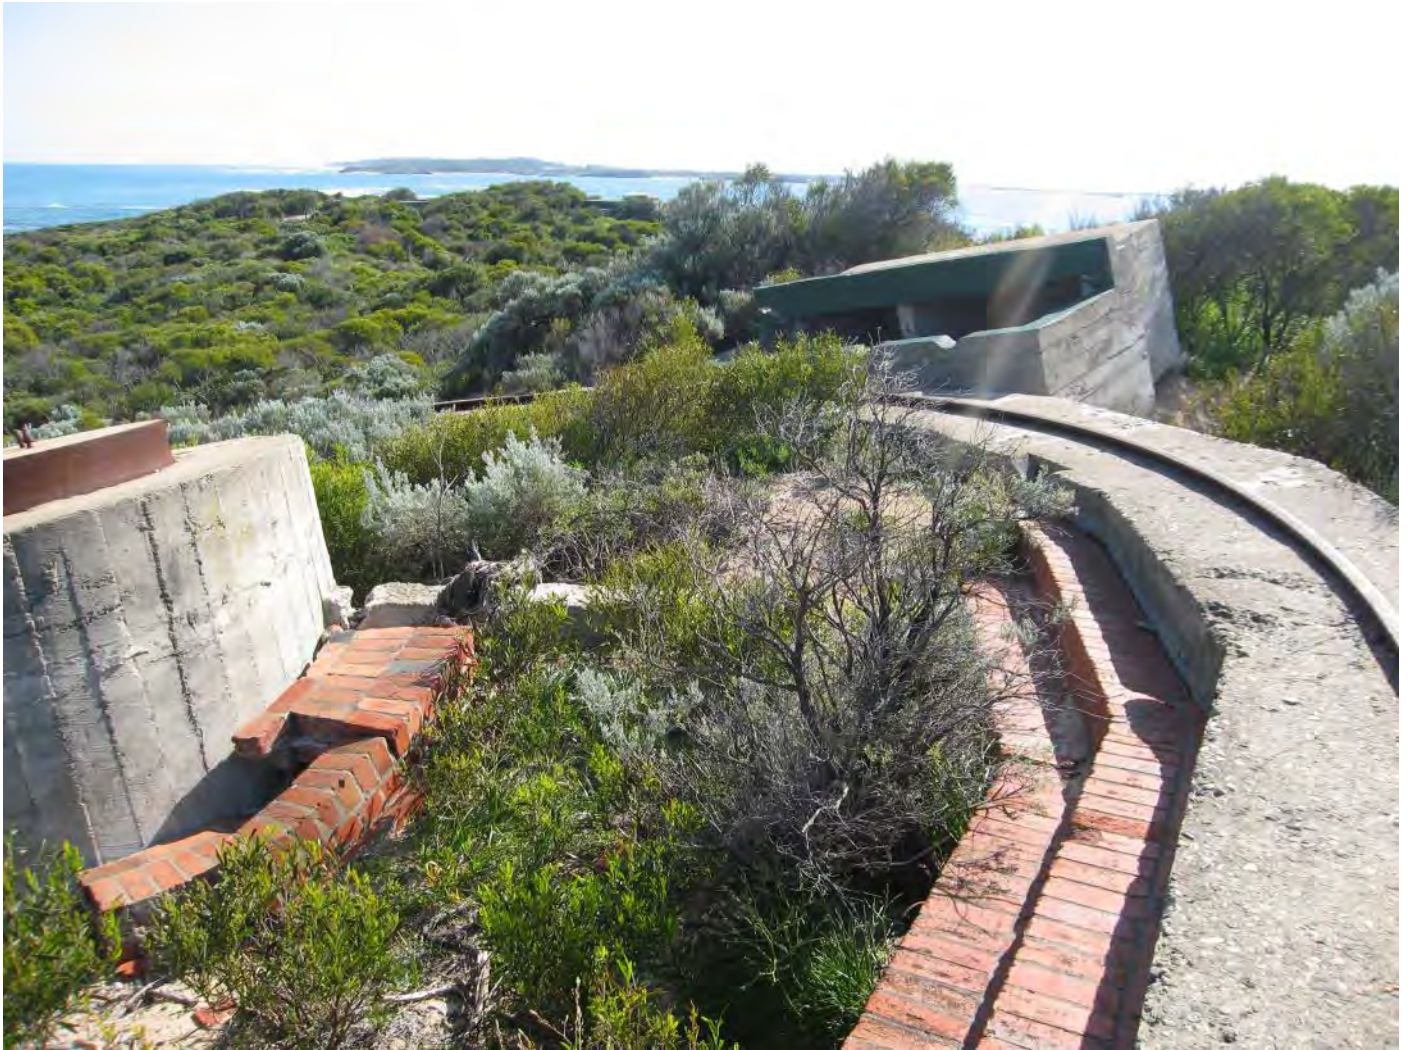
Figure 98: Gun Emplacement

Gun Emplacement No. 1 is not in a good condition, clearly demonstrating how the instable land formation has impacted on the structural stability of the gun emplacement. Over time, the ground levels have changed with much of the sand being eroded revealing the structure of the gun emplacement and eventually undermining its stability as the land has moved away. Much of the original fabric remains in and around the structure but a full understanding of the planning of the gun emplacement and its related structures and functions is no longer clearly visible.

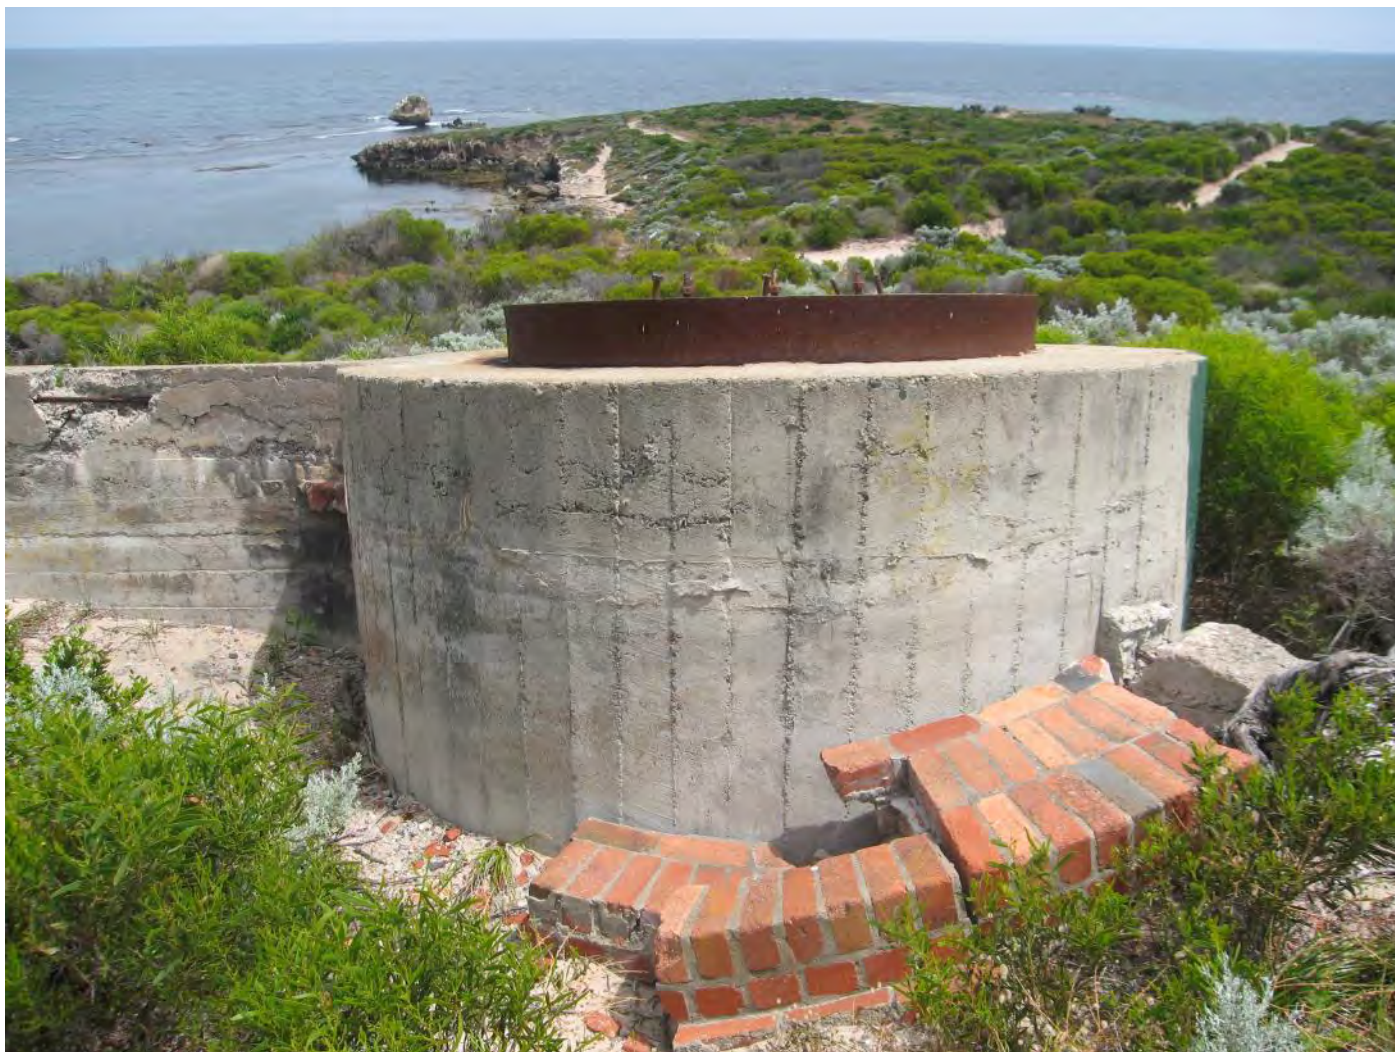
Figure 100: Gun Emplacement

The central gun mount and the concrete walls are all constructed from reinforced concrete. Sections of the concrete have blown due to the rusting of the reinforcements displacing chunks of concrete.

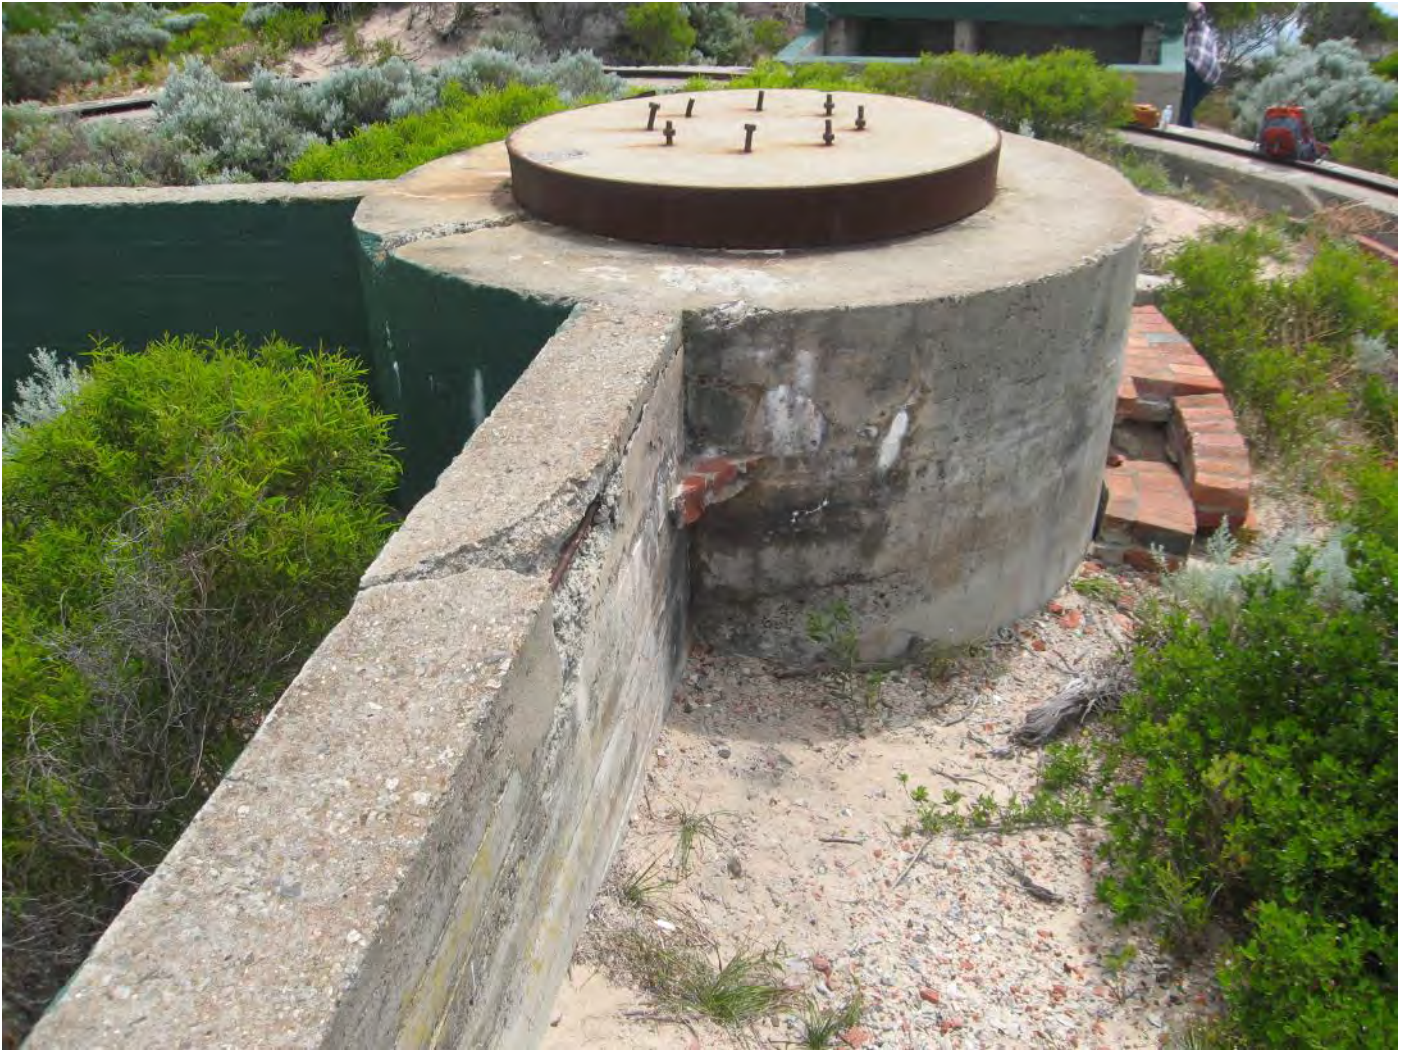
Figure 101: Gun Emplacement - rusted steel reinforcements causing chunks of concrete to blow and break off

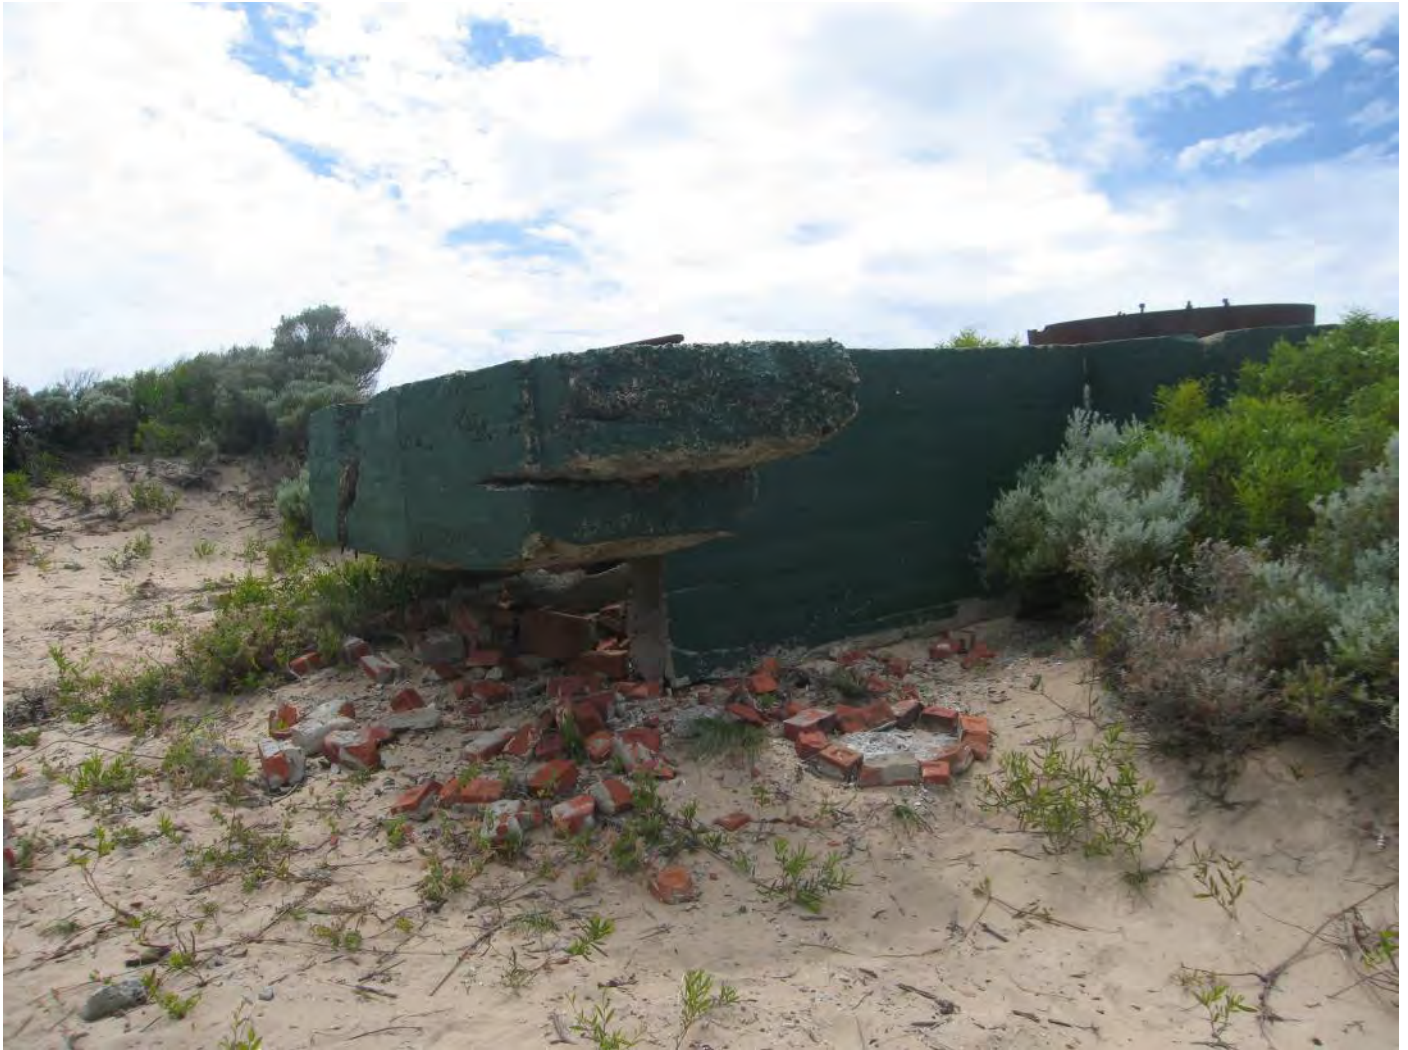
Figure 103: Gun Emplacement

As the underlying ground has moved, the fabric of the gun emplacement has become dislodged and loose. Much of the loose brick fabric appears to be collected on the ground and in the sand underneath the structure.

There is some evidence of concrete cancer in the main structure with elements of concrete breaking off and the reinforcing steel rusted and blown. The movement of the ground and the subsequent displacement of the gun emplacement has also resulted in severe cracking in the concrete structure. Whilst there is no practical reason for the gun emplacement to be reconstructed, the structure must be secured and stabilised as soon as possible.

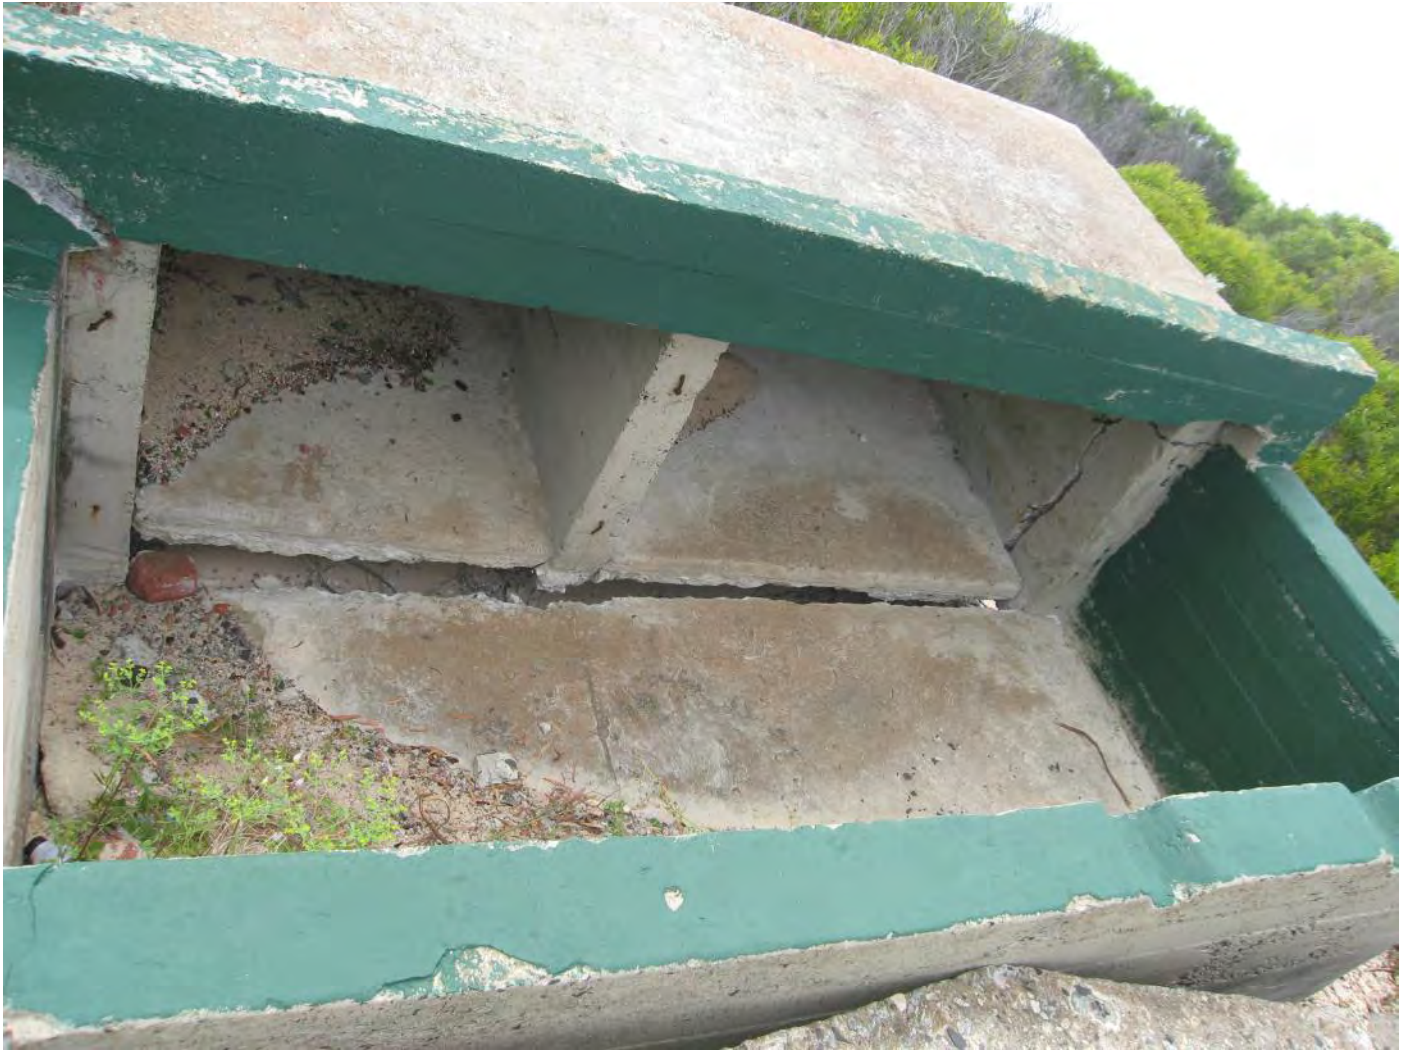
Figure 107: Gun Emplacement - Ammunition Store No. 1

Whilst the structure has remained predominantly in one piece, cracks have occurred in the concrete and the floor of the two store rooms has become displaced. Despite the movement, the concrete walls have remained in tact.

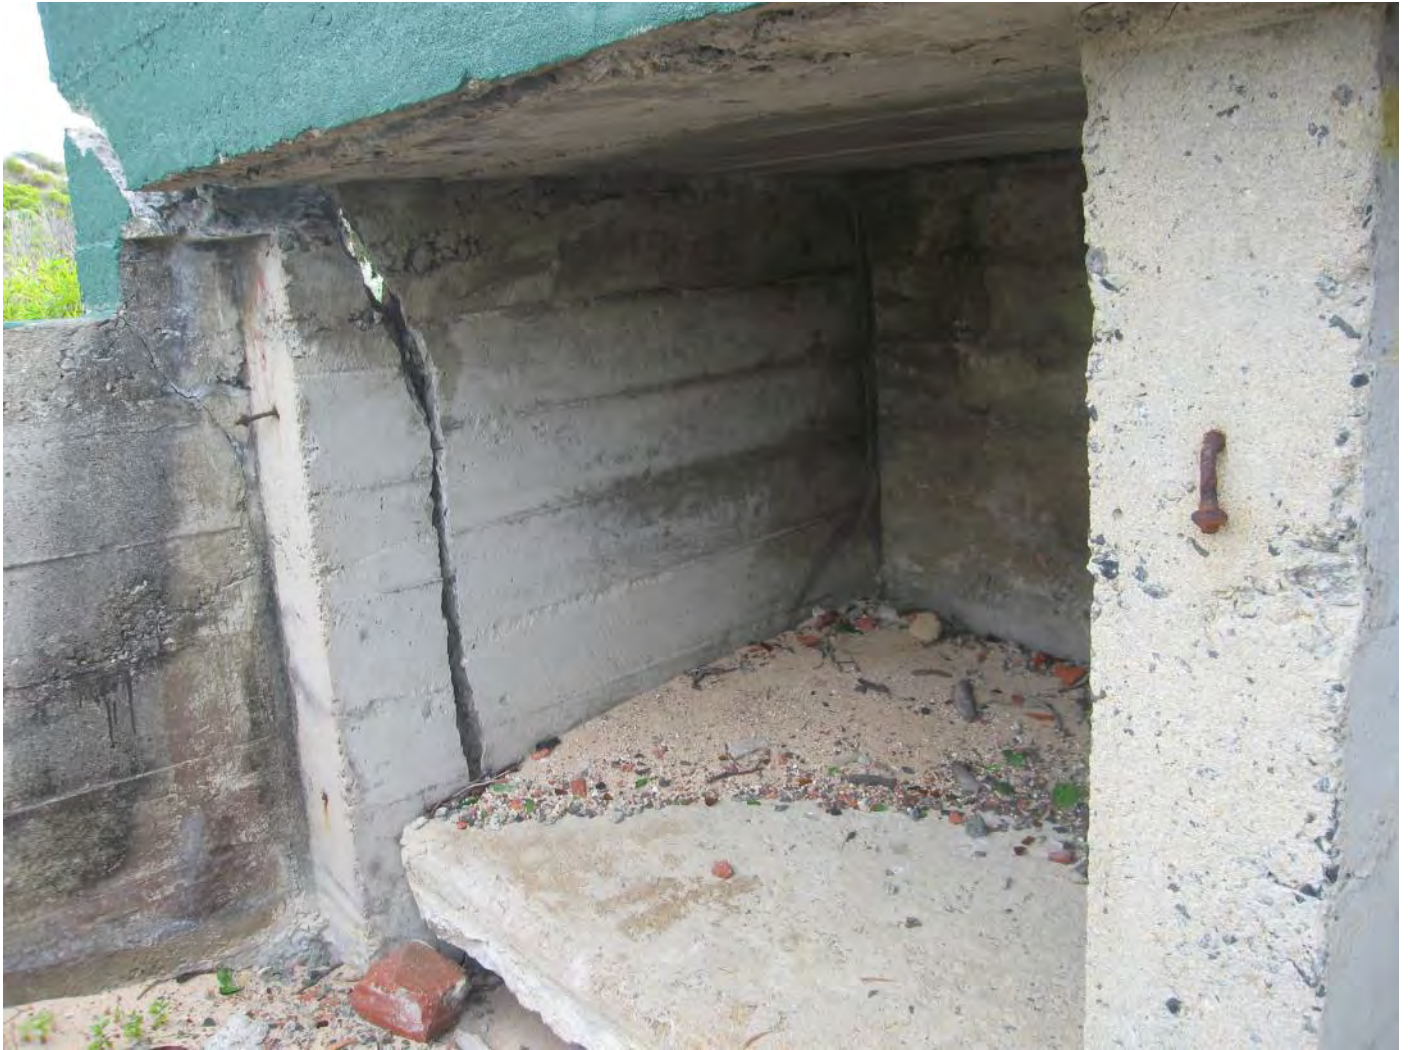
Figure 110: Gun Emplacement - Cracking in the framework of Ammunition Store No. 1

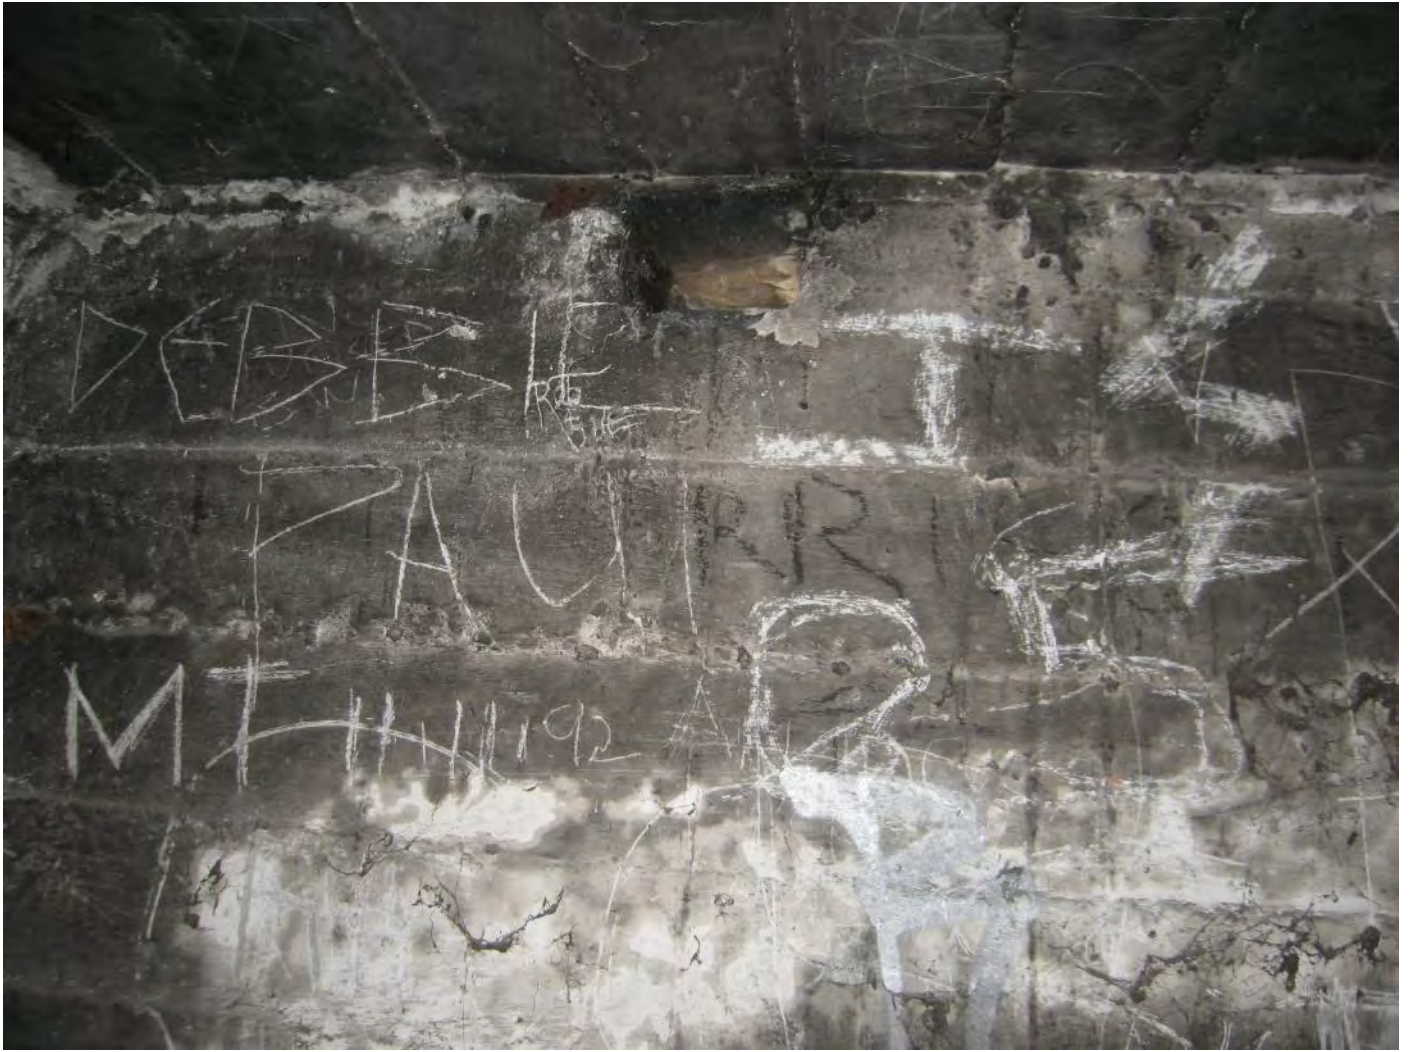
The walls are a dusty white with graffiti with damp staining and possible fire scorch marks.

Figure 123: Ammunition Bunker – graffiti in Room 1
