3.0 Physical Evidence

The physical survey of Point Peron "K" Battery site has been prepared with reference to the available documentary evidence and on an assessment of the existing fabric at the site. The objectives of the survey are to assess the extent of extant fabric and its condition and to determine the extent of conservation works required to safeguard these structures from further deterioration.

3.3 Description of the Surviving fabric

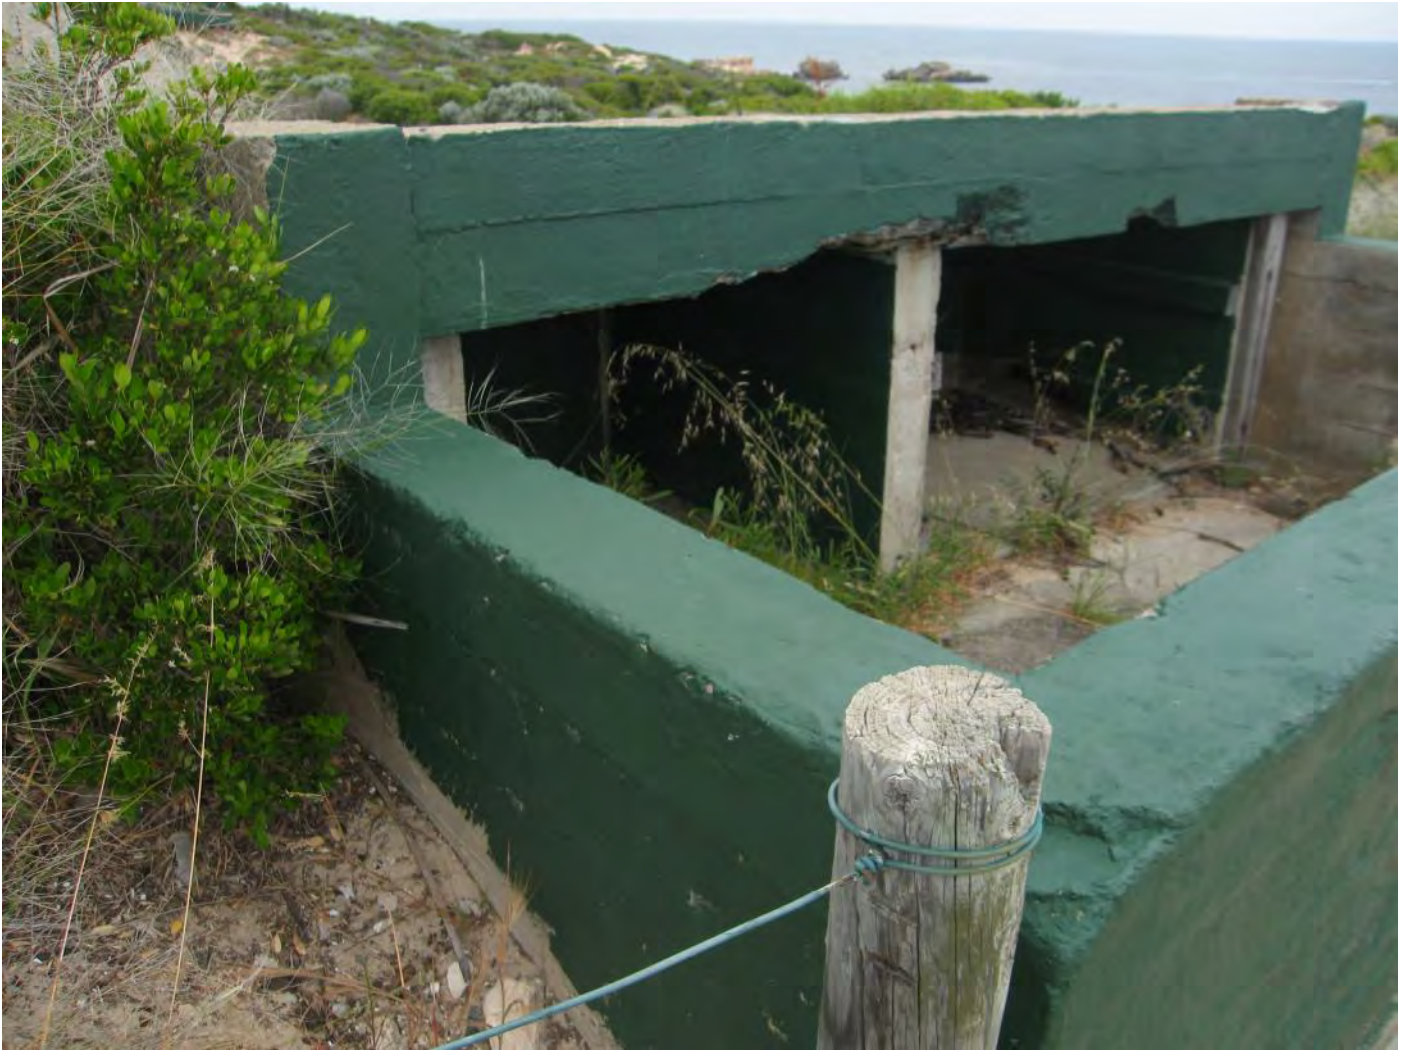
Though generally in good condition, the concrete is beginning to show early signs of concrete cancer in places, especially to the edge of the roof slab where chunks of concrete have broken away and the rusted reinforcing steel is visible.

Figure 135: Gun Emplacement No. 2 – Ammunition Store 1
