Appendix 6: Structural Engineers Assessment Report

Point Peron Rehabilitation Project,
Conservation Management Plan,
Structural Engineering Services Assessment Report

Peter Baxendale (PBCE) was commissioned by Hocking Heritage Studio (HHS) to investigate and advise on the structural condition of the various buildings and building remains at the former Point Peron 'K' Battery site, an integral element of Western Australia's coastal defence during the Second World War.

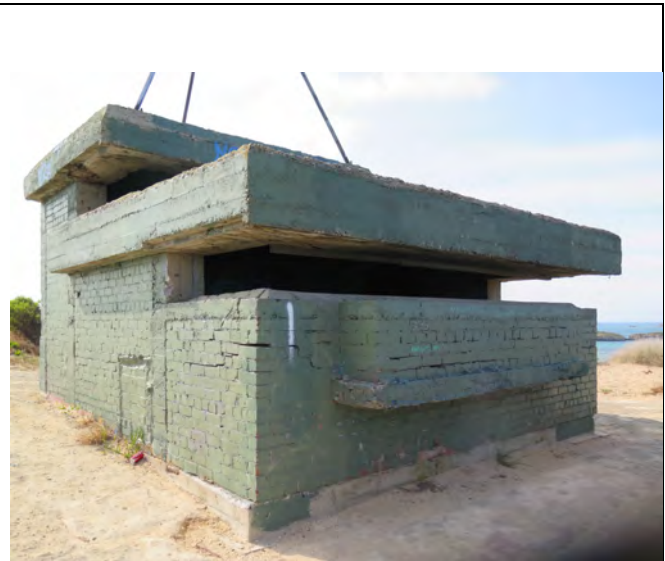
3.1 Observation Tower

The overall condition of the building is good given the original quality and speed of construction, its intended design life at outset, its atmospheric exposure and the levels of maintenance seen since decommissioning.

From the experience of similar sites it is most likely that the rapid acceleration of concrete cancer is not far away. With the cost and invasiveness of concrete repairs, the large scale concrete repair of such structures is likely to be both financially prohibitive and undesirable from a heritage viewpoint due to the scale of fabric loss. A more realistic approach to adopt is that of a managed ruin whereby efforts are focused on measures to slow down the onset of cancer as much as possible. Ultimately cancer will develop but with appropriate measures put in place, particularly those against water ingress and those promoting local and global drainage of surfaces, the timing of such can be slowed down significantly. The building's life is consequently extended significantly as a result.

- i) Re-screeding of concrete roof tops to good falls and with waterproof membrane or acrylic barrier.
- ii) Covers to look out openings at each levels.
- iii) Cover to entrance door opening.
- iv) Possible local concrete patch repairs and/or 'benching' of local surface to improve drainage.
- v) Corrosion inhibitor and epoxy/acrylic barrier coatings to exposed external concrete surfaces.
- vi) Carbonation barrier and corrosion inhibitor coatings to all internal concrete surfaces.

It is unlikely that a cathodic protection approach to concrete cancer management will produce reliable and cost effective results in combating the condition. Weather proofing items i) to iv) above would still be needed as the front line measures against ongoing corrosion.

A permanent solution for the issue outlined in 3.1.3 above is required, whether this is to return backfill against the wall or some other means of providing support to the underside of the storage boxes. Crack damage to the return walls needs to be stitched.

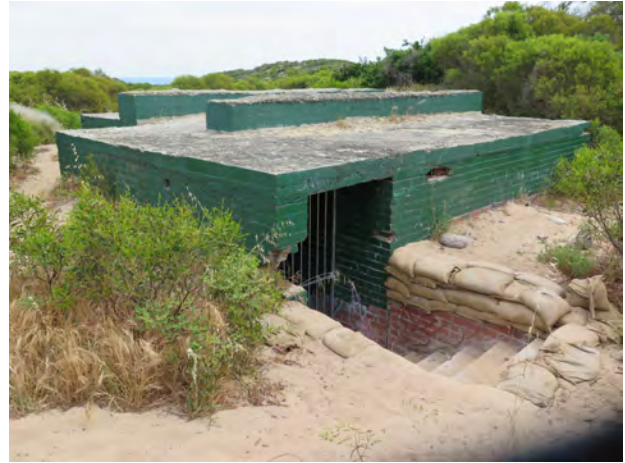
As for the Observation Tower, the structure has fared well given its history. The most vulnerable element on the face of it, the concrete roof slab, is in good condition without widespread cancer damage. Consistent damage has occurred however in the high level courses of the perimeter brickwork onto which the slab immediately drains. Horizontal steel bar bed reinforcement has been used at one course down in the two leafs of brickwork. These have corroded and expanded significantly in locations, particularly at the building corners. Here corrosion forces have been high, sufficient to jack up slab corners and push local brickwork off the building both externally and internally. This is both the most important condition issue and most important safety issue facing the building.

Shifting external ground levels has clearly occurred over time with erosion appearing to dominate the West side and deposition the East. This has not affected the structure much except to increase exposure to lateral moisture penetration on the East side and block the entry (now cleared). Additional lateral pressure is exerted on the brick retaining walls of the entry approach but to no effect as yet since entry clearing work. There has been undermining of the small brick vent shafts on the north side, these have consequently fallen away.

The subject steel causing the high level problems in the brick walls was and remains in fact of little use structurally and is best removed from the structure for the long term good. A systematic approach to raking out joints and removing bars can be used in conjunction with brick and crack repairs.

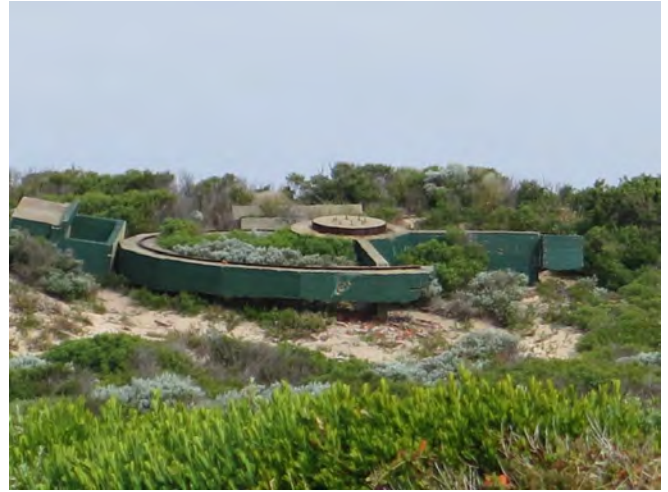
The concrete strip footing of the stay track has been severely undermined and now spans in beam action to where support can be gained from either the dune or radial walls. It has failed in torsion on the North side trying to do this. Steel reinforcement has yielded and a new temporary equilibrium found until further dune erosion brings about a worsening of support conditions. A good deal of the South wing of the footing is suspended and with similar problems. The central concrete pedestal has been partially undermining but has tipped to the North with the weight of the stay footing imposed on it via its wing wall. The brick paving has all but fallen away and the northern munitions store has tipped and slid as a unit in the direction of sand shift, its base breaking up under the movement. The Southern munitions store remains the most stable of the site's features although this too has developed a lean towards downhill.

The principals and actions outlined in 3.1.3 for the Observation Tower apply here for the munitions stores. Issues would not normally be anticipated for the gun mount elements but with their now higher exposure and increased fractures they are much more vulnerable to cancer than their counterparts at Emplacement 2.

Additional concrete repairs

Some additional concrete repairs beyond those for concrete cancer would also possibly be necessary due to the structural damage incurred under dune movement. The scale of these will depend on the scheme selected for re-supporting the structure.

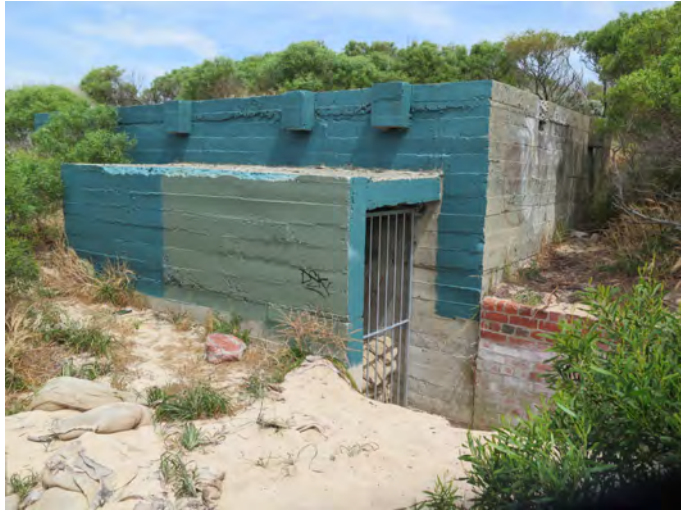
The concrete components have performed remarkably well. Clear concrete cancer is very limited in it's occurrence – at the base of external vent hoods only. The building's location on high ground with good falls away from structure and good drying conditions have benefited the

Internally, brickwork is in good condition. The floor slab are obscured by sand build up but are expected also to be in good condition.

Works needed to secure loose concrete surfaces before re-use is minimal.

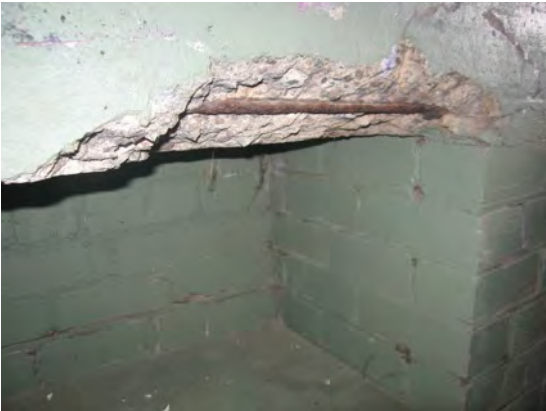
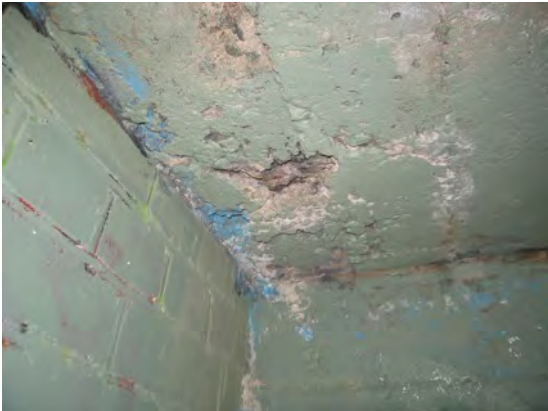
Underside of roof slab forming the ceiling is showing early signs of concrete cancer. Render to concrete column at foot of stairs is drummy, cracking and falling off.

Painted finish with graffiti	Patch repairs to reinforced concrete as outlined above. Monitor condition of ceiling for further deterioration. Remove paint from all elevations as this can contribute to the deterioration of the fabric. Paint removal should not unduly damage the substrate and mortar and test panels in discrete locations should be established prior to embarking on the full removal. Non-caustic solvent based methods or low pressure steam removal can be tried. Peelaway paint removal system can be used or Westox's DeLam which applies a poultice to the paint and will be ready to be removed within a few days. Not all paint traces will be removed due to the texture of the bricks and concrete. Remove drummy render from the concrete column at the foot of the stairs, ensuring that all retained render is in a sound condition. Patch repair in a render mix to match existing. If the structure is to be secured by the metal grille gate graffiti should not be an ongoing issue for the internal space and once all paint and graffiti has been removed, there should not be a requirement to coat the internal fabric with an anti-graffiti coating.	2 2 2

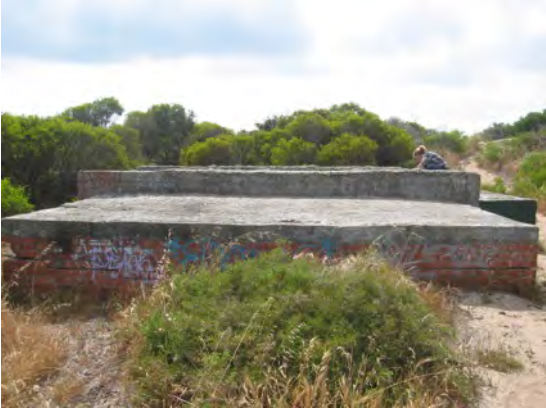
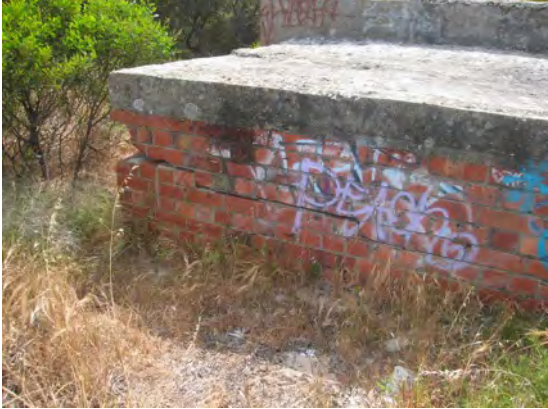
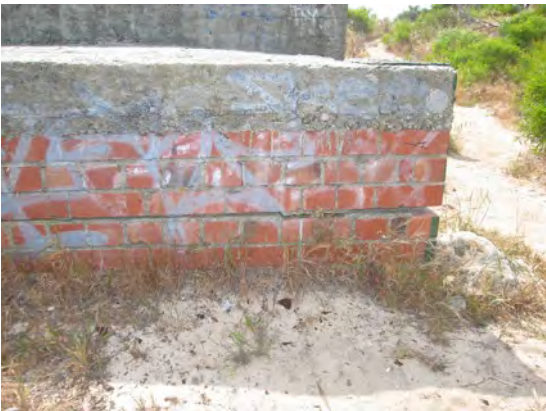
West Elevation	D	<p>Upper sections of brick walls are showing signs of failure due to water damage from the flat roof causing the steel reinforcement bars to rust and expand causing failure to the brickwork.</p>

<p>The reinforcing bars should be removed to prevent further damage. Each should be cut out by raking out the joints, removing the corroded steel, replace with Helibars to crack stitch the walls to engineer specifications.</p> <p>Areas of damaged mortar to be raked out to an appropriate depth to allow the new mortar to hold. New mortar is to match the existing and is advisable to have the mortar analysed to ensure a match is made. The mortar is likely to be a lime mortar which is softer than the brick allowing for moisture to escape through the joints rather than destroy the brick. Due to the harsh environmental conditions the structures are located in, consideration may be given to using a hydraulic lime to give increased strength. The original style of pointing should be replicated in all new work.</p> <p>Where bricks need to be replaced, these should be salvaged bricks to match the existing. Bricks from around the site may be used. All introduced bricks should be the same dimensions as the originals.</p> <p>Concrete elements are to be remediated. Rusting to the structural elements encased by the concrete is becoming visible causing the concrete to spall and break off. The high salt content in the air contributes to the accelerated rate of deterioration as does inadequate protection from water ingress.</p> <p>It is not recommended that the damaged concrete be removed in its entirety, utilising patch repairs to try and retain the original fabric. Where the steel reinforcement has rusted causing the concrete to spall, the concrete needs to be cutback and the steel cleaned, treated with an anticorrosive treatment such as Sika Ferro Guard and new concrete patched in to match existing. Due to the harsh environmental conditions at Point Peron, it is recommended that a corrosion barrier coating is applied to all concrete surfaces to reduce/delay further deterioration.</p> <p>Graffiti is an issue across the site. Santi graffiti coatings can be applied but these should not be to the detriment of the original underlying fabric. Any coating should allow the underlying fabric to breathe and function as designed. Any coating should not impact on the aesthetic of the underlying fabric.</p>	<p>1</p> <p>1</p> <p>1</p>

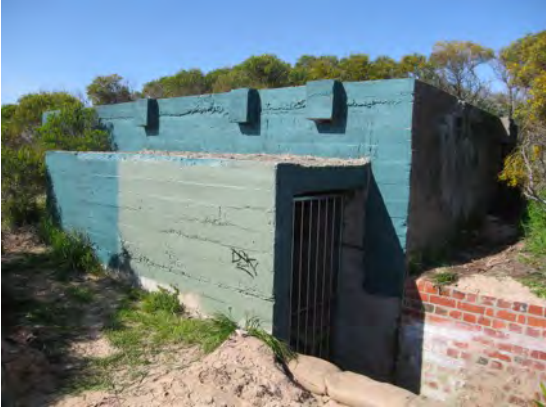
<p>North Elevation</p>	<p>B</p>	<p>The north elevation is the principal façade and is the only elevation that is clearly visible. The key elements being the entrance and the projecting air vents positioned along the roof line of the elevation. Minimal signs of concrete cancer. Painted finish.</p>	<p>Remove paint from entire elevation as this can contribute to the deterioration of the fabric. Paint removal should not unduly damage the substrate and mortar and test panels in discrete locations should be established prior to embarking on the full removal. Non-caustic solvent based methods or low pressure steam removal can be tried. Peelaway paint removal system can be used or Westox's DeLam which applies a poultice to the paint and will be ready to be removed within a few days. Not all paint traces will be removed due to the texture of the bricks and concrete.</p>	<p>2</p>

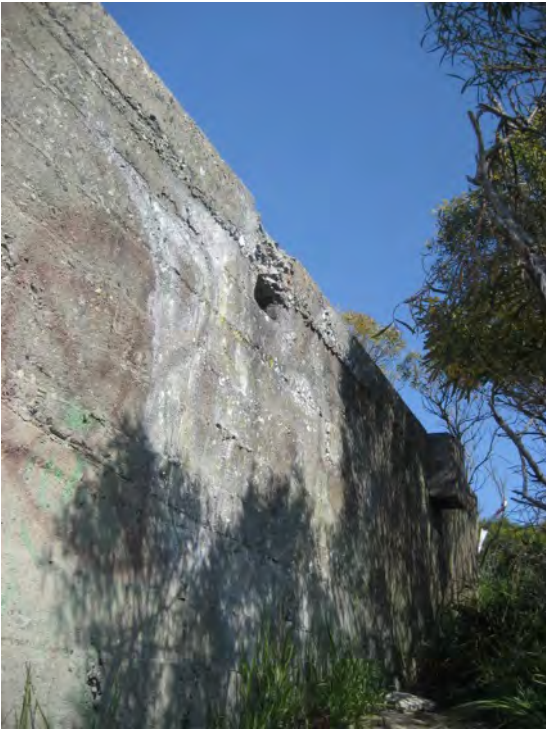
Building Name	Condition Rating	Defect and Location	Work to Rectify Defect	Priority Ranking
West Elevation	C	<p>Slight concrete damage. Loss of ventilation shaft and deterioration to underlying concrete. Water drainage issues from roof causing some of the deterioration.</p>

<p>Repair concrete around the air vent. To prevent further damage the air vent shaft should be reconstructed based on the design of extant air shafts. Protection of the opening will safeguard the vulnerable fabric around the opening and also prevent water ingress into the building.</p>	2
Roof	C	<p>Appears to be in sound condition with only hairline cracking. Water drainage issues causing some damage to the air vent shafts and edge of the concrete roof. Sand build up on the roof with subsequent vegetation growth.</p>

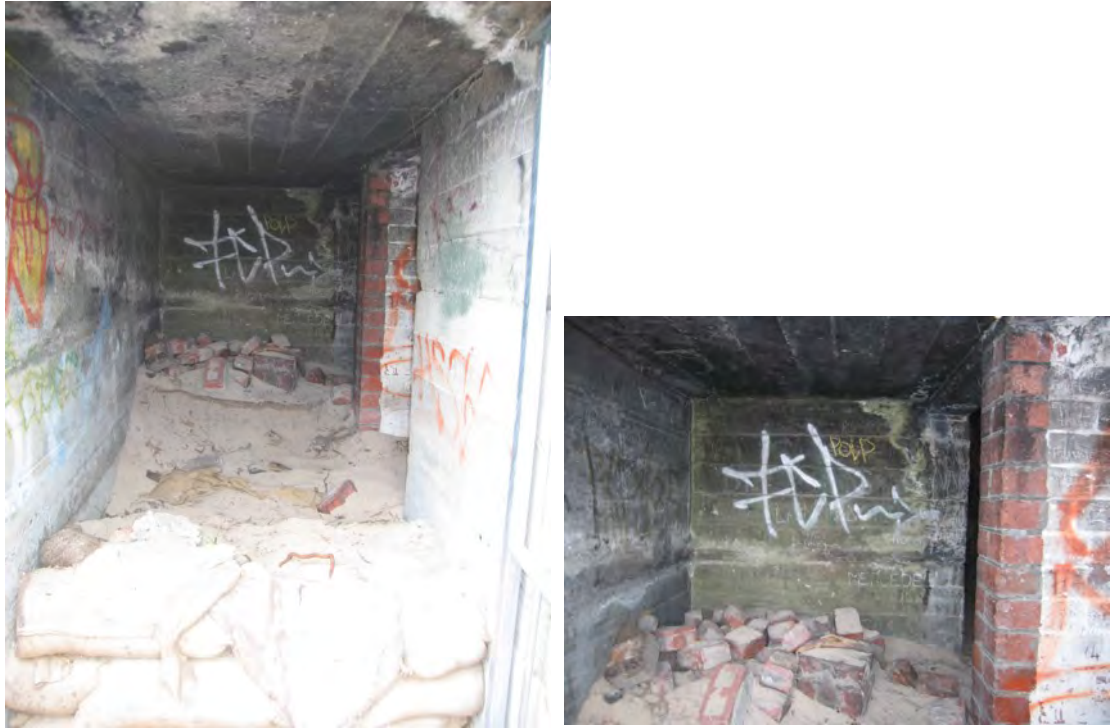
Building Name	Condition Rating	Defect and Location	Work to Rectify Defect	Priority Ranking
<p>Interior Entry passageway</p>	<p>C</p>	<p>Concrete walls, ceiling and floor. Graffiti to most surfaces. Deep sand build-up. Partial painted treatment to walls.</p>

<p>Remove paint from entire elevation as this can contribute to the deterioration of the fabric. Paint removal should not unduly damage the substrate and mortar and test panels in discrete locations should be established prior to embarking on the full removal. Non-caustic solvent based methods or low pressure steam removal can be tried. Peelaway paint removal system can be used or Westox's DeLam which applies a poultice to the paint and will be ready to be removed within a few days. Not all paint traces will be removed due to the texture of the bricks and concrete.</p> <p>Remove sand and inspect walls and floor for damage.</p> <p>Retain all loose bricks for repairs to the structure or other buildings on site.</p>	<p>2</p> <p>1</p>

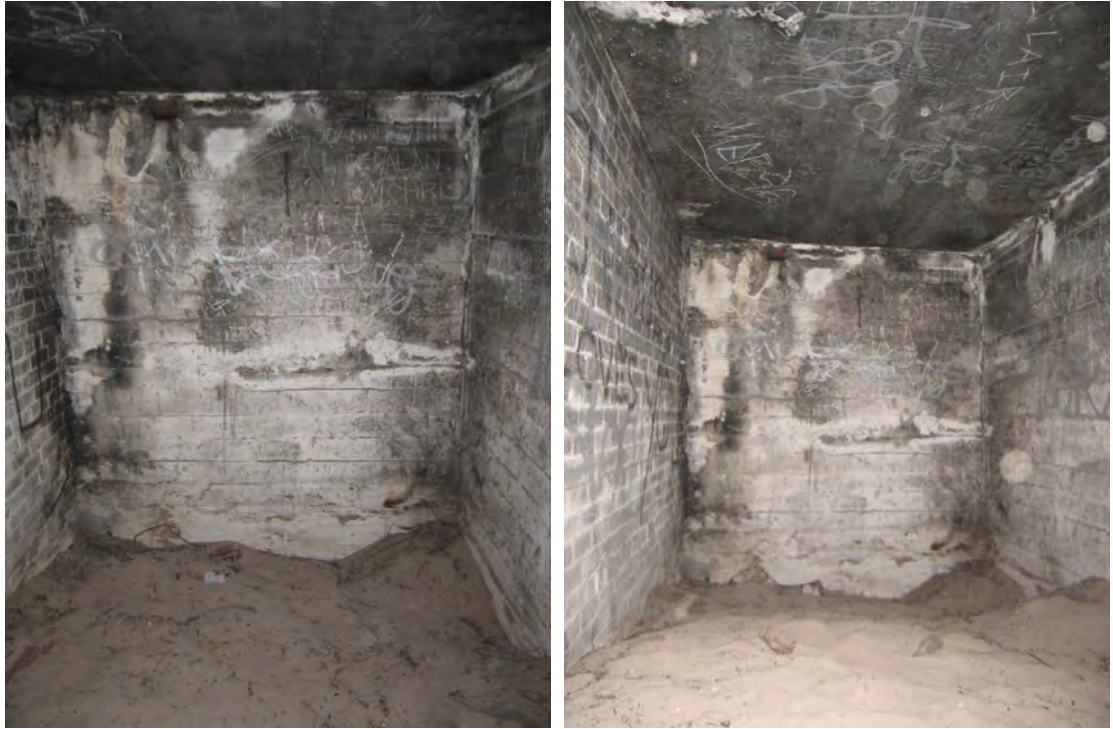
<p>Room 1</p>	<p>C</p>	<p>Concrete outer walls and a brick partition wall. Clouded white paint finish wearing off. Walls with graffiti. Sand accumulation.</p>

<p>Remove sand accumulation and monitor further collections to prevent damage to floor and lower levels of the walls. Remove painted finish and graffiti.</p>	<p>2</p>

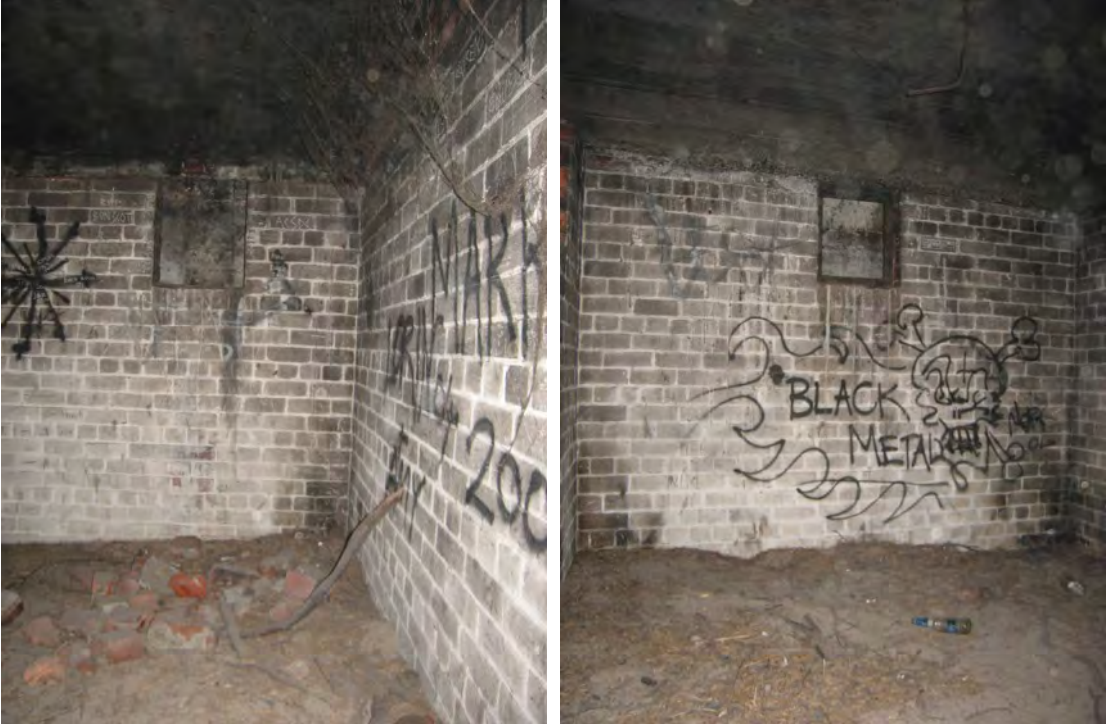
Building Name	Condition Rating	Defect and Location	Work to Rectify Defect	Priority Ranking
Room 2 plus blast corridor	C	<p>Brick internal walls with concrete outer walls. Clouded paint finish to walls with graffiti. Sand accumulation.</p>

<p>Remove graffiti. There is no requirement for an anti-graffiti coating to be applied if public access is going to be controlled. Removal of graffiti should not damage the underlying brick and concrete.</p> <p>Remove painted finish to the walls as per specifications above or other suitable alternative conservation method.</p> <p>Slight signs of concrete deterioration to the ceiling. Further deterioration to be monitored.</p> <p>Sand accumulation to be monitored and removed prior to substantial build-up.</p>	2 2
<p>Gun Emplacement No. 2</p> <p>Reinforced concrete retaining wall, brick steps and paving, central reinforced concrete gun mount</p>	B	<p>Gun Emplacement No. 2 is in good condition and has not suffered from the same fate as its counterpart Gun Emplacement No. 1. Shifting sand and ground conditions do not appear to be impacting on the structural condition of this structure.</p> <p>There is some concrete damage to the top of the gun mount and the steel perimeter edging around the top of the mount has rusted in places, springing loose from the concrete it is encasing.</p> <p>Sand accumulation in places.</p> <p>Non-original painted surfaces.</p>	<p>Conservation works are limited to replacing the steel edge to the gun mount and regularly removing the sand. The paint should be removed from the gun mount as per the methodology specified elsewhere in this report.</p> <p>The concrete elements should be regularly monitored as they will be susceptible to the harsh coastal environmental conditions.</p> <p>As this element is to be the main focus of the site and potentially the site for a memorial, the visitor numbers will be higher. The paving and brick steps should be regularly inspected to ensure they are not loose and creating trip hazards.</p>	2

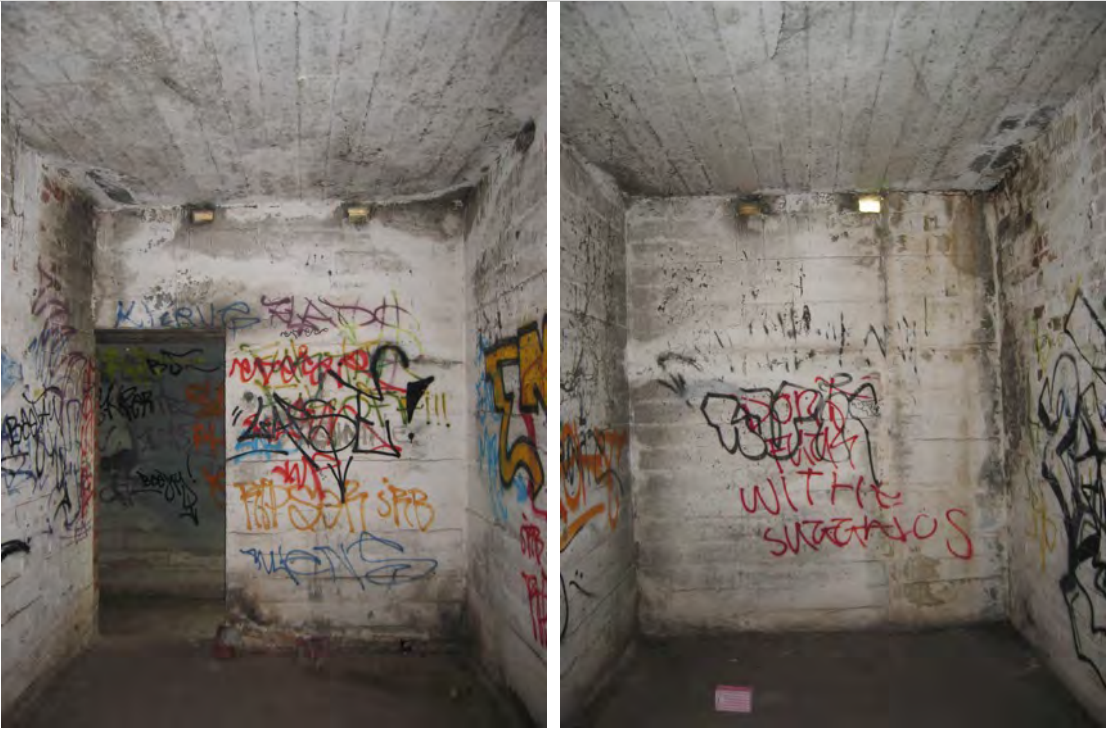
<p>Room 2 plus blast corridor</p> <p>Concrete outer walls and brick inner walls, concrete ceiling and floor</p>	<p>C</p>	<p>Brick work to the internal walls is generally in sound condition, with some graffiti. Dusted white painted finish wearing off from the walls. Some slight signs of damp at the junction between the wall and ceiling, likely to be in line with the roof cracks. Evidence of recent sand removal from both the main room and the blast corridor. Signs of early concrete cancer to the roof with some of the enforcement bars rusting and breaking through the concrete.</p>

<p>Remove paint from entire elevation as this can contribute to the deterioration of the fabric. Paint removal should not unduly damage the substrate and mortar and test panels in discrete locations should be established prior to embarking on the full removal. Non-caustic solvent based methods or low pressure steam removal can be tried. Peelaway paint removal system can be used or Westox's DeLam which applies a poultice to the paint and will be ready to be removed within a few days. Not all paint traces will be removed due to the texture of the bricks and concrete.</p> <p>Remove graffiti. An anti-graffiti coating is not required.</p> <p>Ensure sand levels are monitored, removing any sand build up on a regular basis.</p>	<p>2</p> <p>2</p> <p>1</p>
