Point Peron "K" Battery Conservation Management Plan

South West Corridor Development Foundation Inc.

March 2016

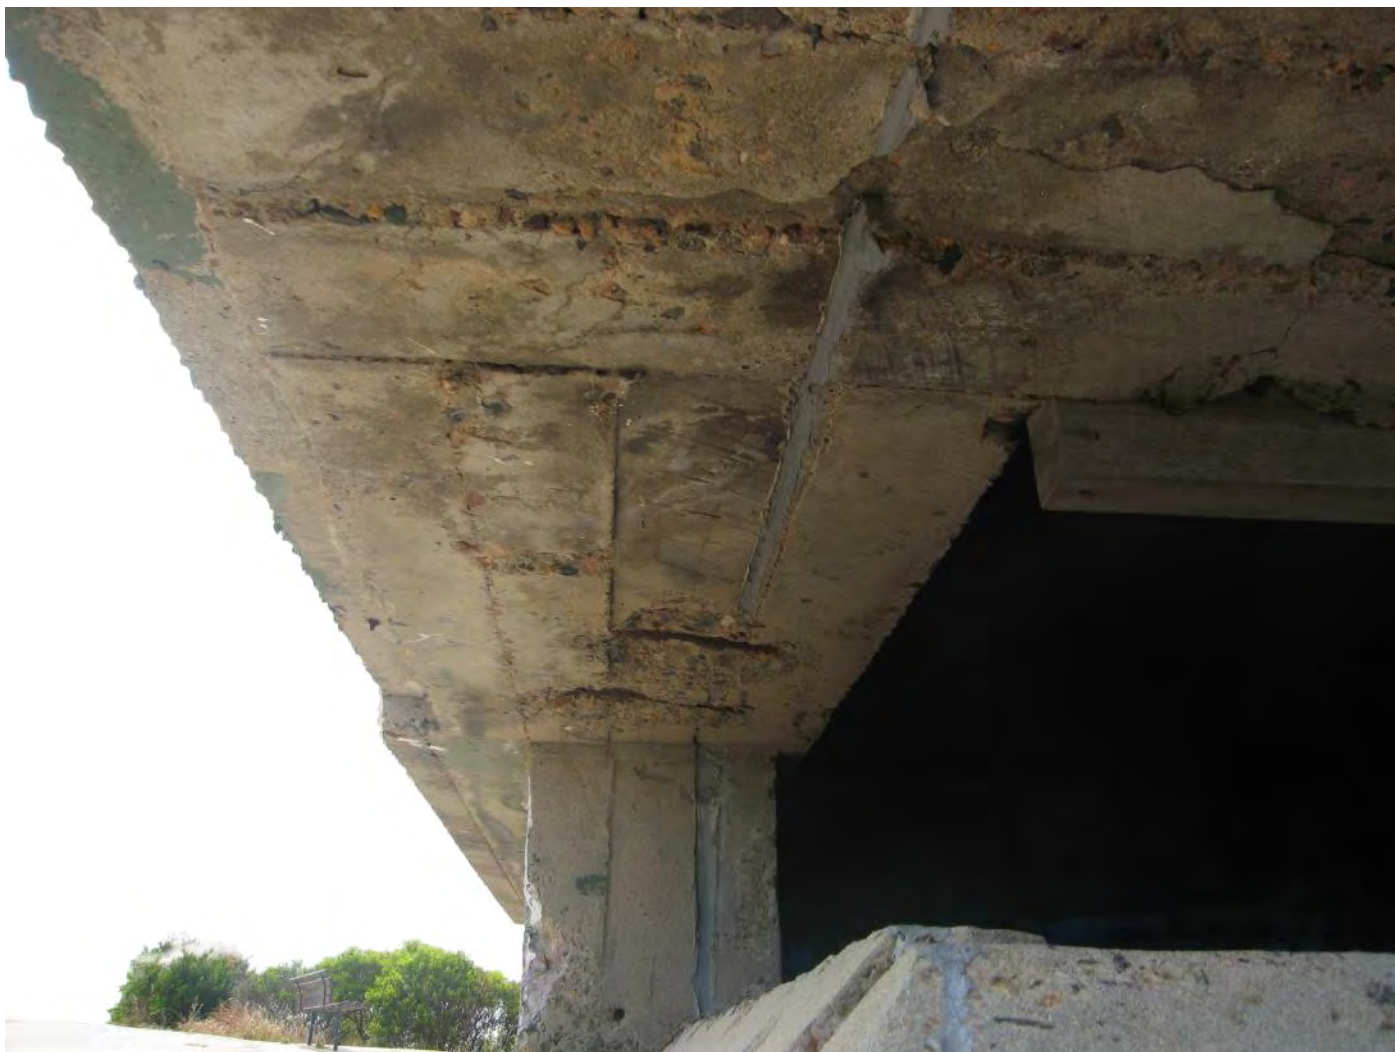
Research has shown that in similar structures, the ground level often came up to the bottom of these projection or slightly above providing support. Over time the ground level has eroded or has been manually removed to provide a flat walking surface around the structure which has removed all support for the projecting element. As a consequence, the weight of the projecting storage area is pulling the wall away from the rest of the structure which is evident in the cracking seen along the brick joints.

Figure 61: Underside of Concrete Overhang to Observation Opening

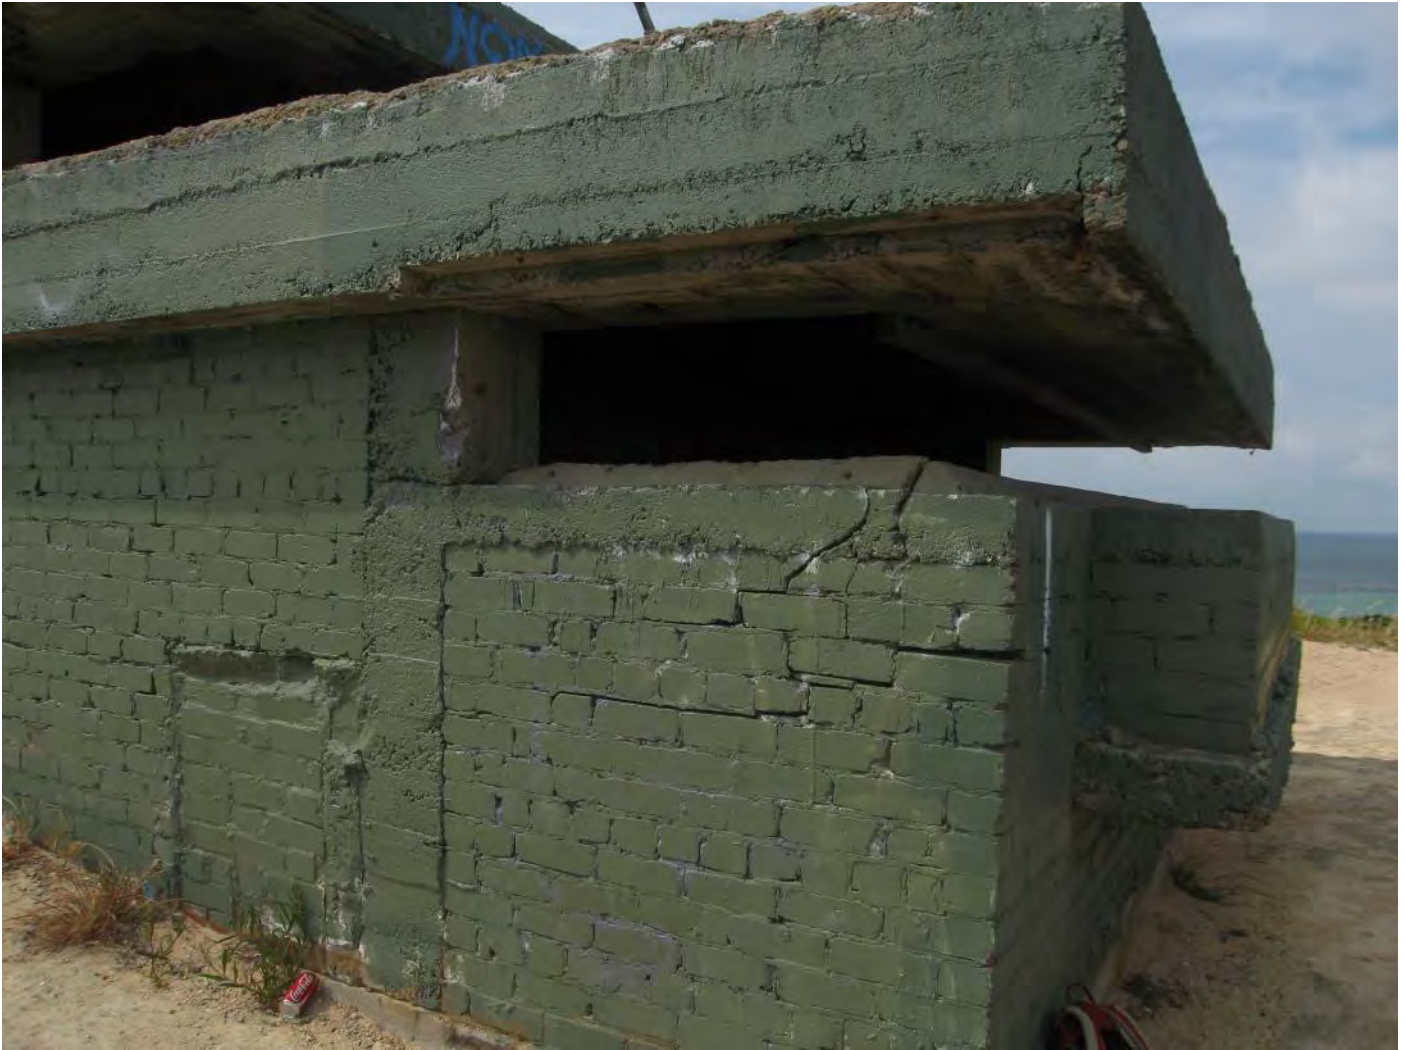
Figure 63: North Elevation – western corner being pulled away from the main elevation

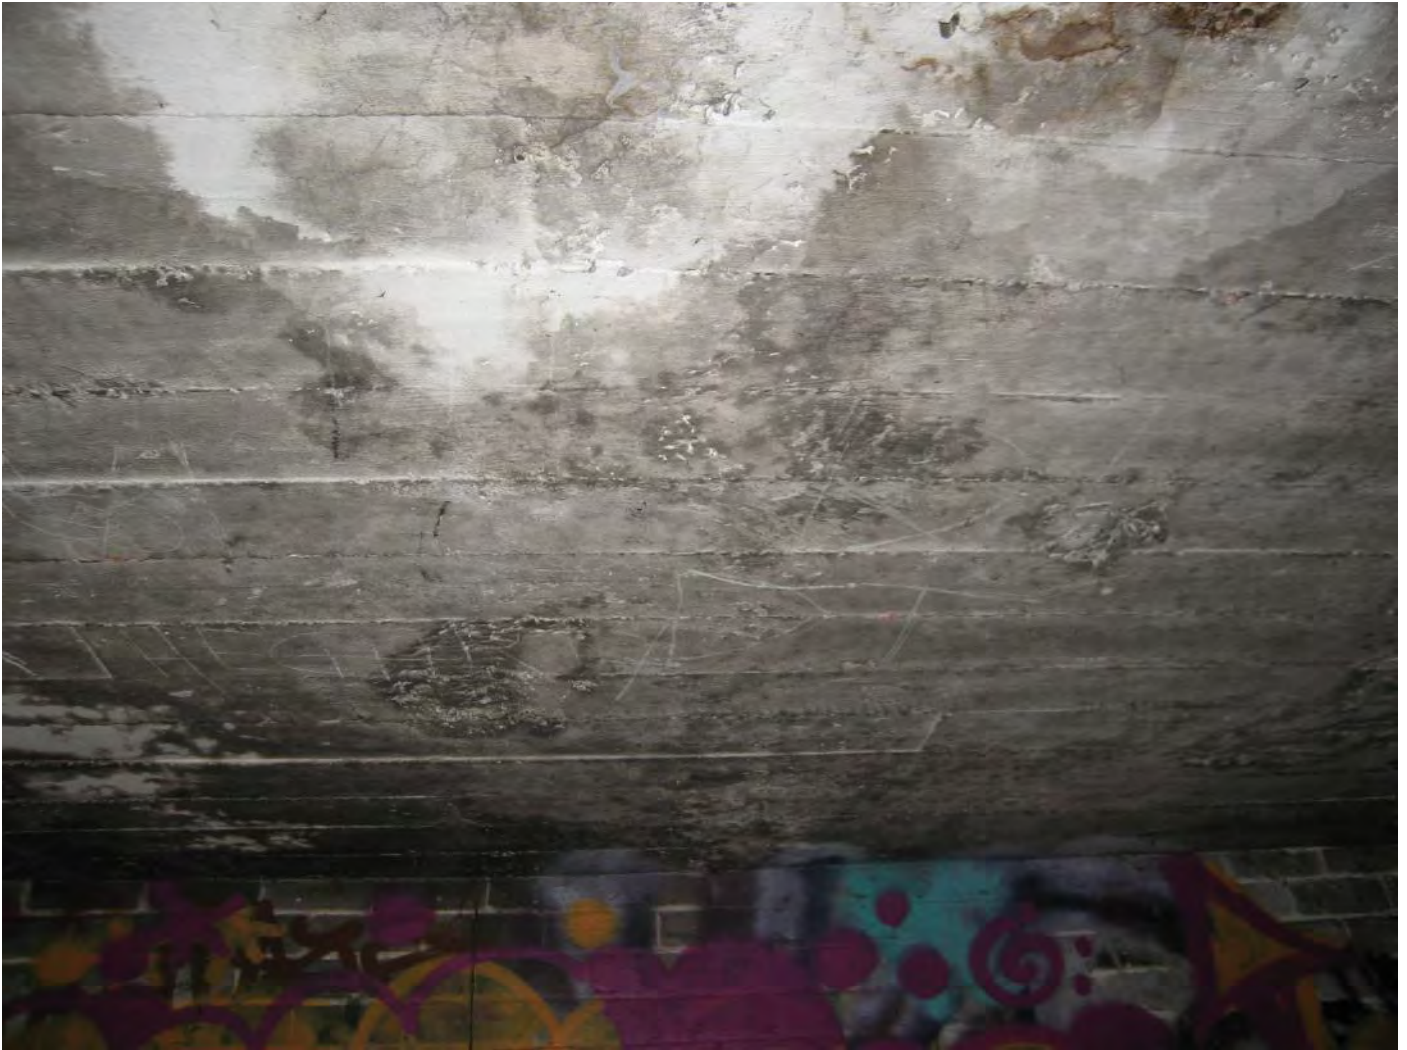
Figure 93: Operations Bunker – Ceiling plan

The lower levels of the walls are showing some signs of damp, most of which is attributable to the build up of sand over the years and the inability of the fabric to breathe.

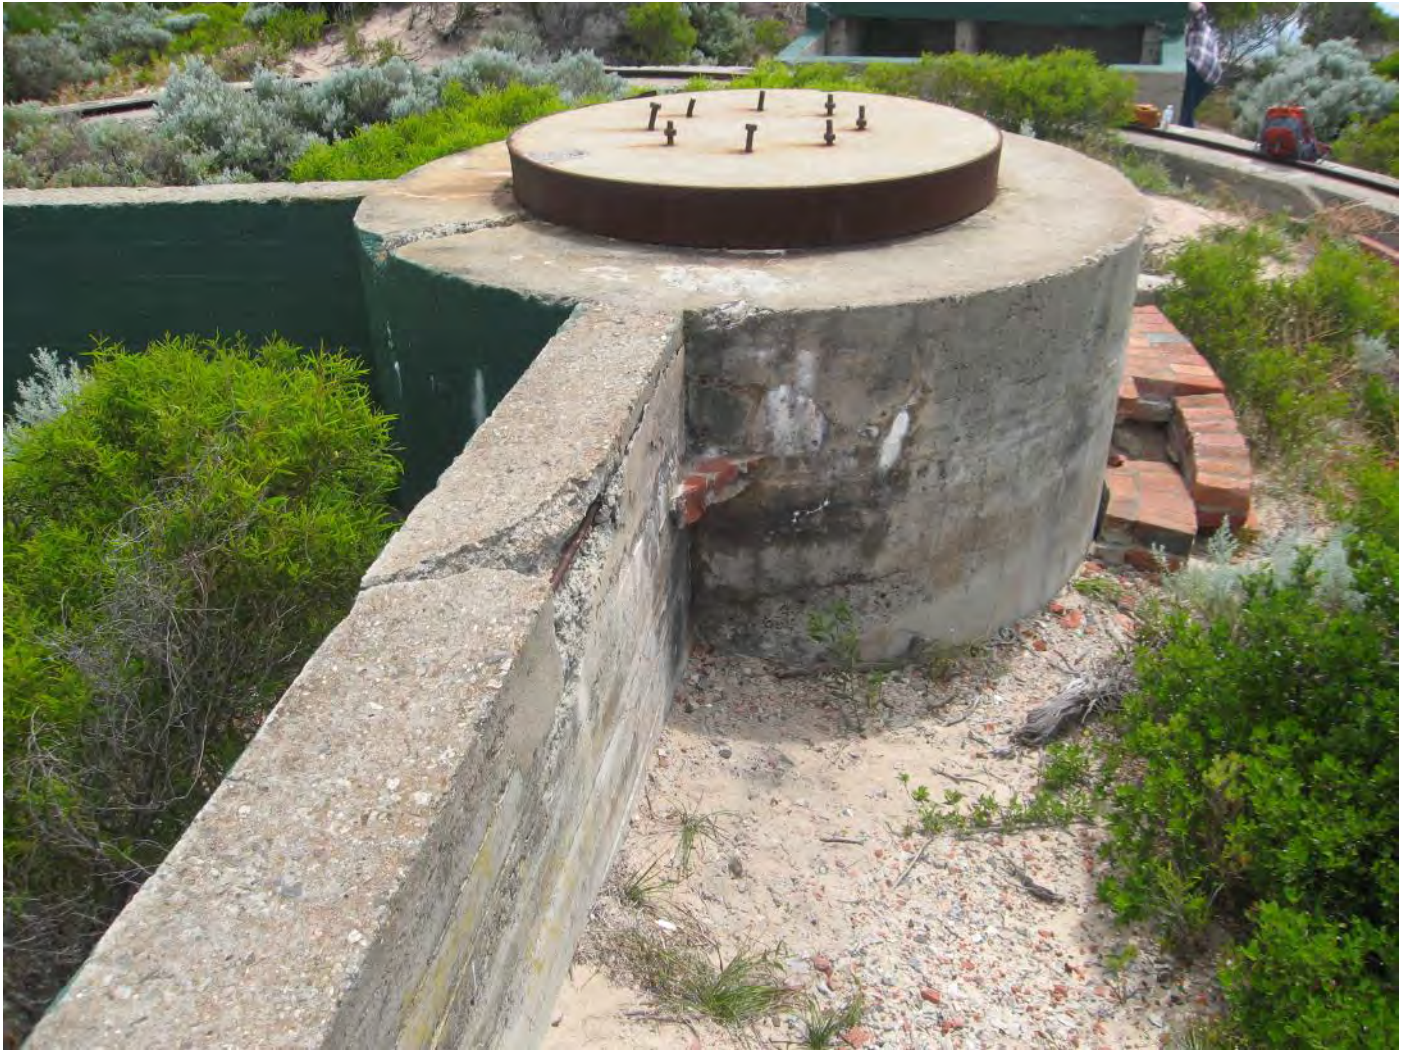
Figure 101: Gun Emplacement - rusted steel reinforcements causing chunks of concrete to blow and break off

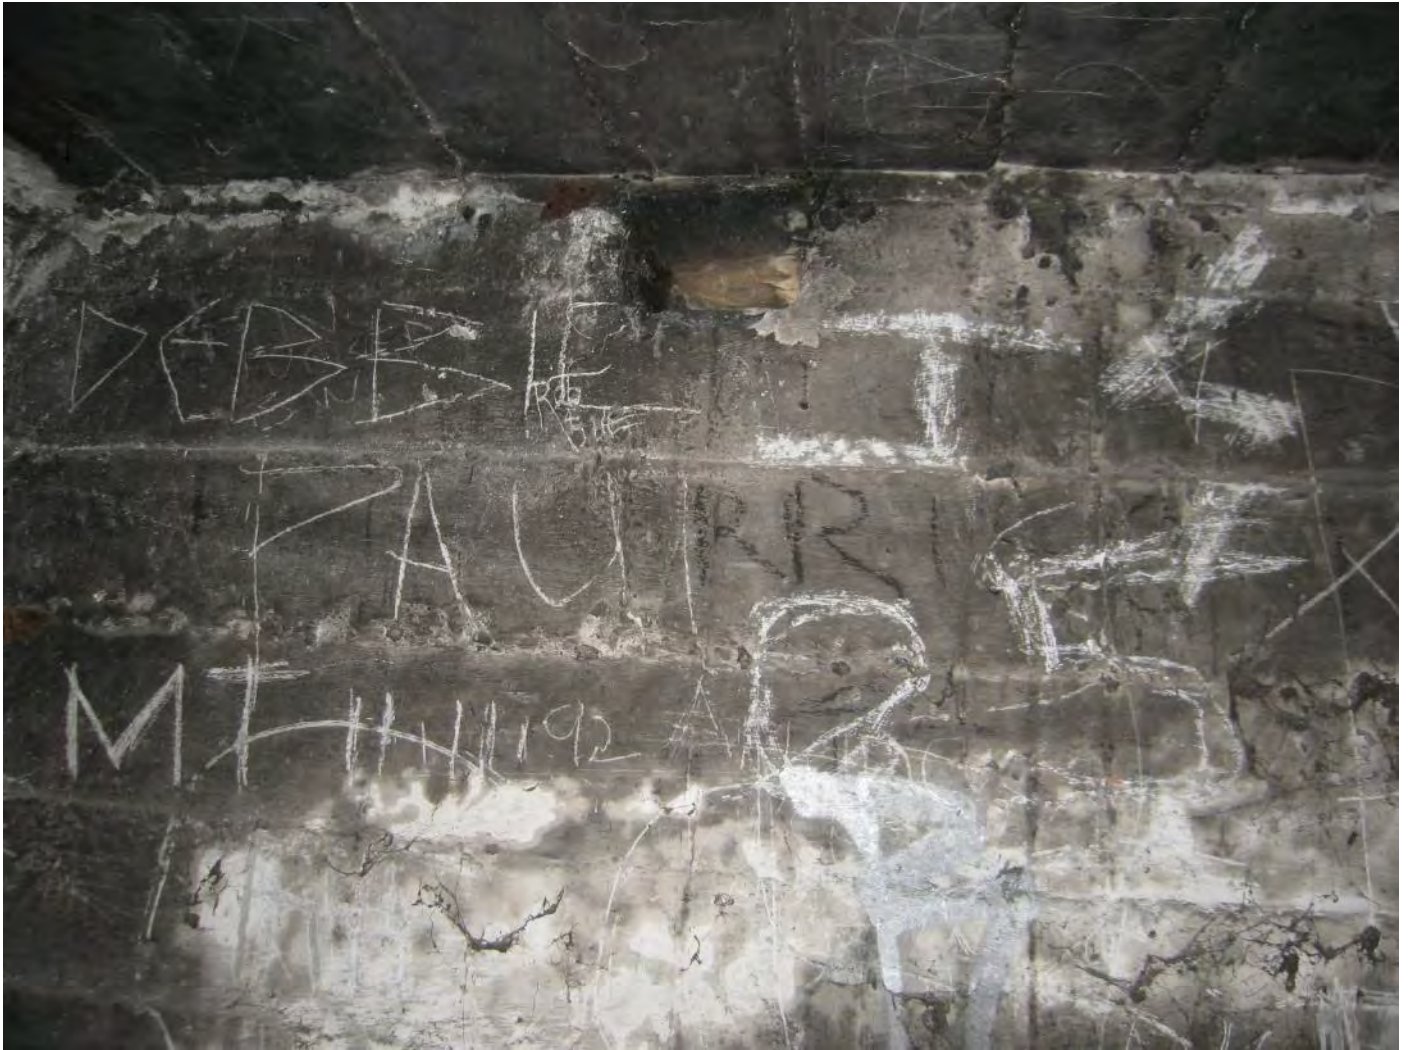
Figure 123: Ammunition Bunker – graffiti in Room 1
