3.0 Physical Evidence

The physical survey of Point Peron "K" Battery site has been prepared with reference to the available documentary evidence and on an assessment of the existing fabric at the site. The objectives of the survey are to assess the extent of extant fabric and its condition and to determine the extent of conservation works required to safeguard these structures from further deterioration.

3.3 Description of the Surviving fabric

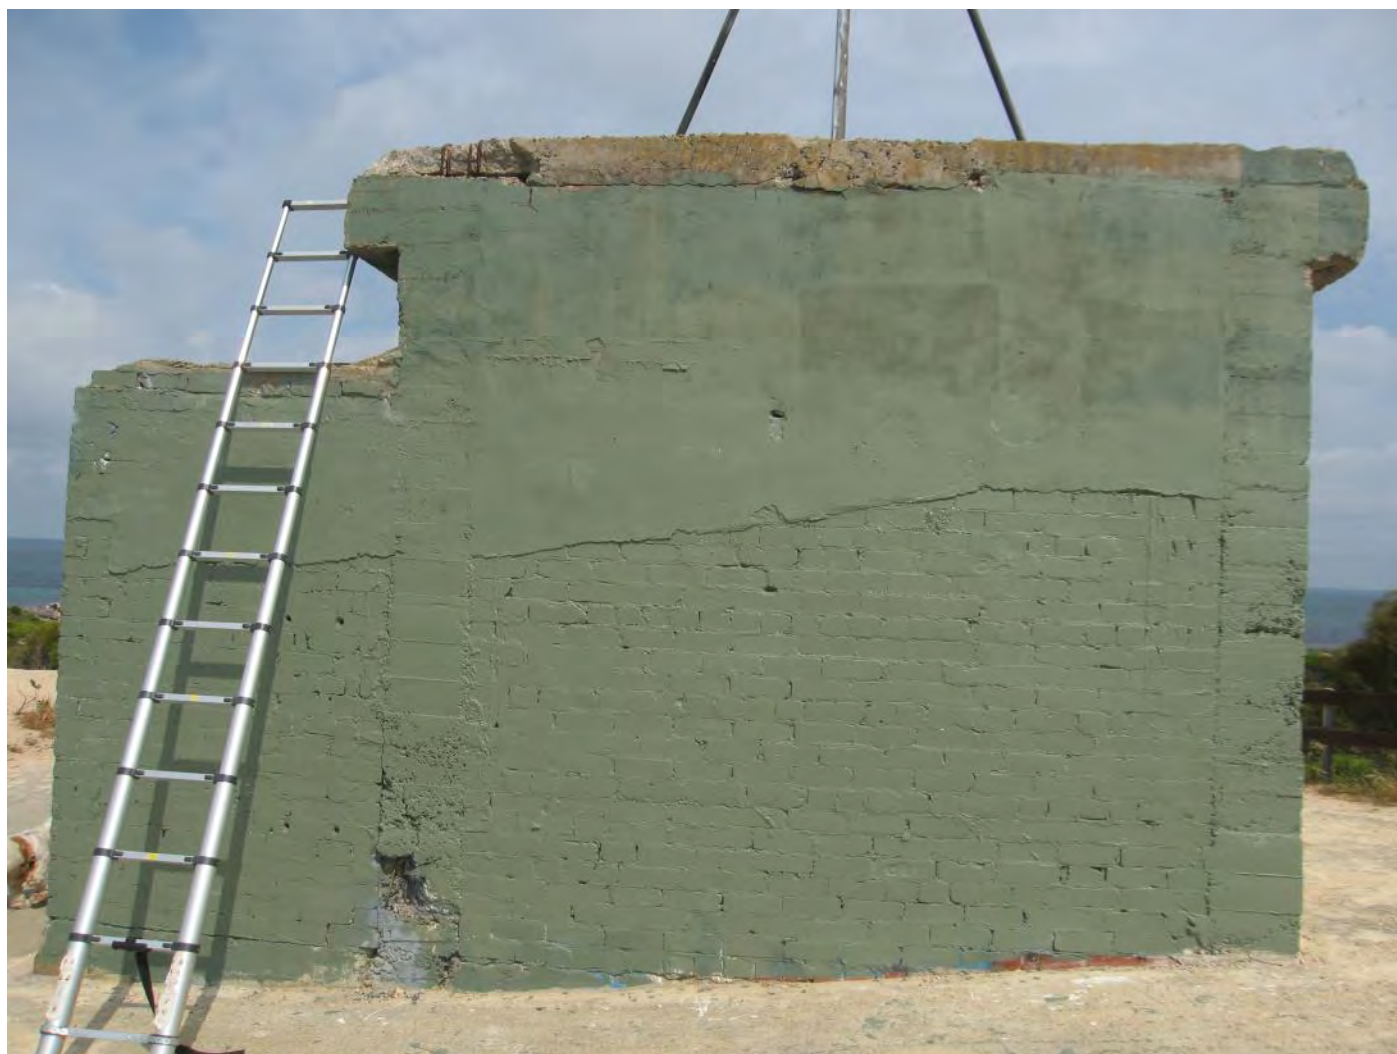
Figure 54: Observation Post - East Elevation

When approaching the observation tower from the steps you are faced with the blank wall of the east elevation. The elevation has been painted green in an attempt to reduce the impact of graffiti which has served to obscure the differentiation between the construction materials. The two concrete columns supporting the roof structure are visible on closer inspection but the clear distinction between the materials has been lost. The upper section of this wall also contains remnant render which is not visible on any of the other elevations. The brickwork laid in English Garden Bond is visible under the paint finish.

The east elevation is the rear of the structure and presents with no activation. The elevation is stepped in terms of roof height with the lower section corresponding to the ground floor area of the structure and the higher level being the stairs to the upper section. The upper section of the east elevation has been rendered at an earlier stage, with the brick and mortar below this level being in variable condition. The reinforced concrete framework is also showing signs of deterioration.

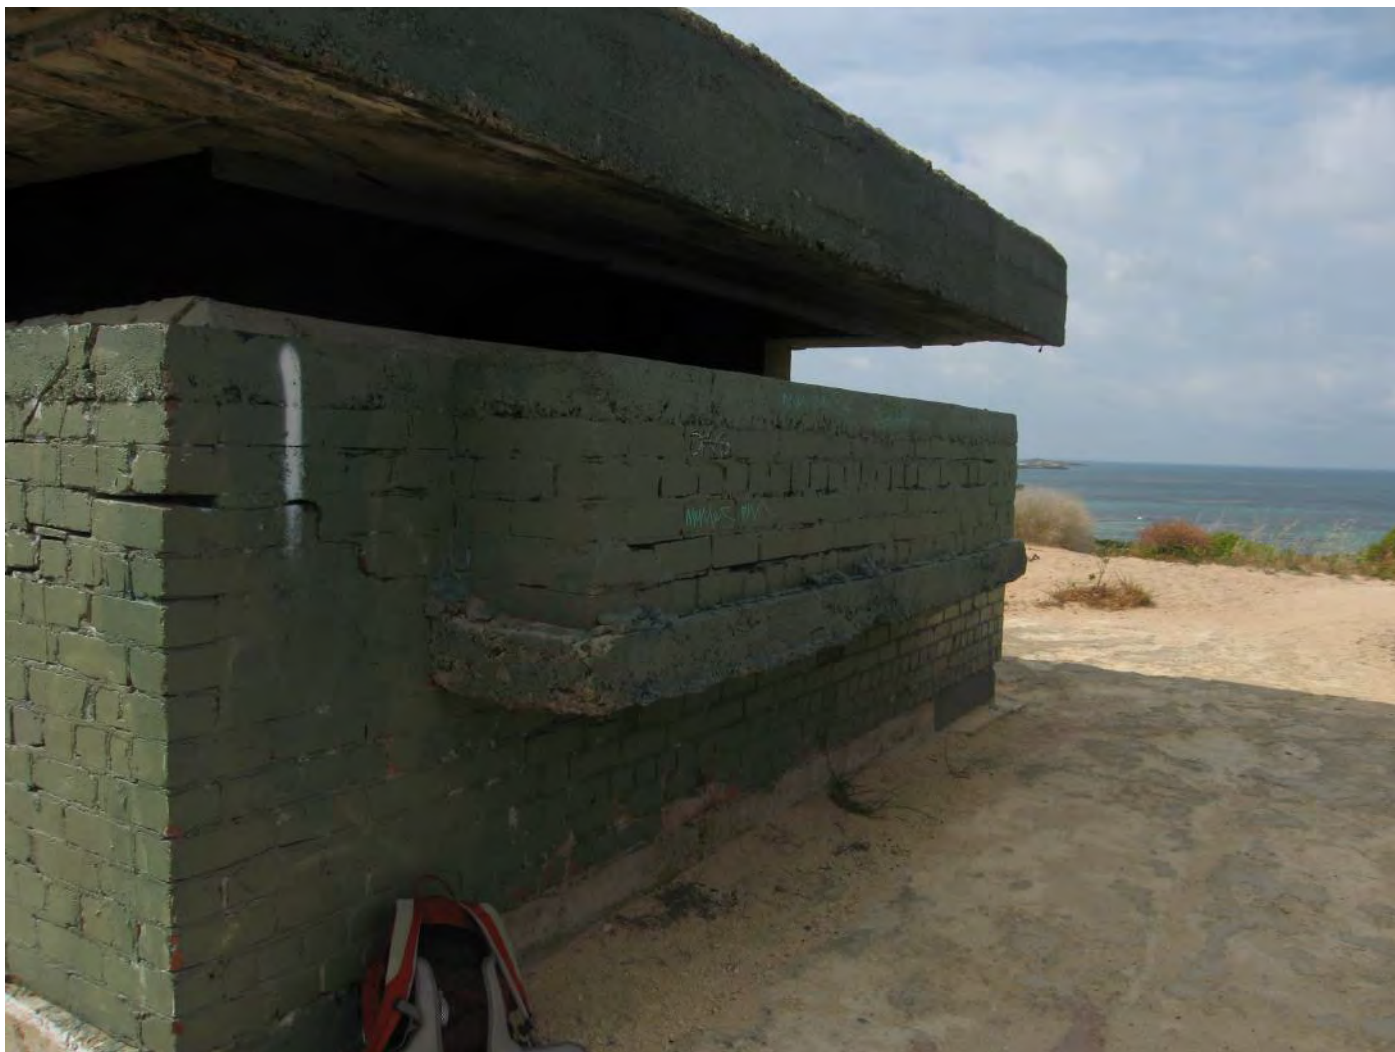
Figure 60: West Elevation - Observation Opening

The west elevation is the principal façade of the structure with clear observations over the coast line. The observation opening, embrasure, extends across the full width of the elevation before returning along the north and south walls. Immediately below the opening on the west elevation is a projecting storage area of brick and concrete construction which is in poor condition.

Research has shown that in similar structures, the ground level often came up to the bottom of these projection or slightly above providing support. Over time the ground level has eroded or has been manually removed to provide a flat walking surface around the structure which has removed all support for the projecting element. As a consequence, the weight of the projecting storage area is pulling the wall away from the rest of the structure which is evident in the cracking seen along the brick joints.

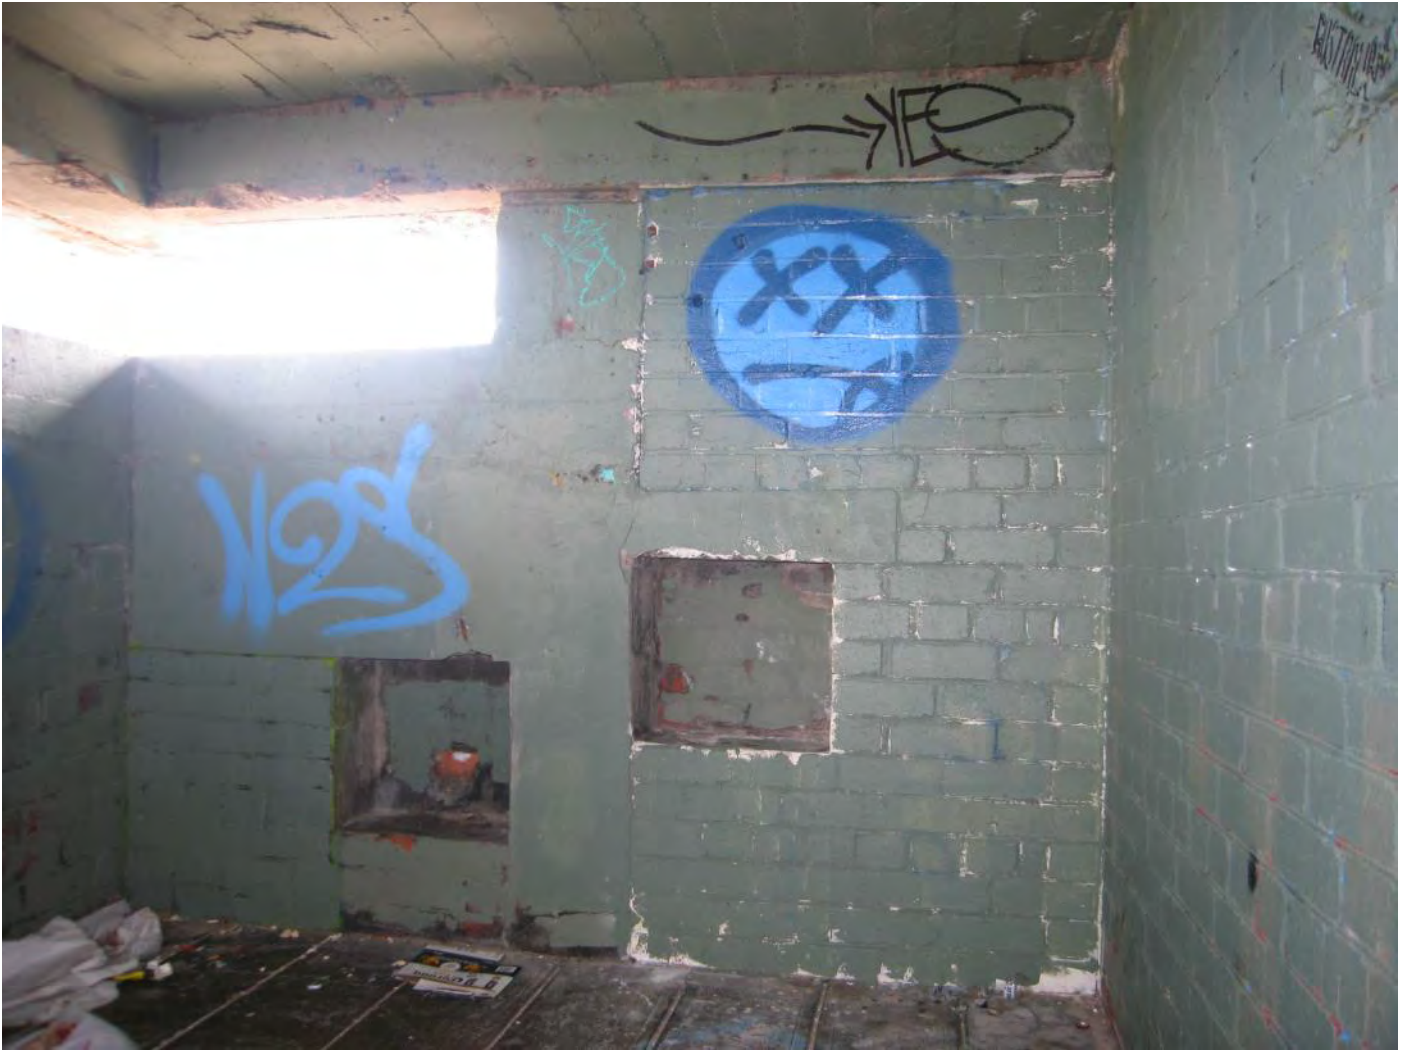
Figure 73: Storage areas incorporated into the north wall of the upper level

The upper level of the Observation Post takes the same form as the ground level with the brick and concrete construction being painted and the concrete slabs creating a panelled look to the ceiling. The floor has not been covered with the concrete laid in long narrow slabs,

Small storage areas have been constructed into the north wall.

The entire space is full of debris and has been subjected to graffiti.

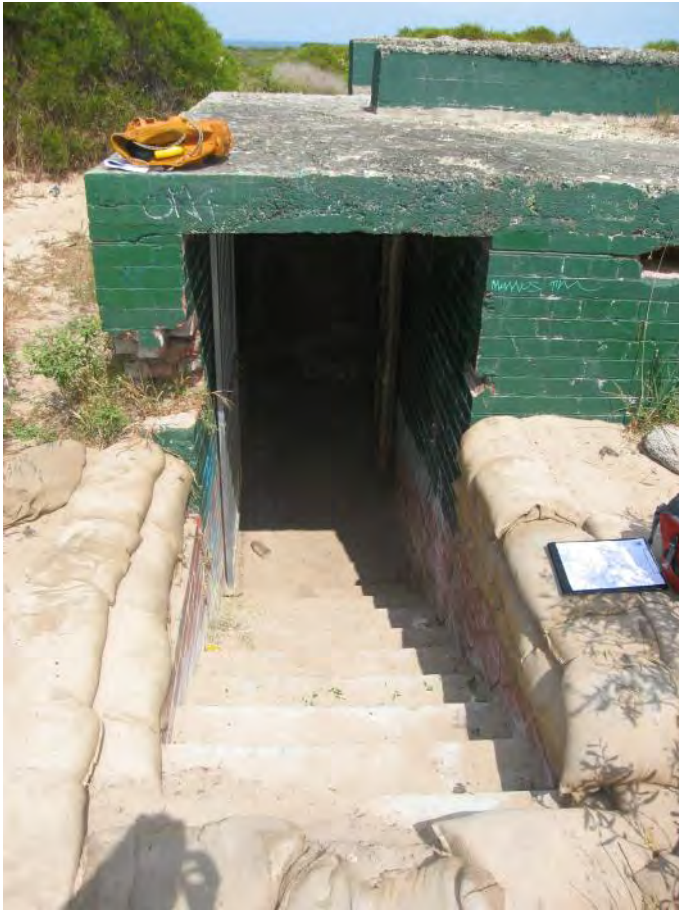
Figure 78: Operations Bunker – steps down to the entrance

The entrance structure is located on the south of the Operations Bunker but accessed from the east. The actual entrance is located at the far end of the access tunnel, which in turn is accessed via a flight of brick and concrete steps. The tunnel and entrance have recently been cleared from sand accumulation with sandbags placed around the retaining walls and top step in an attempt to reduce the amount of sand that accumulates in the void.

A metal grille gate has been installed at the foot of the steps to prevent general access into the entrance.

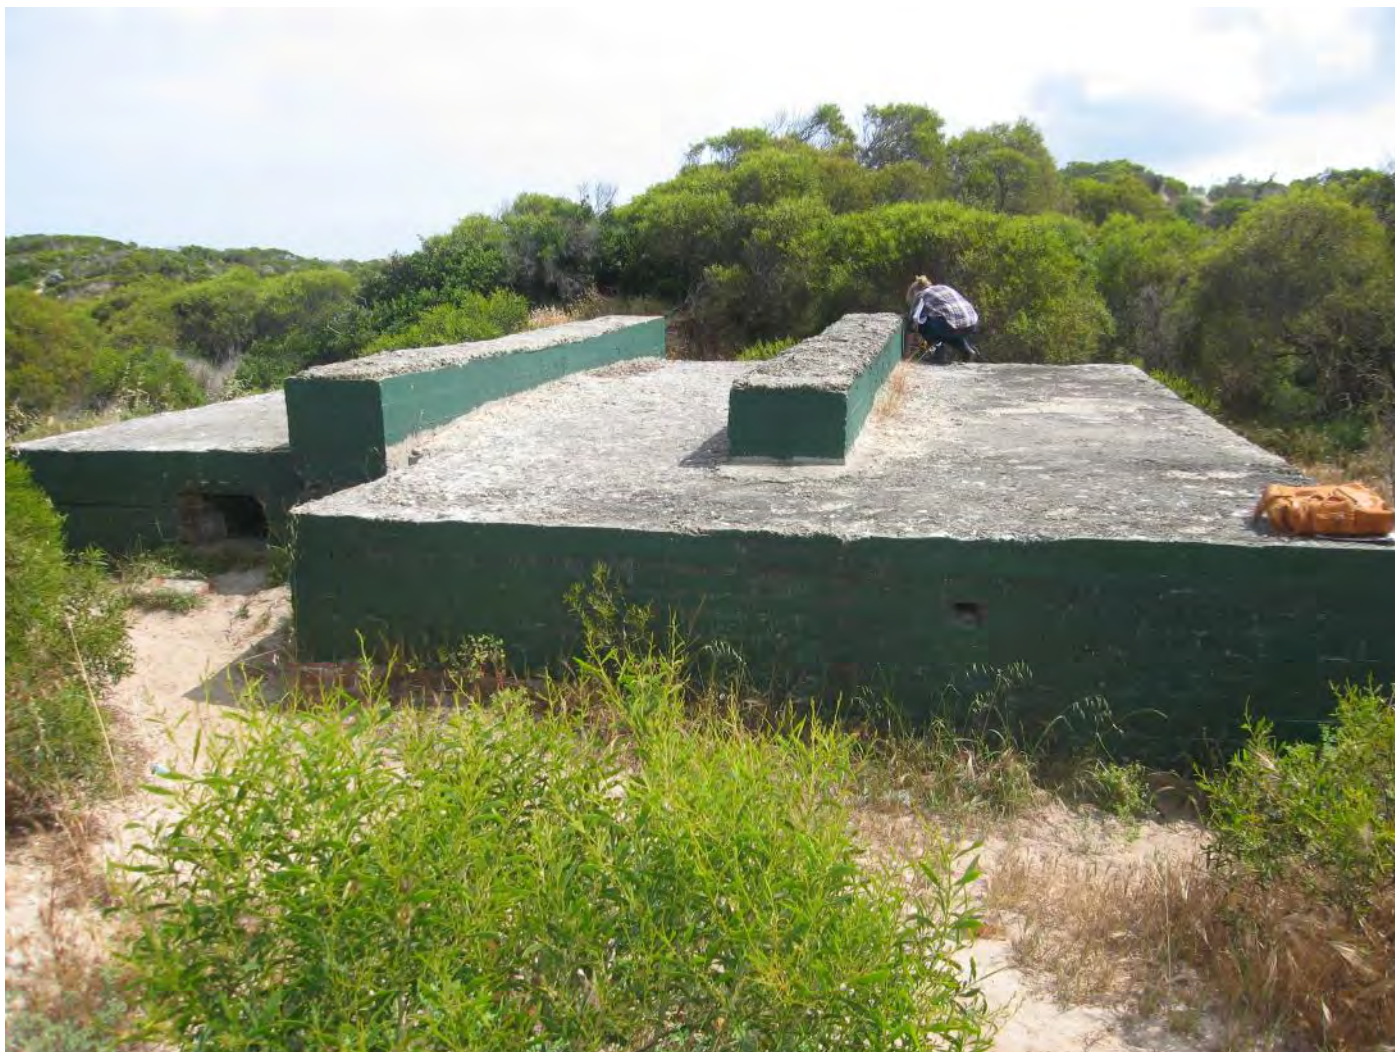
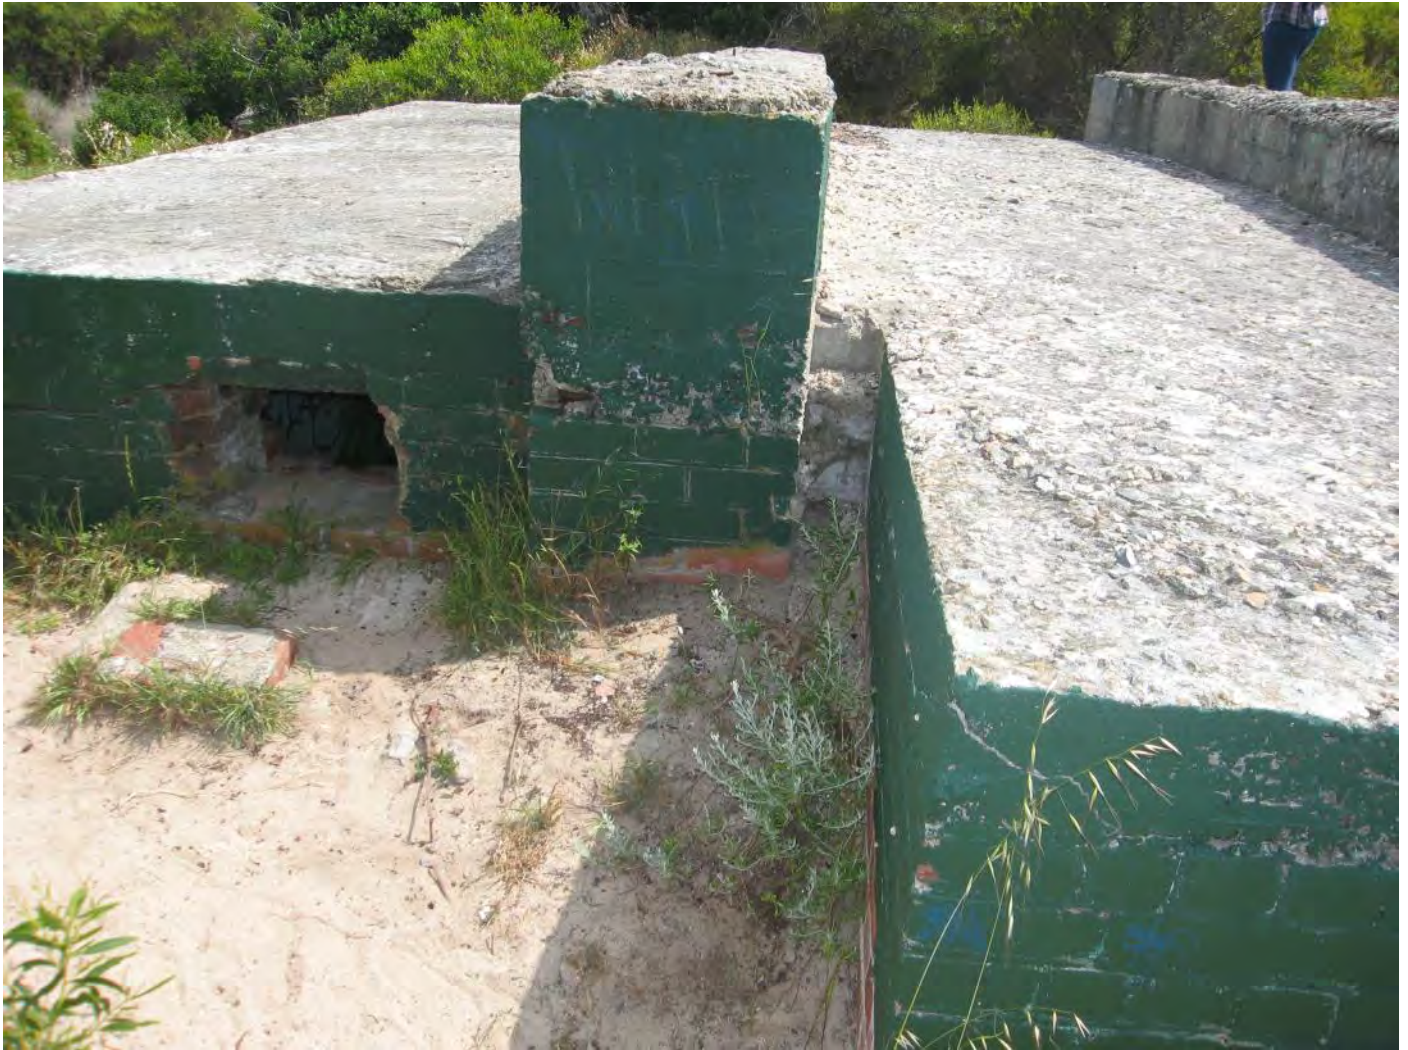
Figure 79: Operations Bunker – Roof plan

The roof of the Operations Bunker is reinforced concrete slab with raised reinforced concrete beams extending across the roof in a north-south direction, across the main structure only.

The layered blocks of the concrete are visible in the reinforced beams, each being three slabs high with a roughcast concrete top layer. Sand accumulation around the base of the beams is allowing for grass growth along the beams.

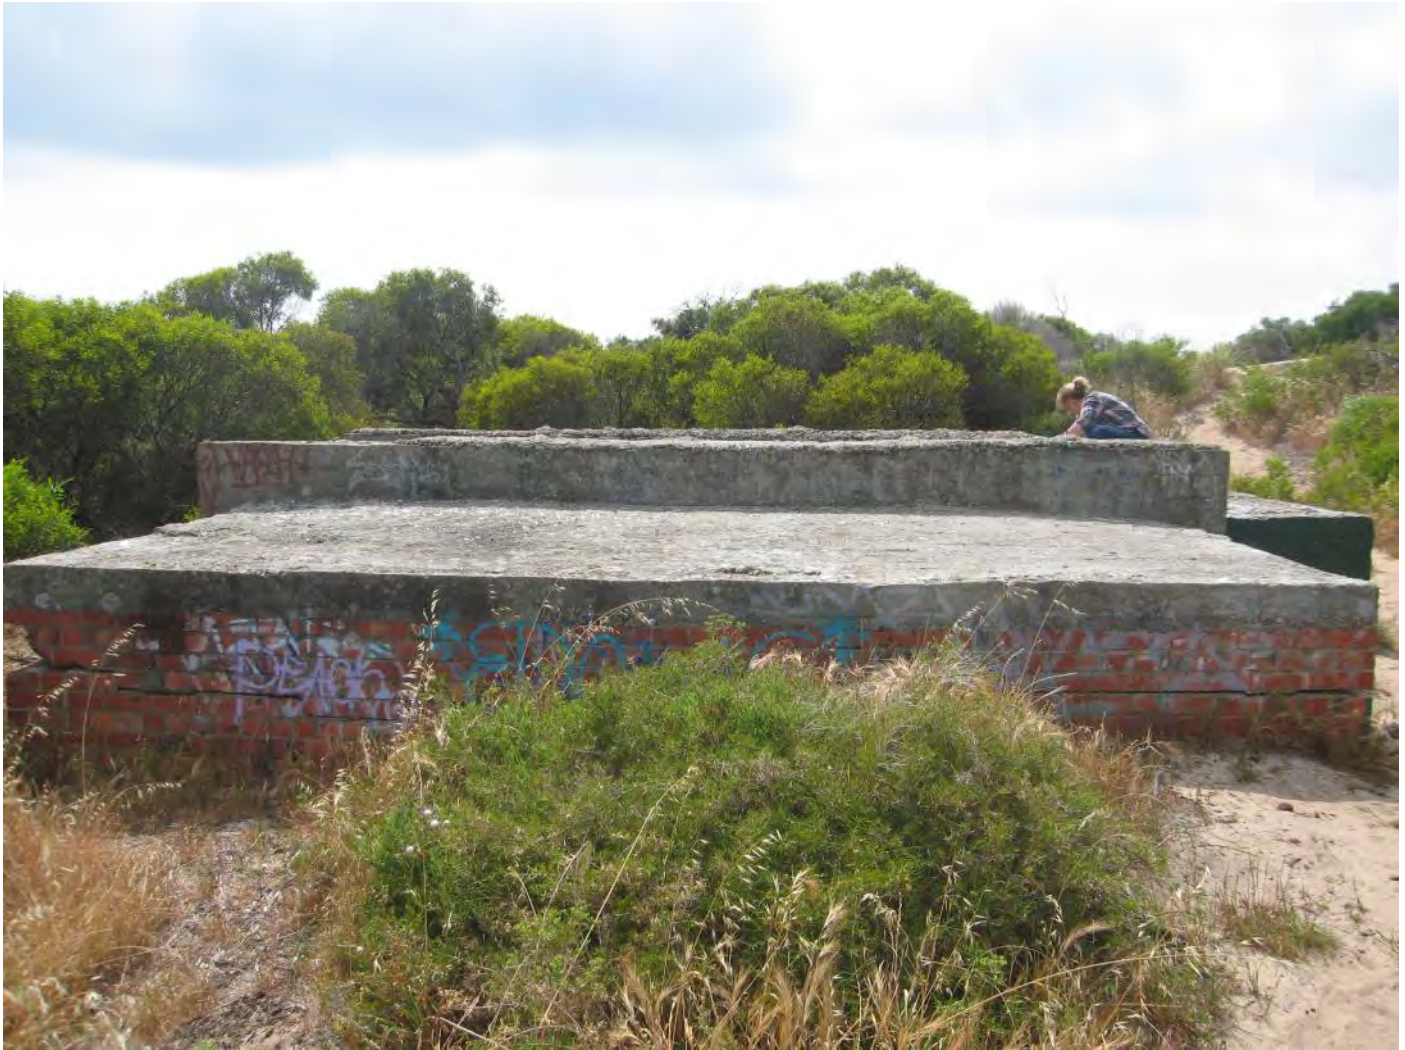
Figure 84: Operations Bunker – west elevation

The majority of the walls have been painted in an attempt to hide existing graffiti and to try and reduce additional graffiti. The north and west elevations have not been painted and still present in the original brick and concrete form, again covered in graffiti.

The west elevation is largely submerged in the sand dune but the top ten brick courses are visible with an extensive crack extending along the full extent of the elevation, following the mortar joints. The crack is caused by the failure of the steel bar reinforcement in the brickwork which has rusted and expanded causing the brickwork to move and become loose. Brick from the north west corner are missing which will contribute to the continued deterioration of the brickwork and enlargement of the crack.

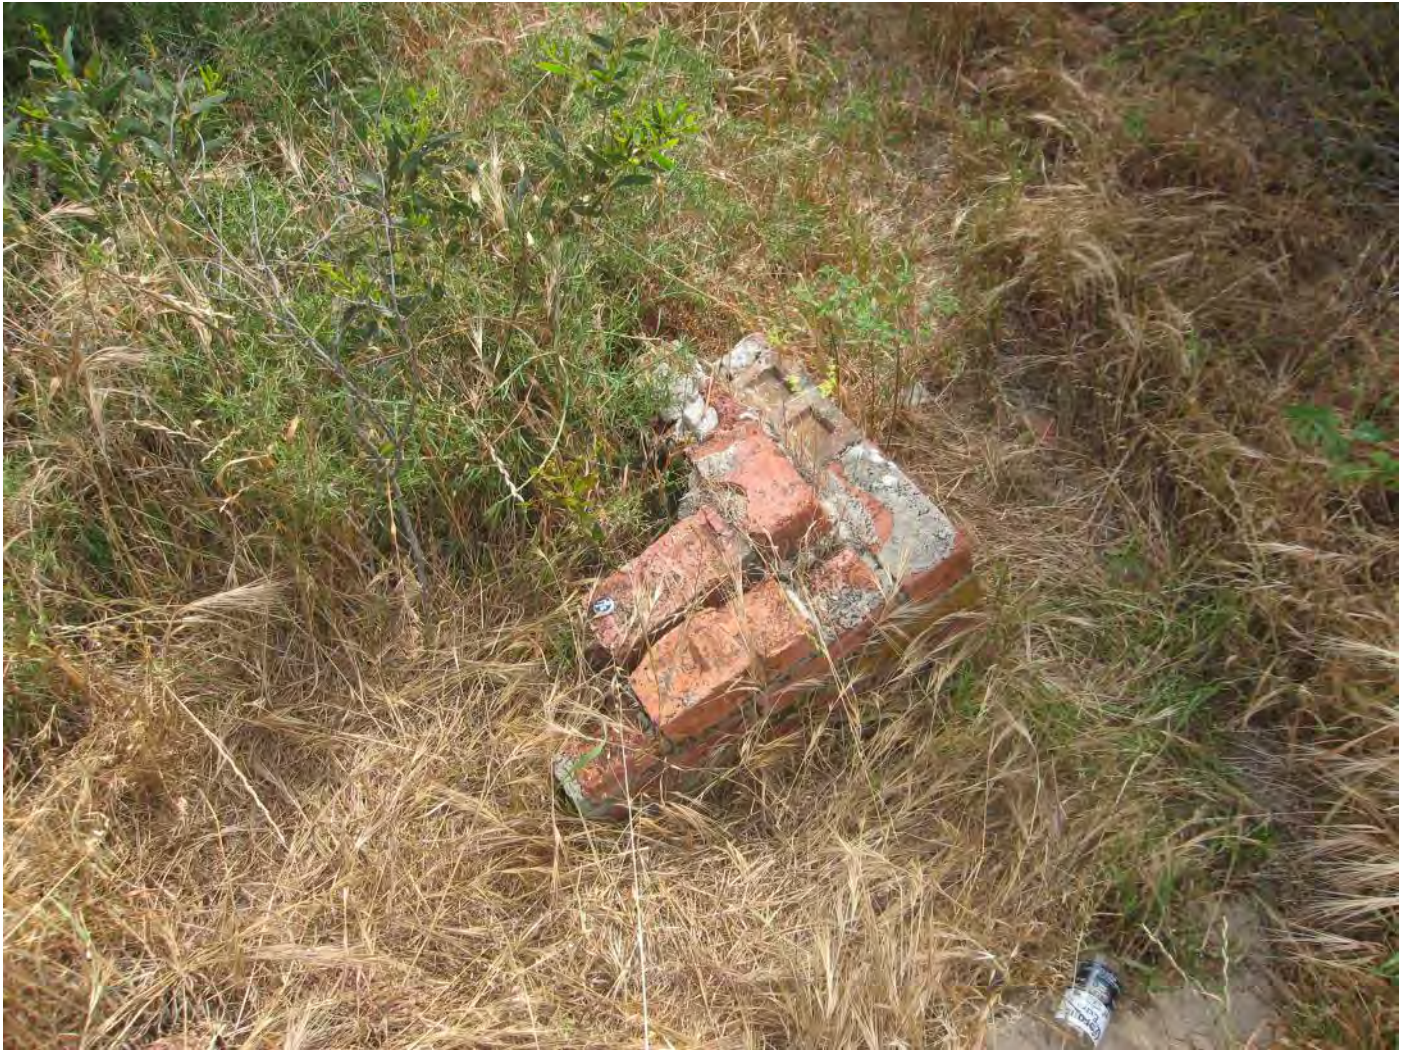
Figure 87: Operations Bunker – Remnant fabric lying close by the east elevation of the structure

A further opening of the same dimensions is located towards the eastern end of the north elevation with much of the brickwork around the opening being in poor condition, with the faces of the bricks having spalled and fallen off and large chunks of brick have broken off from the around the opening. A three-sided brick element is laying on the ground adjacent to the opening. This element was originally attached to the north elevation around the opening allowing for ventilation to enter the building. This element was not keyed into the main structure, and was only attached by mortar which has failed over time and eventually resulted in the brick flue falling off.

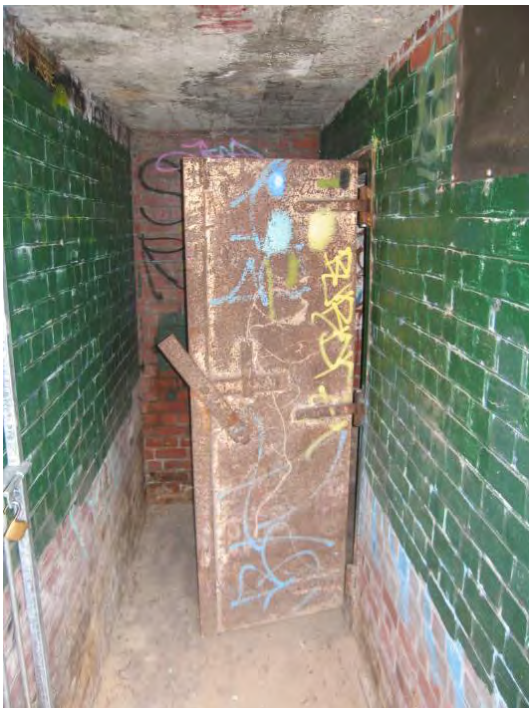
Figure 89: Operations Bunker – Extant steel entrance doors

The brick and concrete steps lead down into the entrance tunnel which is of brick construction with concrete floor and roof. The tunnel is about 3m long with the main entrance doors into the Operations Bunker being located at the far end on the south wall of the main building. The steel doors are the original heavy doors with each door being held in place with three hinges and locked by a pivot lock. The doors have been scratched and graffitied over time and are now presenting with surface rust.

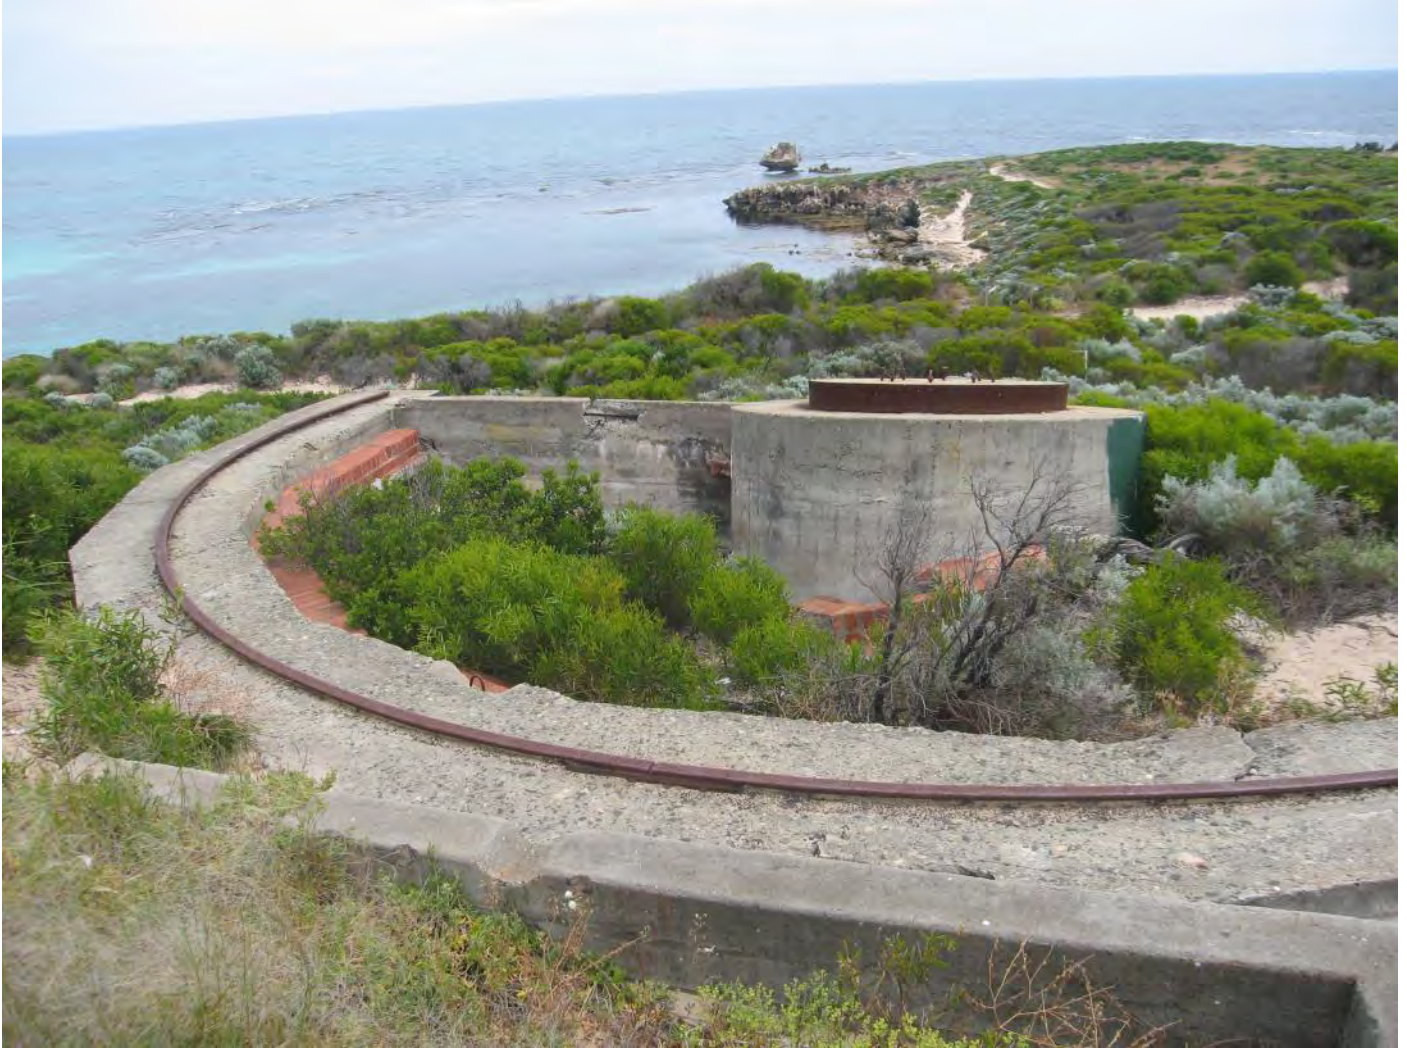
Figure 99: Gun Emplacement

The gun emplacement is principally a $\frac{3}{4}$ circular reinforced concrete structure that was originally submerged. The external and internal sides of the concrete wall consist of 13 straight sided segments. The sunken nature of the emplacements allowed the central concrete gun mount to have clear view over the waters the gun was protecting. A steel rail extends around the top of the concrete walls as part of the remnant fabric.

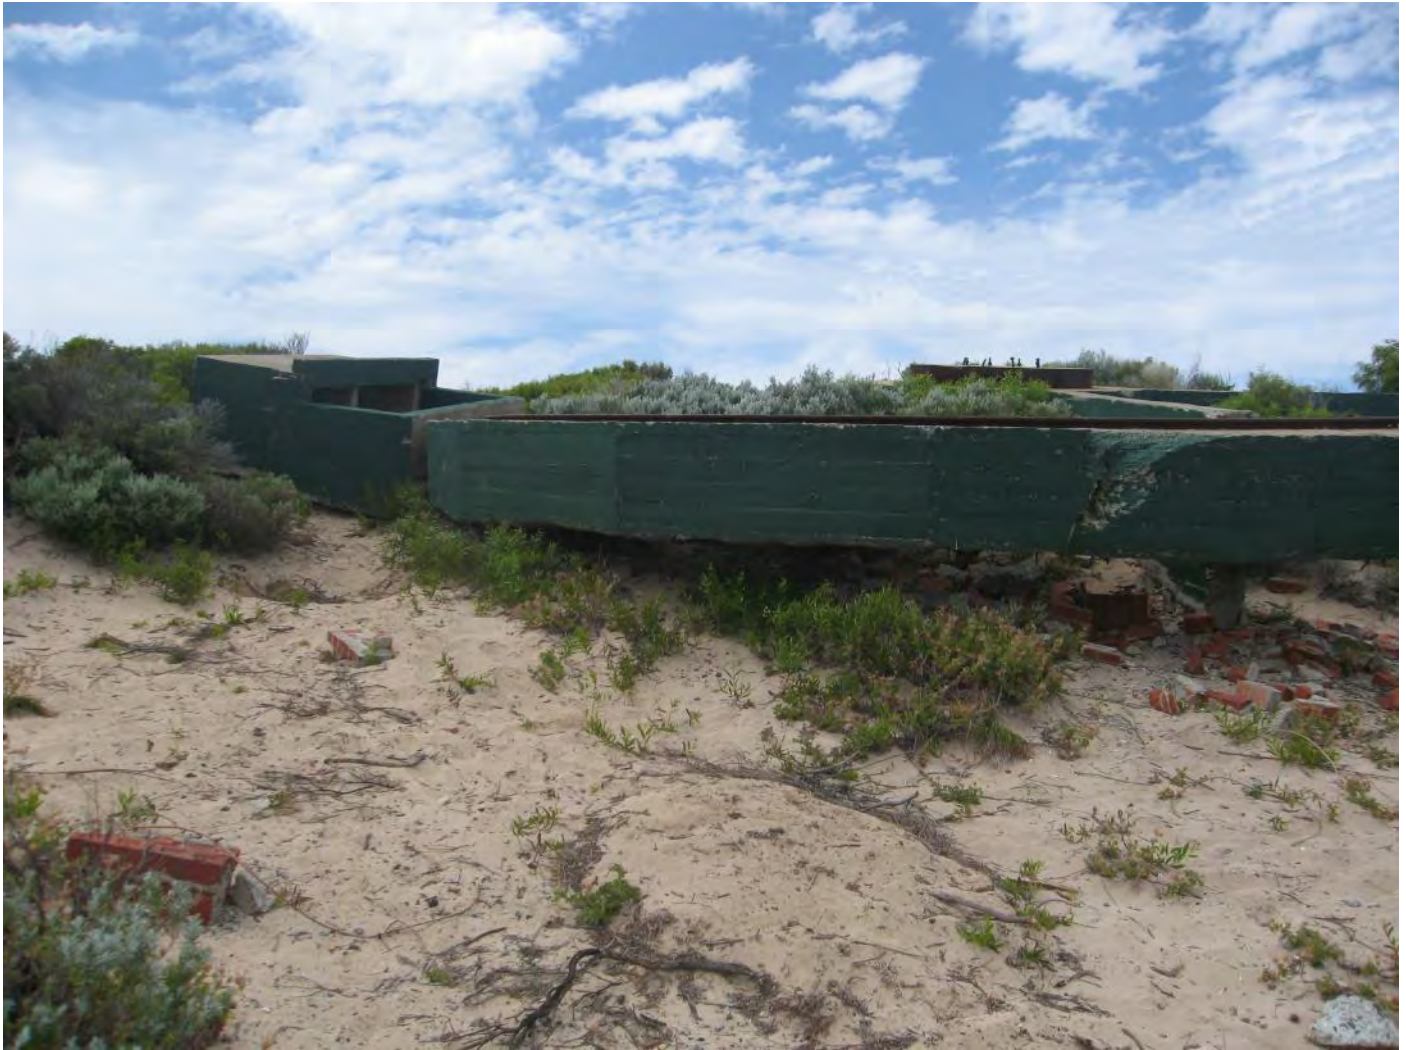
Figure 102: Gun Emplacement

The external structure of the gun emplacement is not meant to be visible but due to the erosion of the sand, the construction method is now visible which provides some understanding of how the structures were erected.

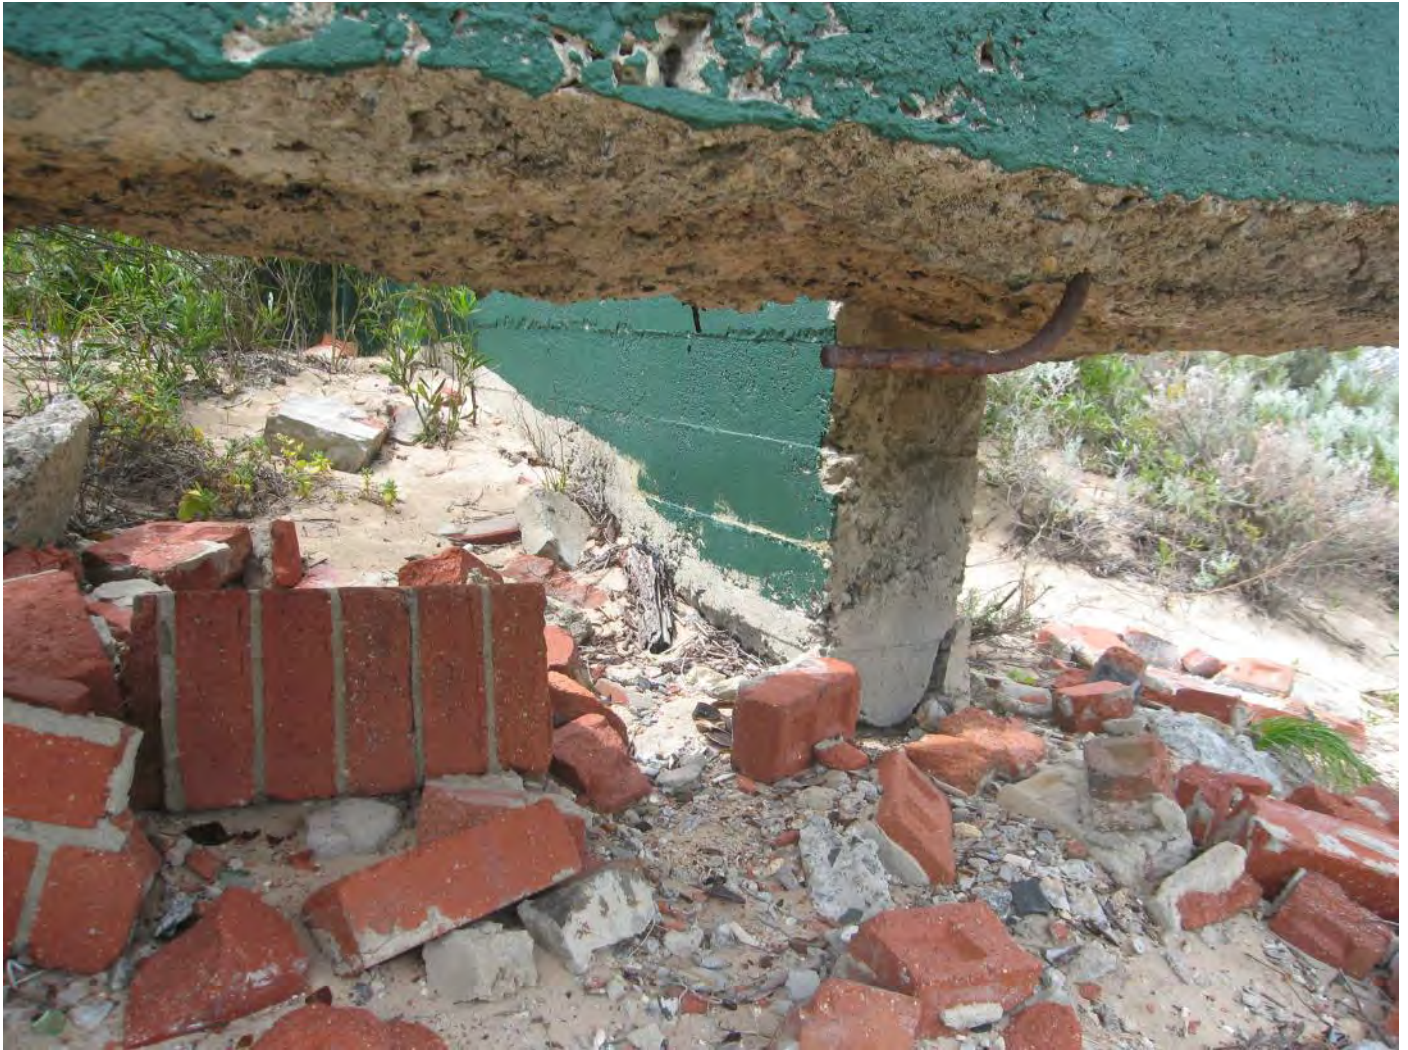
Figure 104: Gun Emplacement - underside of the concrete structure

As the underlying ground has moved, the fabric of the gun emplacement has become dislodged and loose. Much of the loose brick fabric appears to be collected on the ground and in the sand underneath the structure.

There is some evidence of concrete cancer in the main structure with elements of concrete breaking off and the reinforcing steel rusted and blown. The movement of the ground and the subsequent displacement of the gun emplacement has also resulted in severe cracking in the concrete structure. Whilst there is no practical reason for the gun emplacement to be reconstructed, the structure must be secured and stabilised as soon as possible.

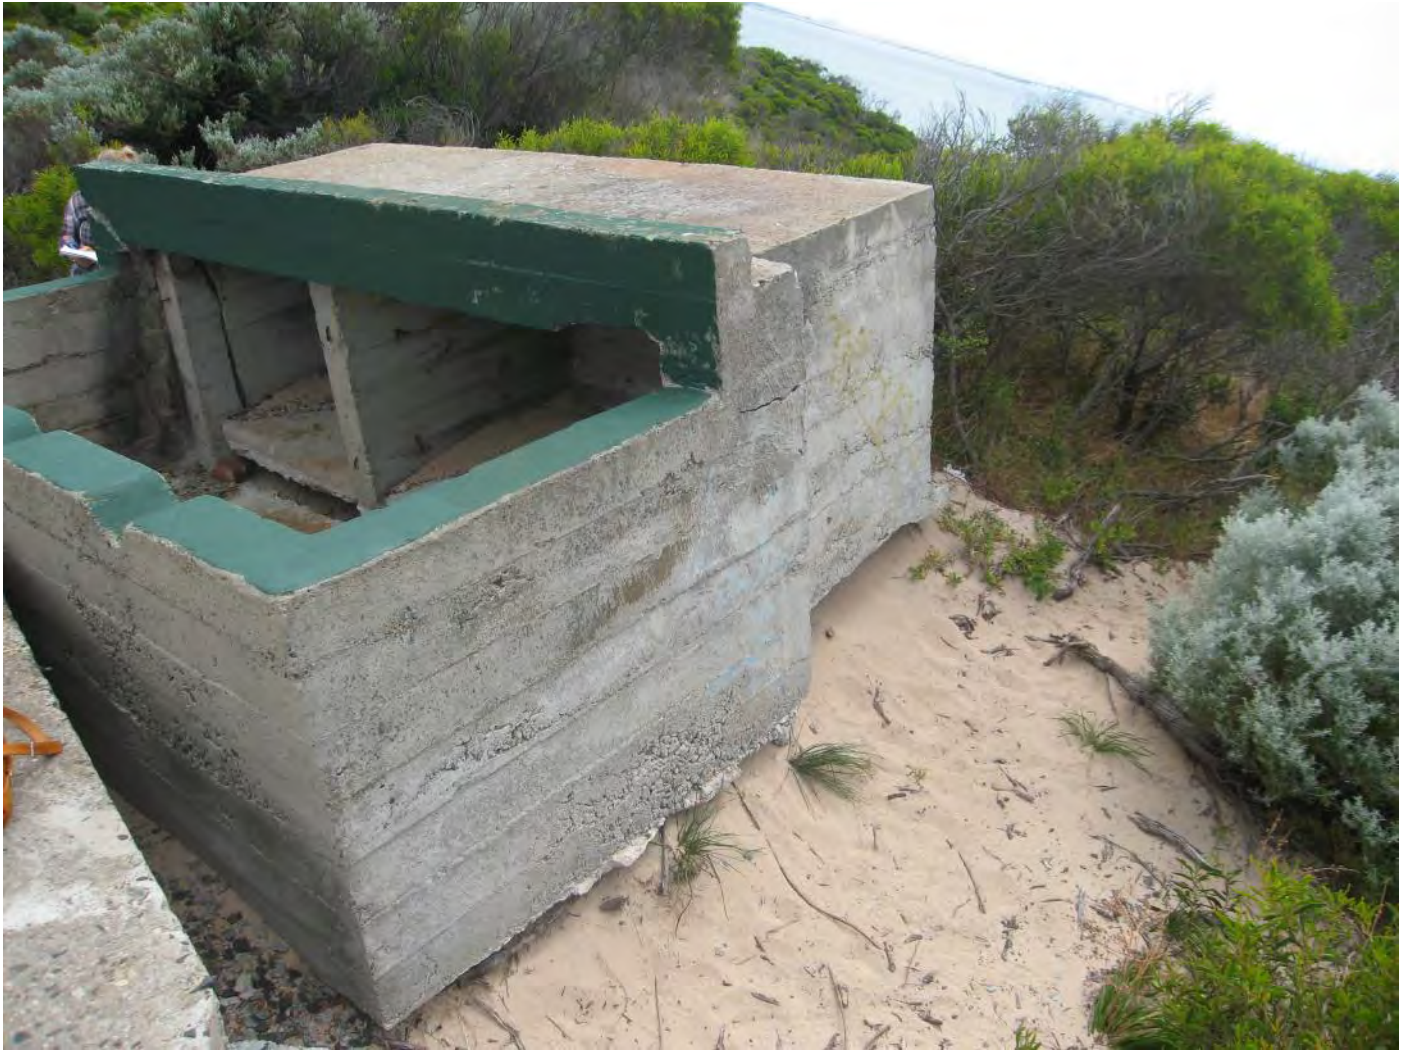
Figure 108: Gun Emplacement - Ammunition Store No. 1

The entire Store is now sitting on the sand rather than being partially submerged. Sections have been painted but the majority of the structure remains in the natural concrete state, clearly illustrating the layered slab construction.

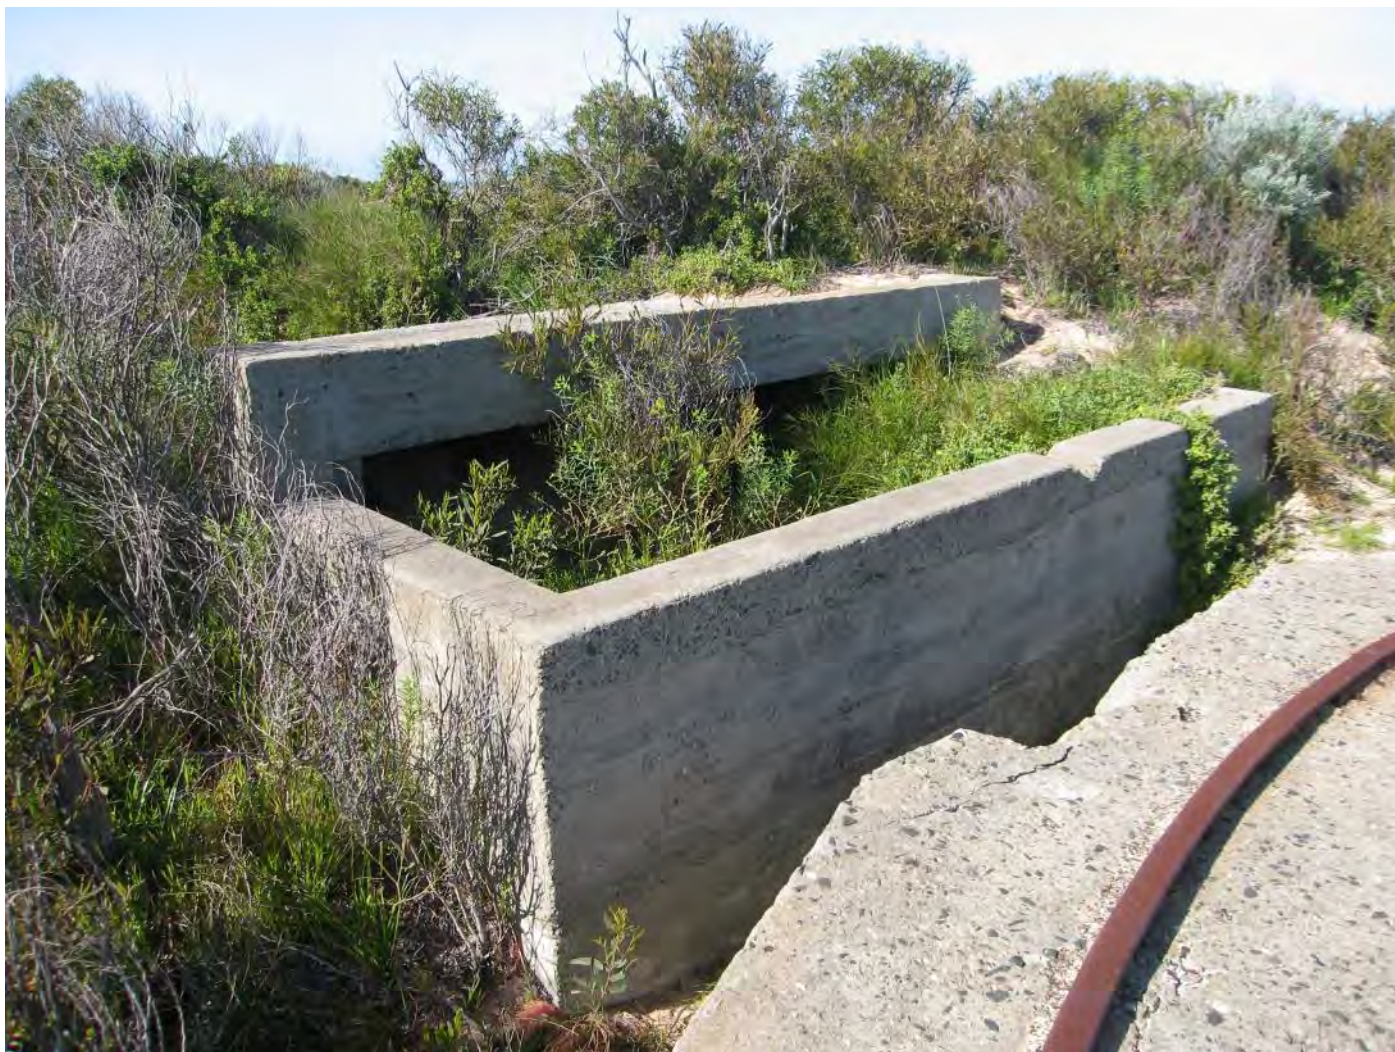
Figure 111: Gun Emplacement - Ammunition Store No. 2

Ammunition Store No. 2 is positioned to the south east of the gun emplacement and looks to be in, or close to, its original position. The structure has become largely submerged in the sand with the majority of the structure being obscured from view. Sand has accumulated on the roof and internally resulting in the growth of vegetation which will ultimately contribute to the deterioration of the concrete structure.

As far as can be determined, Ammunition Store No. 2 appears to have remained in tact with no obvious signs of cracking or displacement of the elements.

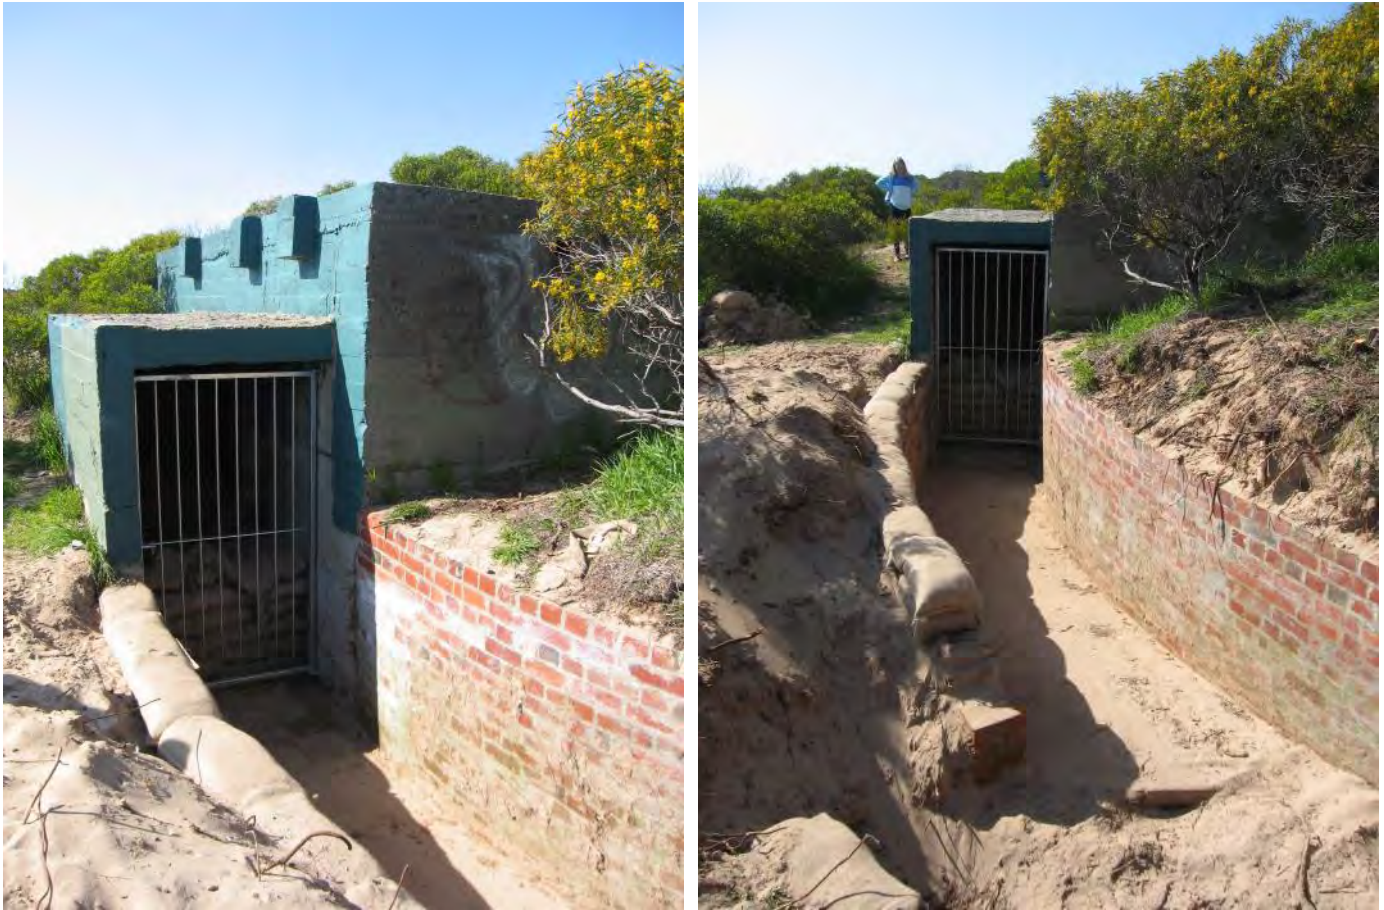
Figure 116: Ammunition Bunker - entrance

A metal grille gate has been installed across the entrance into the building, again to prevent general access into the Bunker. Sandbags have been placed directly behind the gate in an attempt to prevent further sand accumulation in the entry tunnel.
