3.0 Physical Evidence

The physical survey of Point Peron "K" Battery site has been prepared with reference to the available documentary evidence and on an assessment of the existing fabric at the site. The objectives of the survey are to assess the extent of extant fabric and its condition and to determine the extent of conservation works required to safeguard these structures from further deterioration.

3.3 Description of the Surviving fabric

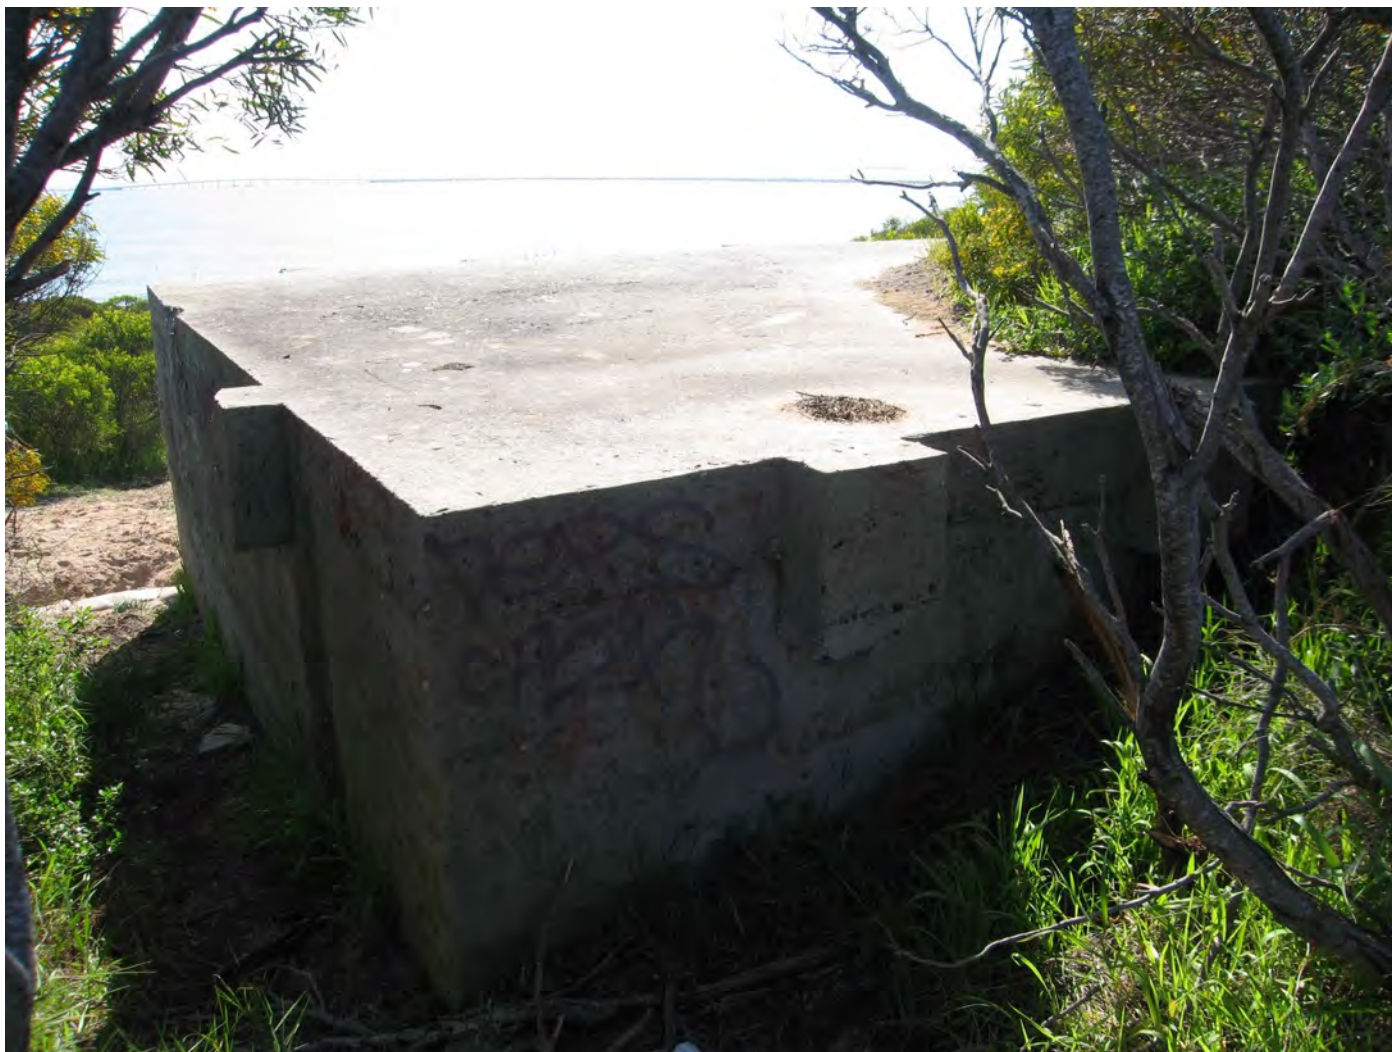
Figure 118: Ammunition Bunker – view across the roof

The Ammunition Bunker is a simple structure bearing similarities to the plan form and construction method of the other structures around the site. The external walls are of reinforced concrete construction with the roof being a reinforced concrete slab. Projecting vent shafts are placed at regular intervals around the building, level with the roof and extending down to approximately two concrete slab courses. One of the shafts on the north elevation has fallen off revealing a small opening in the wall.

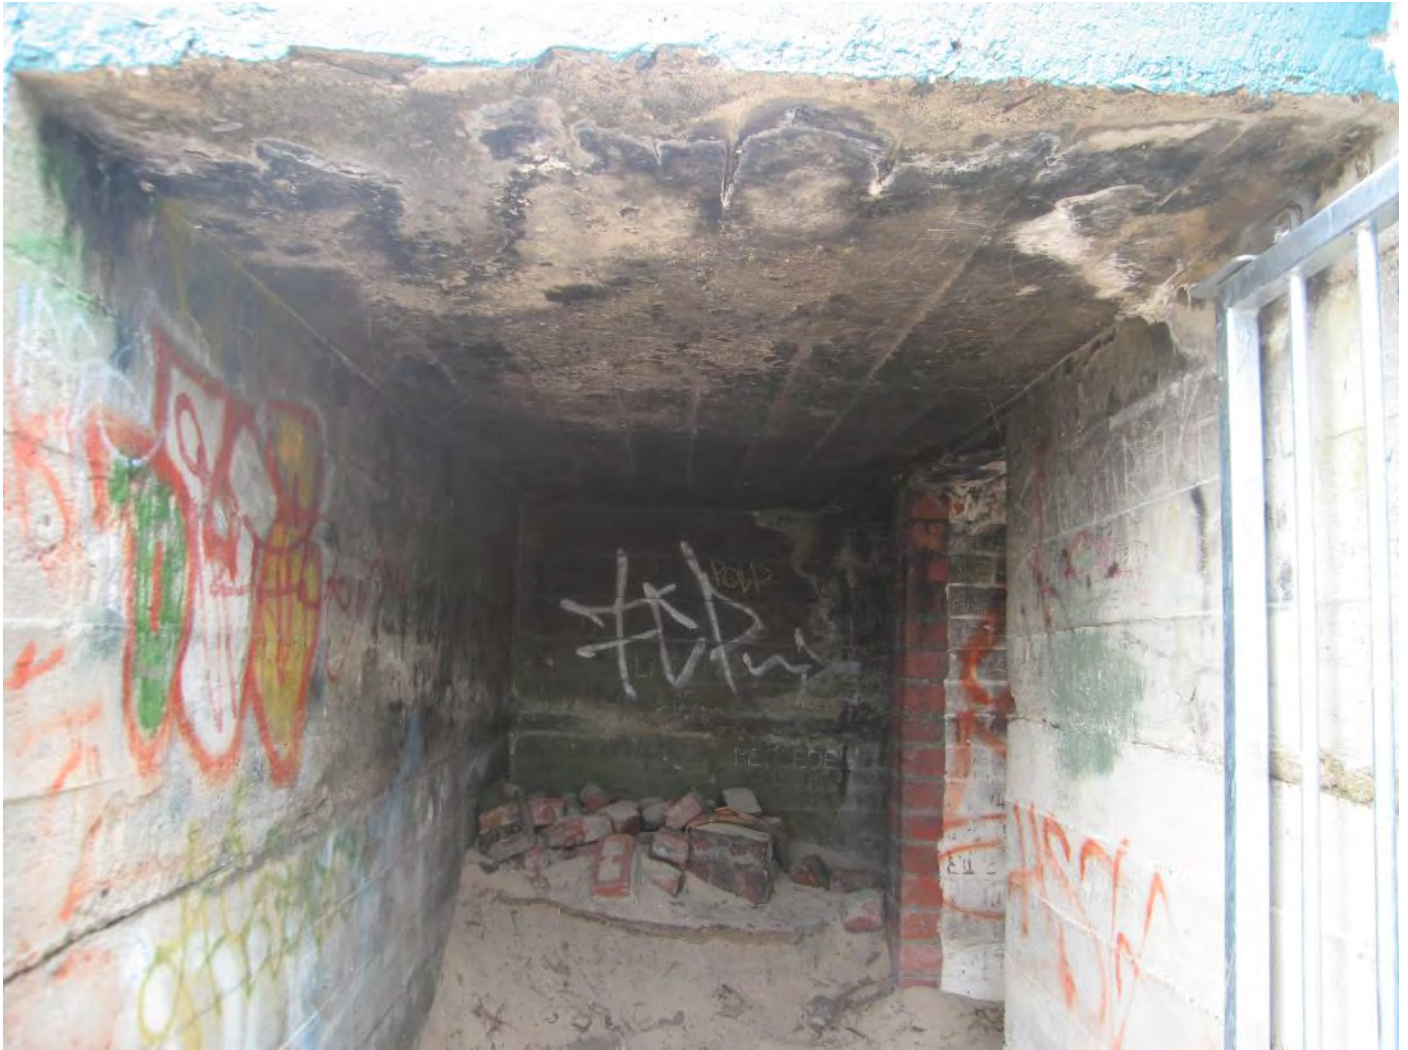
Figure 120: Ammunition Bunker

The interior of the bunker is accessed via an entry tunnel with the doors to the two rooms having been removed at an earlier date. The entrance is of concrete construction to walls, floor and roof, partially painted and covered in graffiti and filled to half height with sand. The two rooms branch off to the right side of the entry.

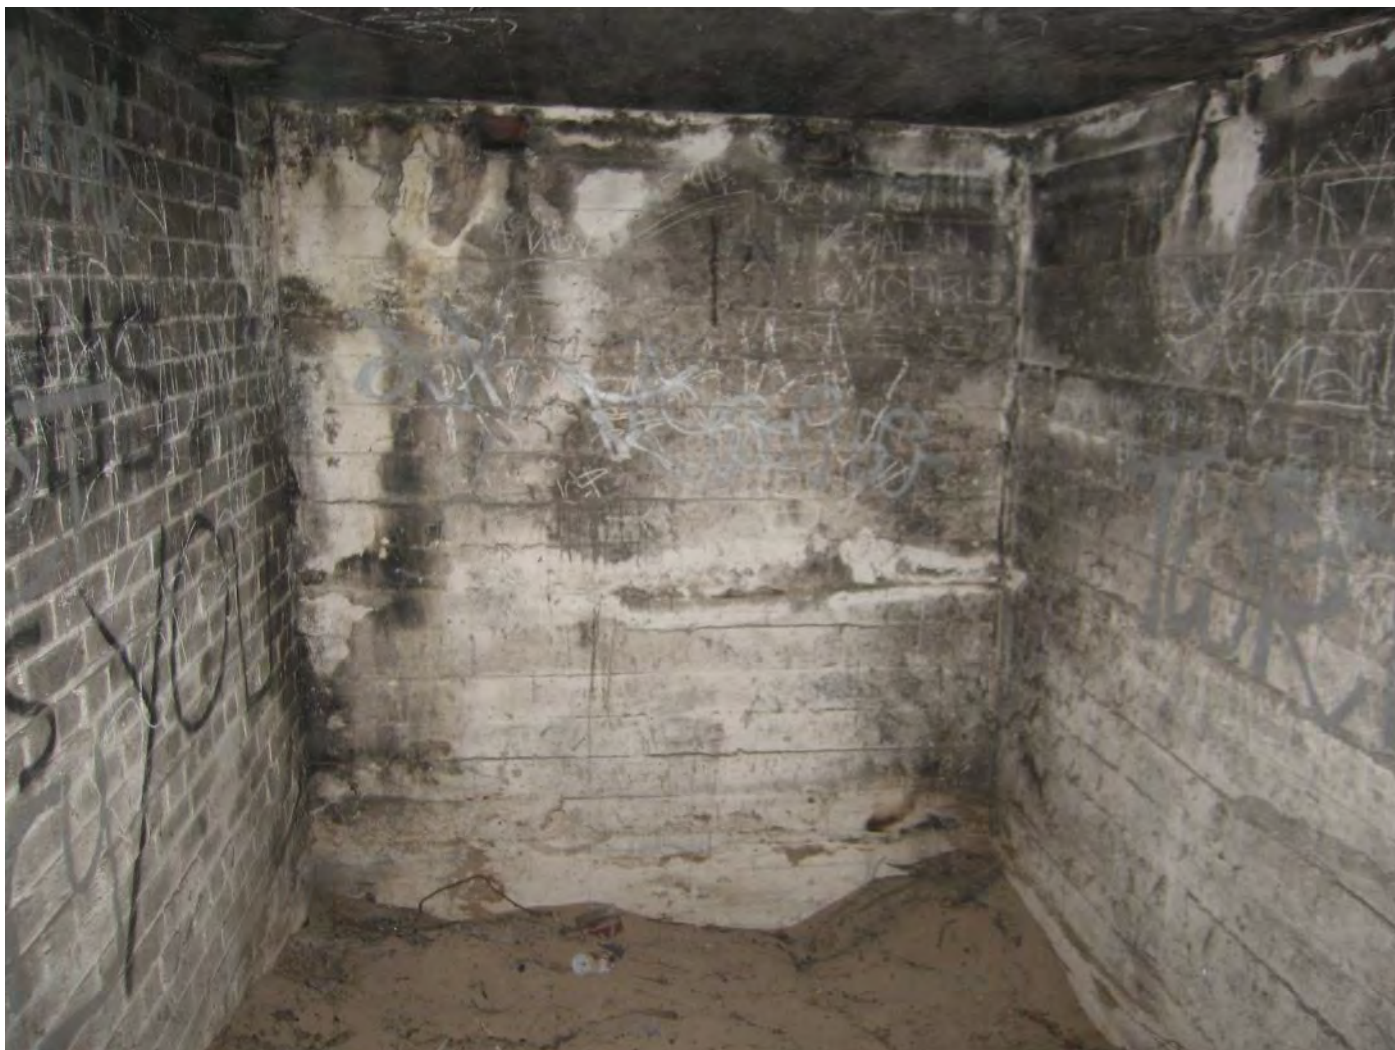
Figure 122: Ammunition Bunker – Room 1

The first room is a small rectangular space with no natural light flowing into the room. The three external walls are of concrete construction, the floor (under the cover of sand at the time of writing) is concrete and the roof is also reinforced concrete. The fourth wall, the west wall, is a double leaf brick load bearing wall.

The walls are a dusty white with graffiti with damp staining and possible fire scorch marks.

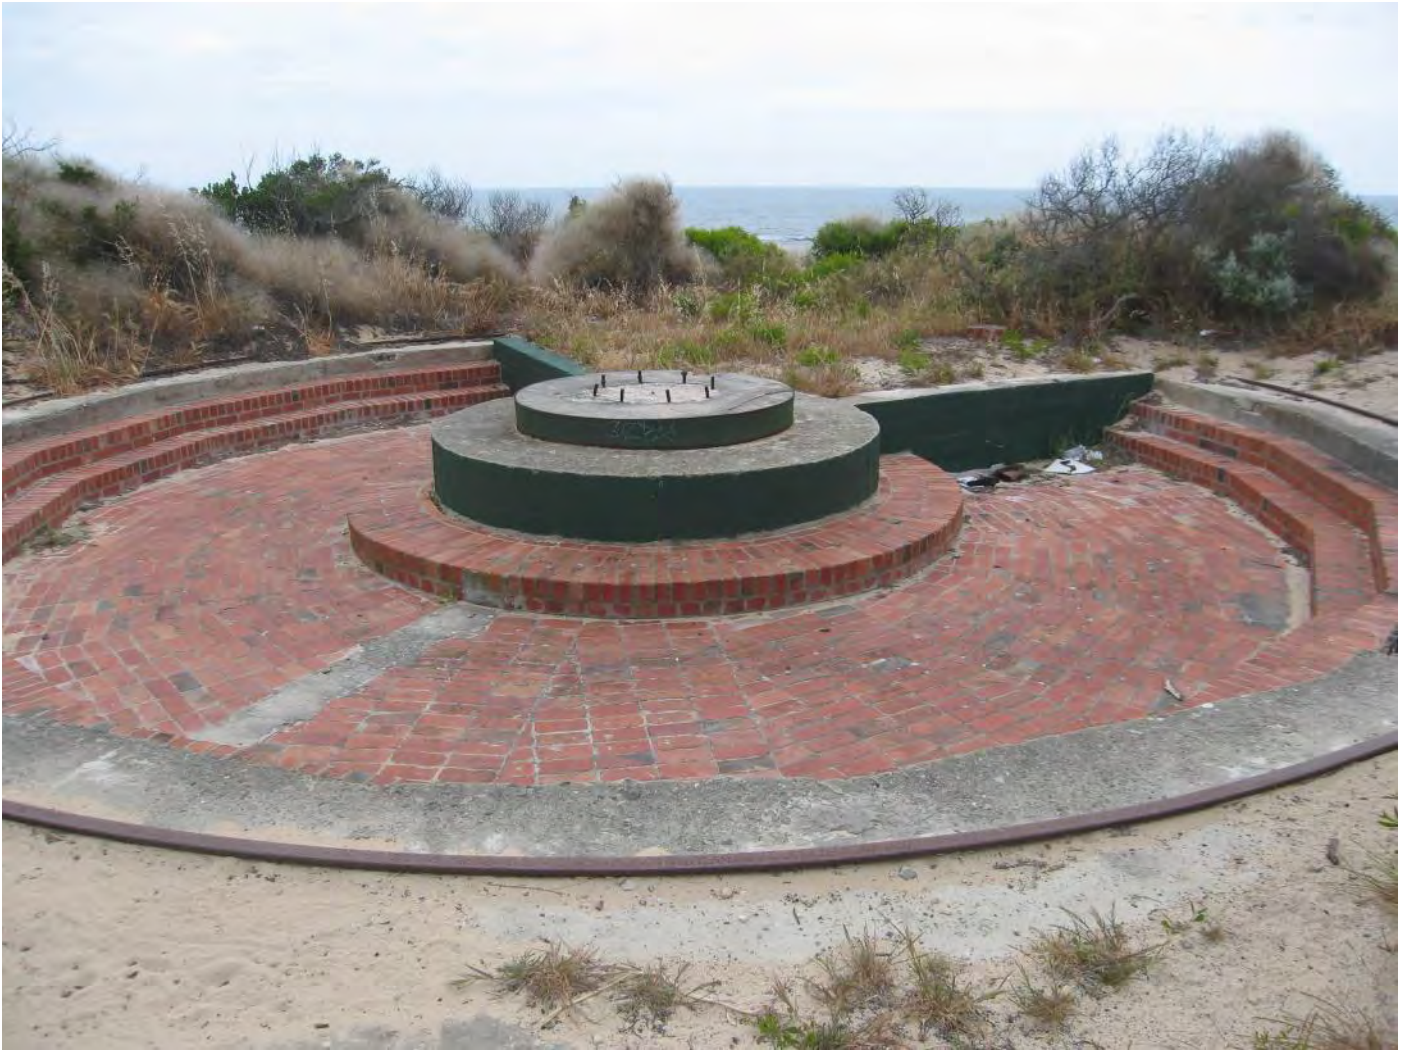
Figure 129: Gun Emplacement No. 2

Gun Emplacement No.2 is exactly the same as the Emplacement No. 1 apart from its condition. Gun Emplacement No. 2 is intact and presents as originally constructed which aids understanding of the form and function of the structure.

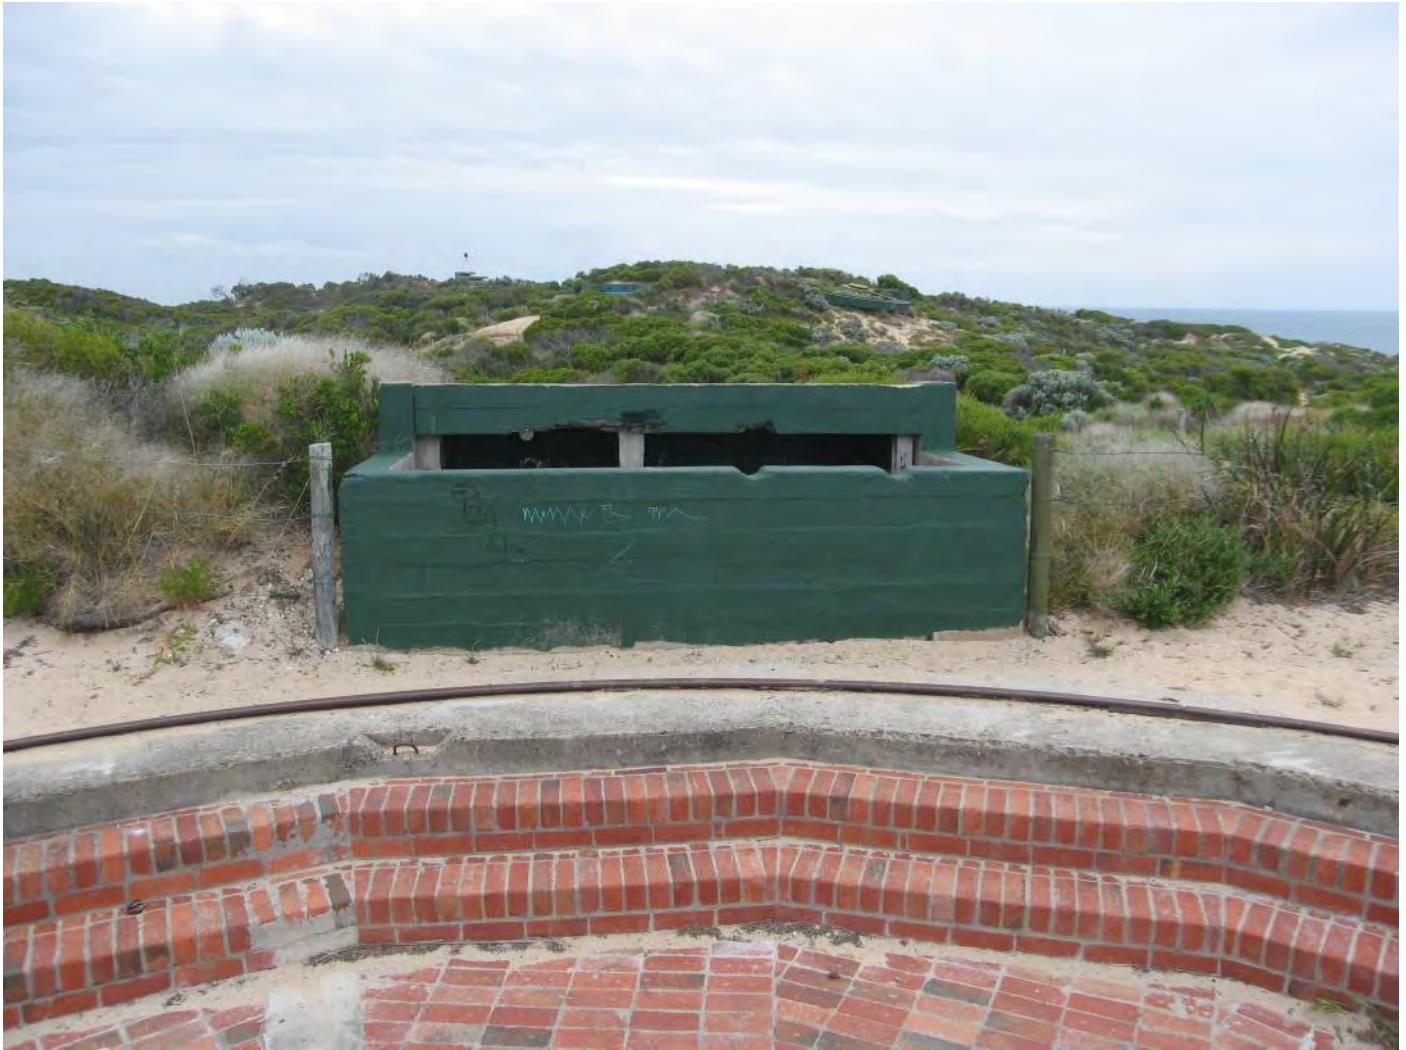
Figure 134: Gun Emplacement No. 2 – Ammunition Store 1

Both are in good condition and clearly demonstrate the plan form of the structures. Both are partially obscured by the sand around the sides and the rear of the structures but not to any great detrimental effect.

Though generally in good condition, the concrete is beginning to show early signs of concrete cancer in places, especially to the edge of the roof slab where chunks of concrete have broken away and the rusted reinforcing steel is visible.

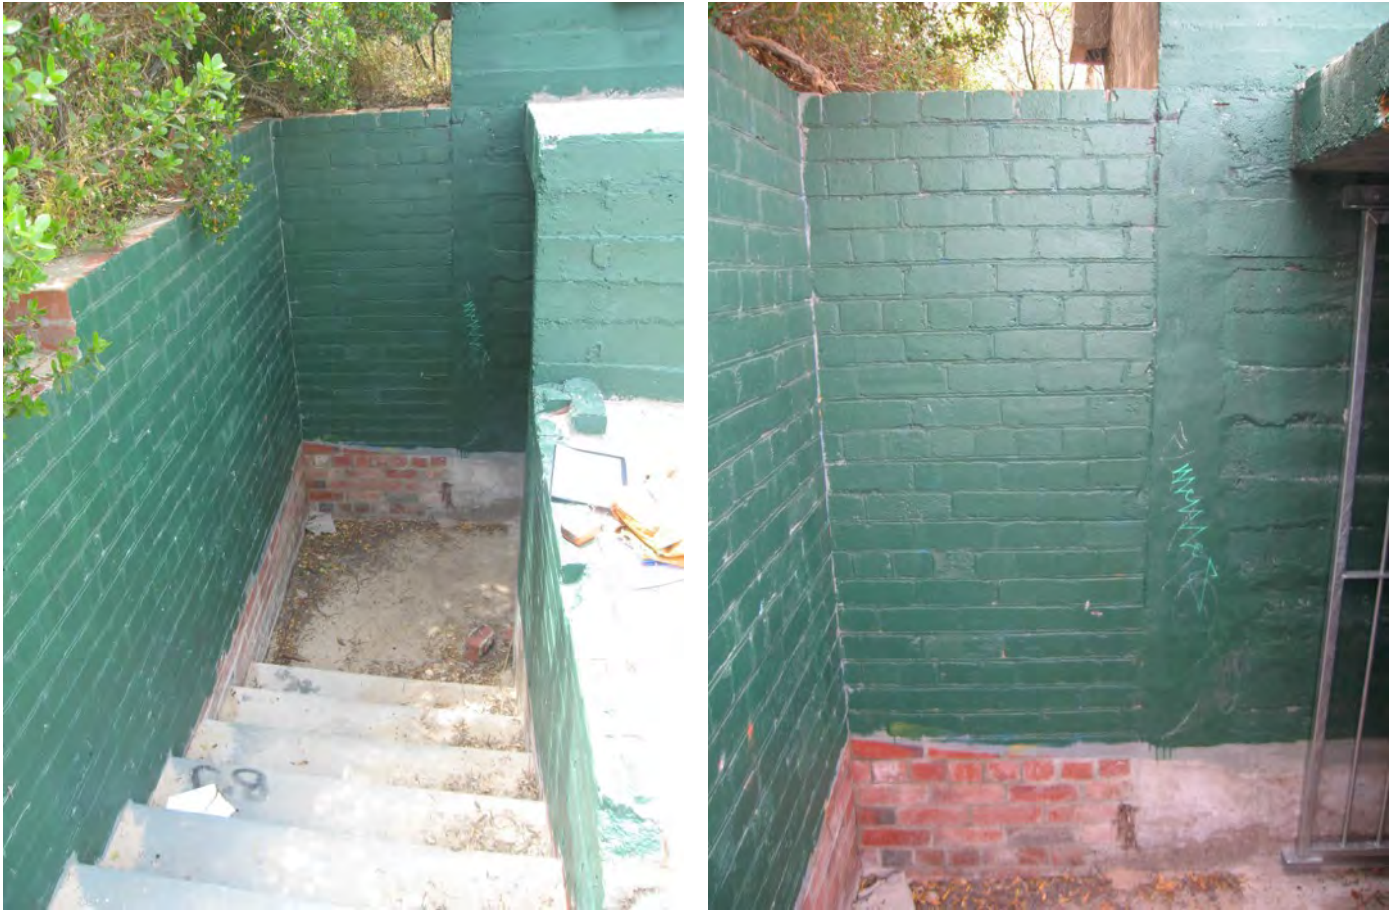
Figure 143: Ammunition Bunker No. 2 – Entrance

The entrance is located on the south-west elevation with the concrete steps projecting out from the main building line of the structure, before doglegging to the right and accessing the Bunker. The steps are protected by twin brick retaining walls, the majority of which have been painted with only the lower brick courses remaining in the natural state. Sand accumulation prevented the walls being painted fully to ground level. The brickwork is laid in English Garden bond consisting of three stretcher courses followed by a header course. The terminating brick wall at the foot of the steps abuts the concrete frame of the bunker structure and has not been keyed in.

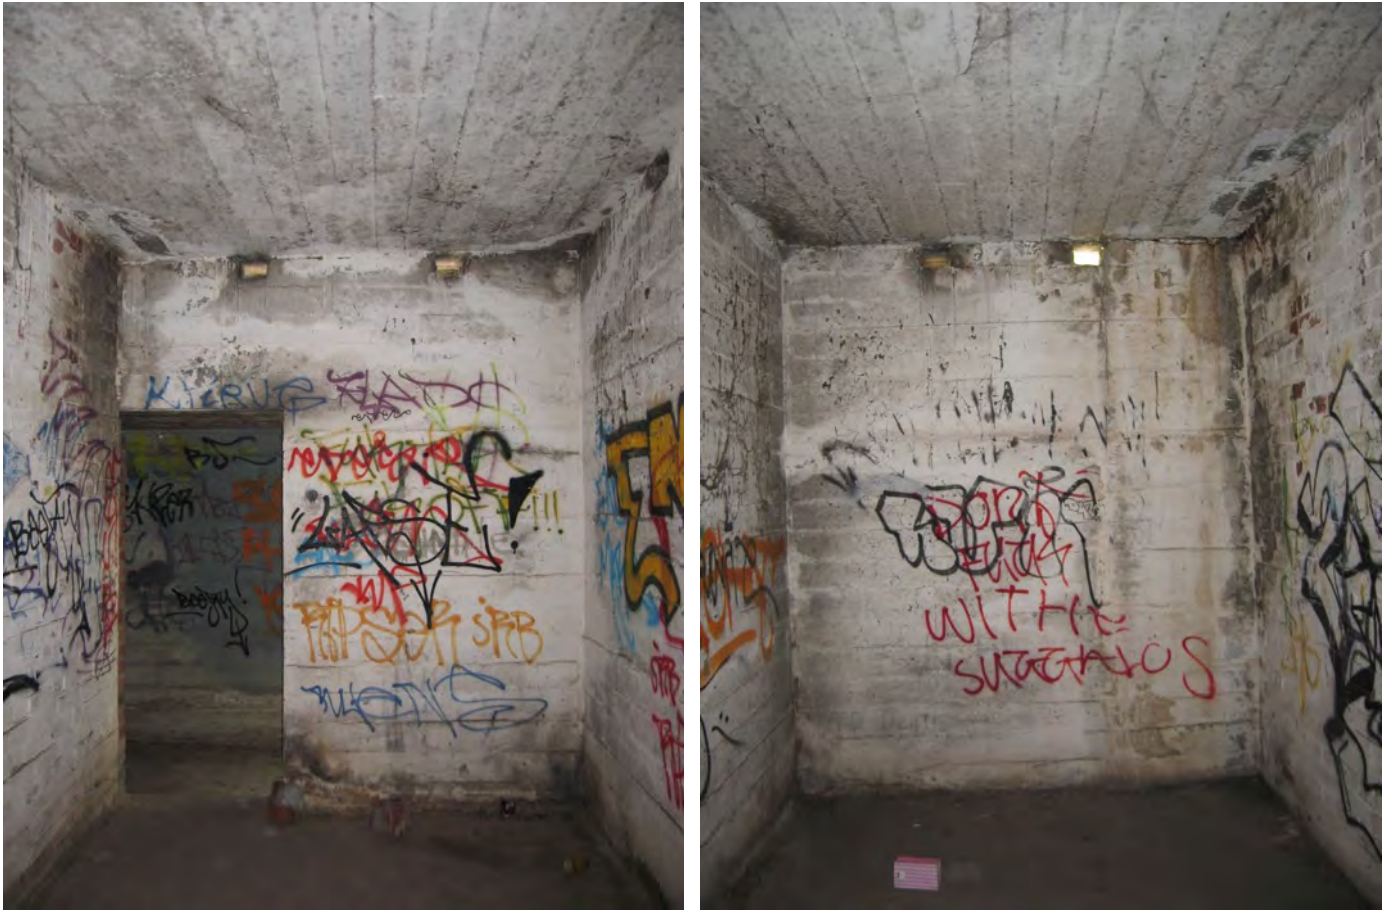
Figure 146: Ammunition Bunker - Room 1

Internally, the bunker has the same plan form as Bunker 1 with the main space divided into two rooms plus an entry tunnel. The smaller room, Room 1, has three external concrete walls with a fourth double leaf loading bearing brick wall dividing Room 1 from Room 2. The concrete to Room 1 has been painted white which is wearing off and has been covered in graffiti. Small ventilation holes are positioned directly below the ceiling. The sand has been removed but the walls are showing slight signs damp at lower level which may dry out now the sand has been cleared.

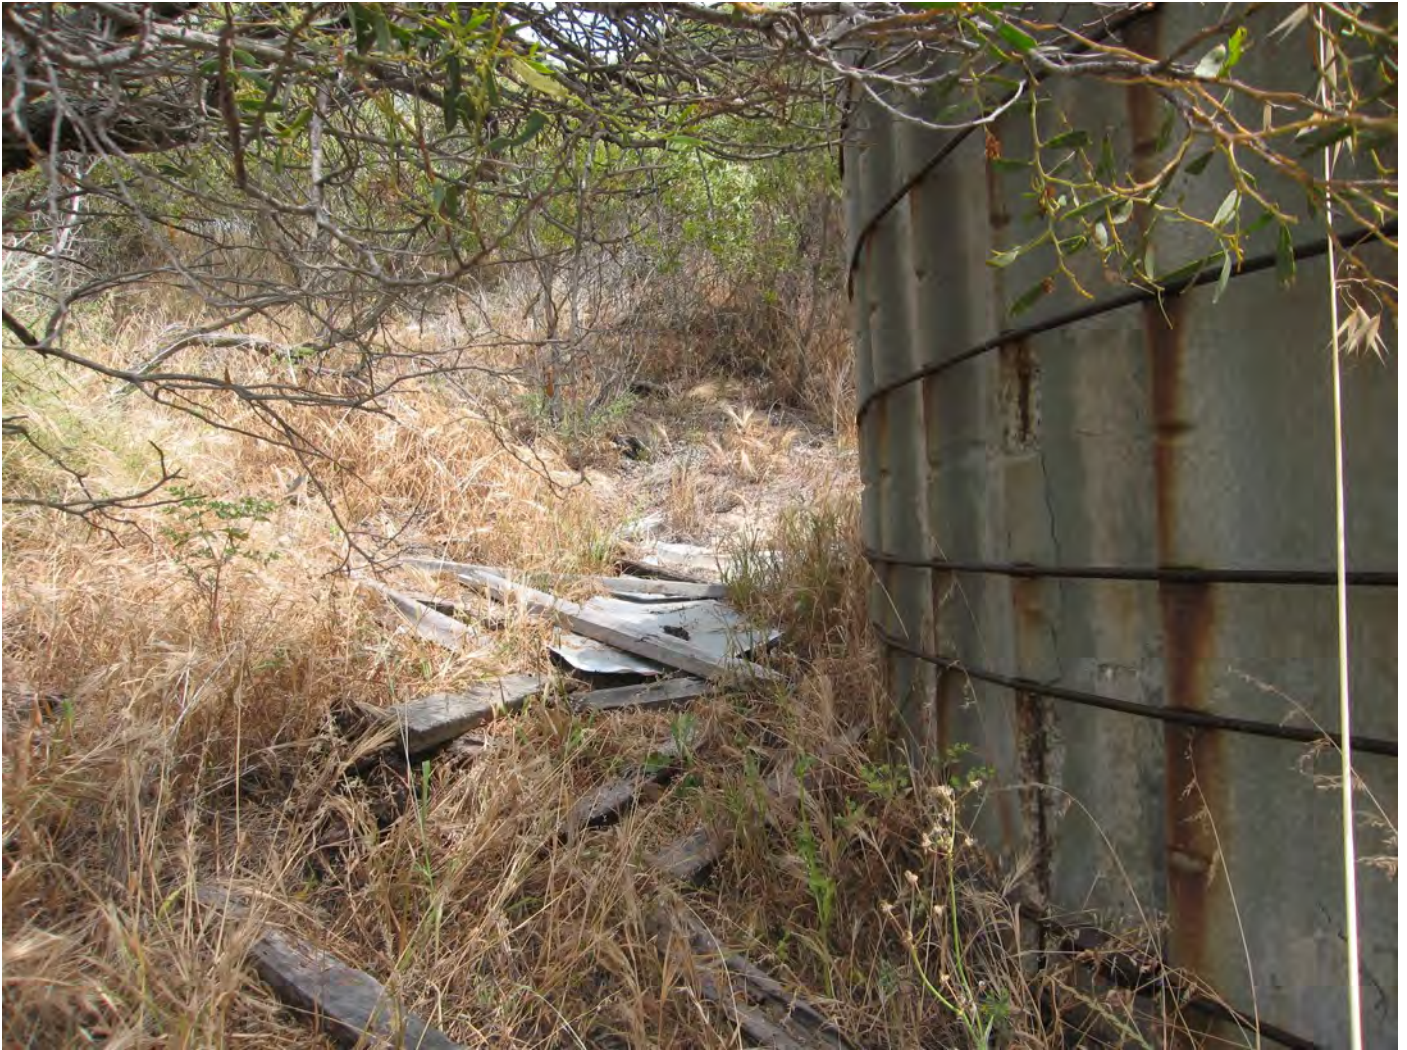
The tank is circular, of reinforced concrete construction with steel bracing wrapping around the fluted sides at various positions up the height of the walls.

The roof is no longer extant with remnant corrugated iron and timber laying in the bottom of the tank and around the edges.

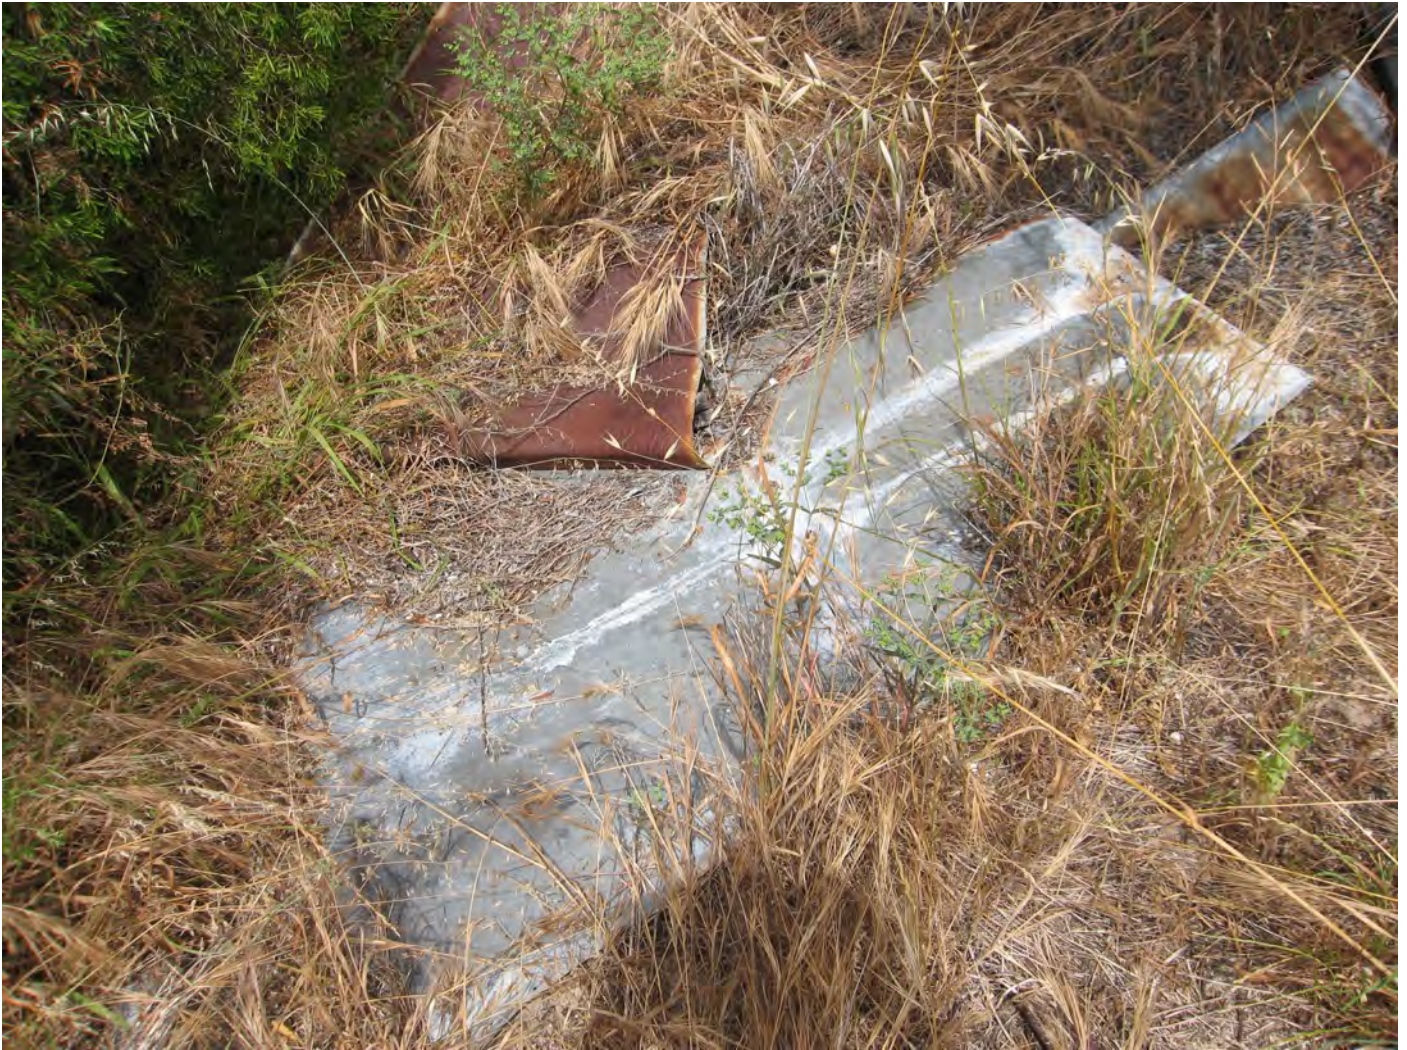
Figure 154: Water Tank – remnant roofing material

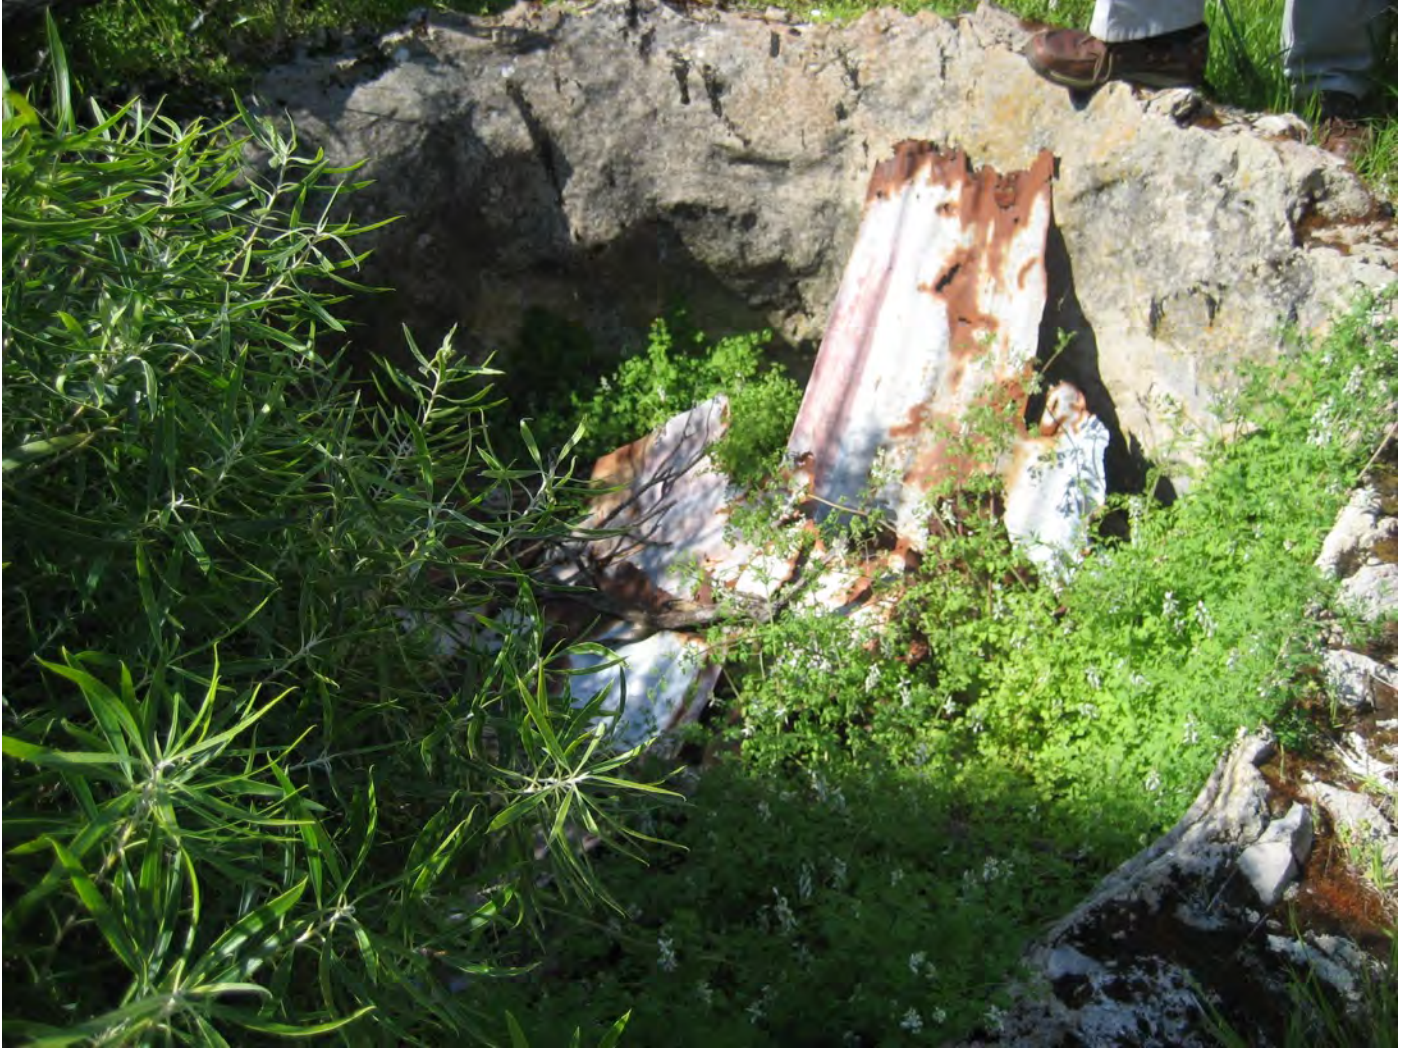
The remnants of the well consist of a circular stone lined void of indeterminable depth. Remnant corrugated iron sheets are laying in the well which may have formed part of the well lid. The well is now full of building debris, sand and weeds.

Figure 160: Well lining and remnant covering fabric
