Appendix 6: Structural Engineers Assessment Report

Point Peron Rehabilitation Project,
Conservation Management Plan,
Structural Engineering Services Assessment Report

Peter Baxendale (PBCE) was commissioned by Hocking Heritage Studio (HHS) to investigate and advise on the structural condition of the various buildings and building remains at the former Point Peron 'K' Battery site, an integral element of Western Australia's coastal defence during the Second World War.

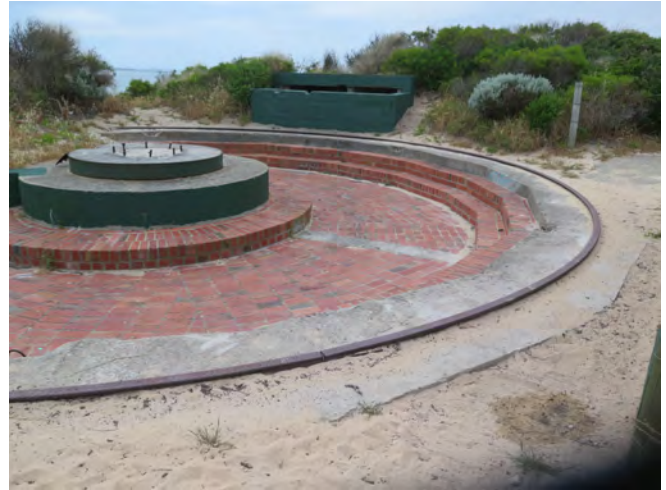
The emplacement remains are in good general structural condition. Shifting soil issues do not appear to have adversely affected stability of this site unlike the Emplacement 1 site. Concrete cancer is evident on the soffits of the munitions stores' roof slabs but the gun mount is relatively unaffected.

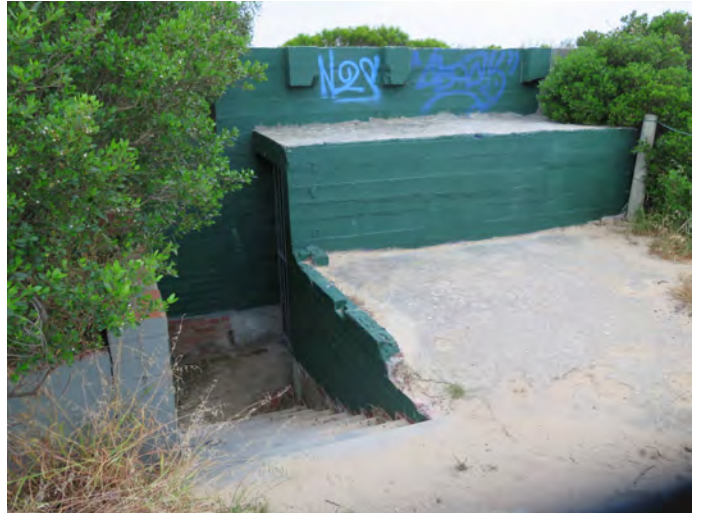
The building is similar in construction and condition to the bunker at Gun Emplacement 1.

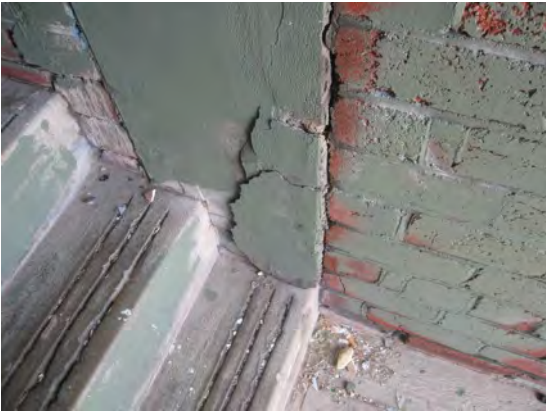
Underside of roof slab forming the ceiling is showing early signs of concrete cancer. Render to concrete column at foot of stairs is drummy, cracking and falling off.

Painted finish with graffiti	Patch repairs to reinforced concrete as outlined above. Monitor condition of ceiling for further deterioration. Remove paint from all elevations as this can contribute to the deterioration of the fabric. Paint removal should not unduly damage the substrate and mortar and test panels in discrete locations should be established prior to embarking on the full removal. Non-caustic solvent based methods or low pressure steam removal can be tried. Peelaway paint removal system can be used or Westox's DeLam which applies a poultice to the paint and will be ready to be removed within a few days. Not all paint traces will be removed due to the texture of the bricks and concrete. Remove drummy render from the concrete column at the foot of the stairs, ensuring that all retained render is in a sound condition. Patch repair in a render mix to match existing. If the structure is to be secured by the metal grille gate graffiti should not be an ongoing issue for the internal space and once all paint and graffiti has been removed, there should not be a requirement to coat the internal fabric with an anti-graffiti coating.	2 2 2

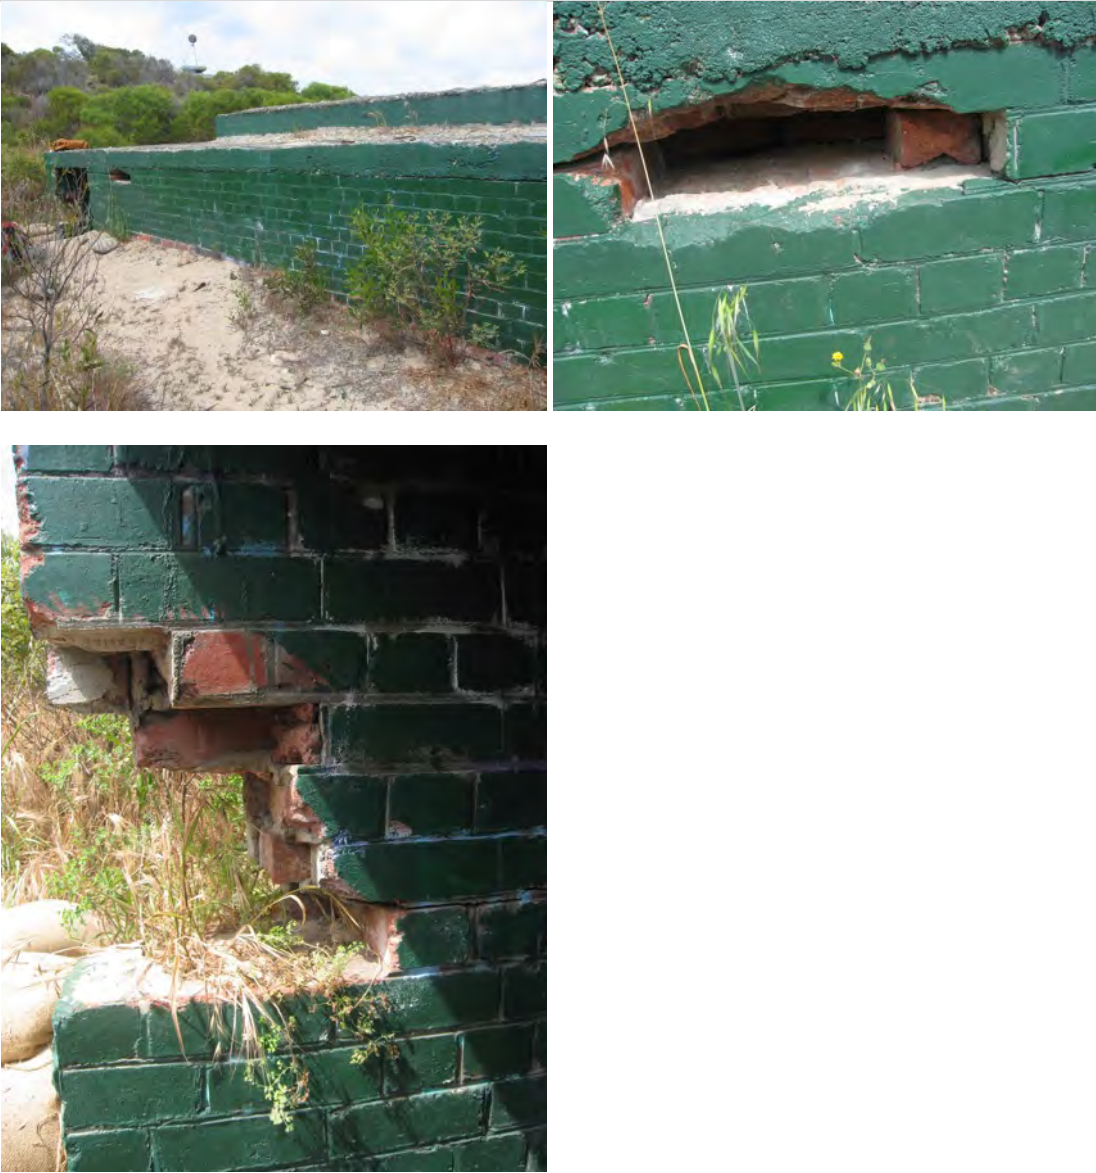
East Elevation	B	<p>The east elevation incorporates the entrance and is generally in good condition. Bricks are missing to the south east corner by the entrance and along the main elevation.</p>	<p>Remove paint from entire elevation as this can contribute to the deterioration of the fabric. Paint removal should not unduly damage the substrate and mortar and test panels in discrete locations should be established prior to embarking on the full removal. Non-caustic solvent based methods or low pressure steam removal can be tried. Peelaway paint removal system can be used or Westox's DeLam which</p>	2

<p>applies a poultice to the paint and will be ready to be removed within a few days. Not all paint traces will be removed due to the texture of the bricks and concrete. Specifier's instructions are to be followed in the application.</p> <p>The missing brickwork around the entrance should be reinstated. Check around the structure to look for bricks. If salvaged bricks are to be used, ensure they are clean of mortar debris prior to reinstatement. Rake the mortar joints out to a good depth to ensure the new mortar will hold and relay the bricks using the same bond and pointing style as the original.</p>	1
South Elevation	B	<p>Upper sections of brick walls are showing signs of failure due to water damage from the flat roof causing the steel reinforcement bars to rust and expand causing failure to the brickwork.</p>

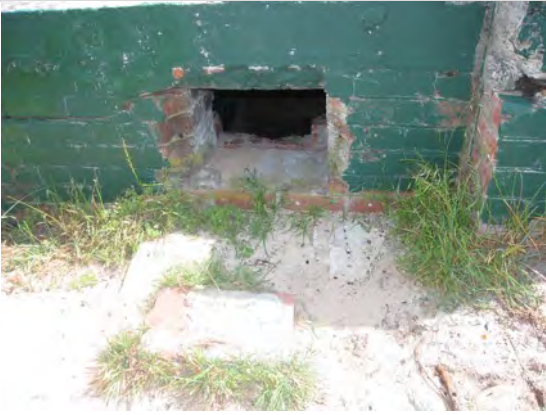
West Elevation	D	<p>Upper sections of brick walls are showing signs of failure due to water damage from the flat roof causing the steel reinforcement bars to rust and expand causing failure to the brickwork.</p>

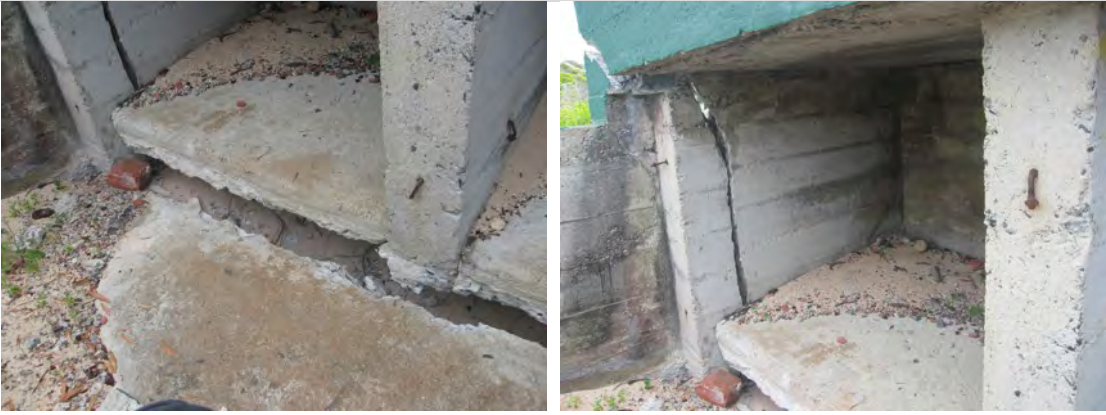
<p>Ammunition Store 2 Reinforced concrete</p>	<p>C</p>	<p>The second ammunition store has fared much better with only slight movement from its original position and has not been subjected to the same degree of twist and torsion and has therefore remained virtually in tact. The structure is largely submerged in the sand dune which may have contributed to its protection. The Ammunition Store is full of sand and vegetation.</p>  	<p>Remove the sand and vegetation growth from within the structure, address any signs of concrete cancer utilising the methodology outlined above.</p>	<p>1</p>
<p>Ammunition Bunker No. 1 Reinforced concrete walls and roof, brick internal walls, concrete slab floor, brick retaining walls to entrance</p>	<p>C</p>

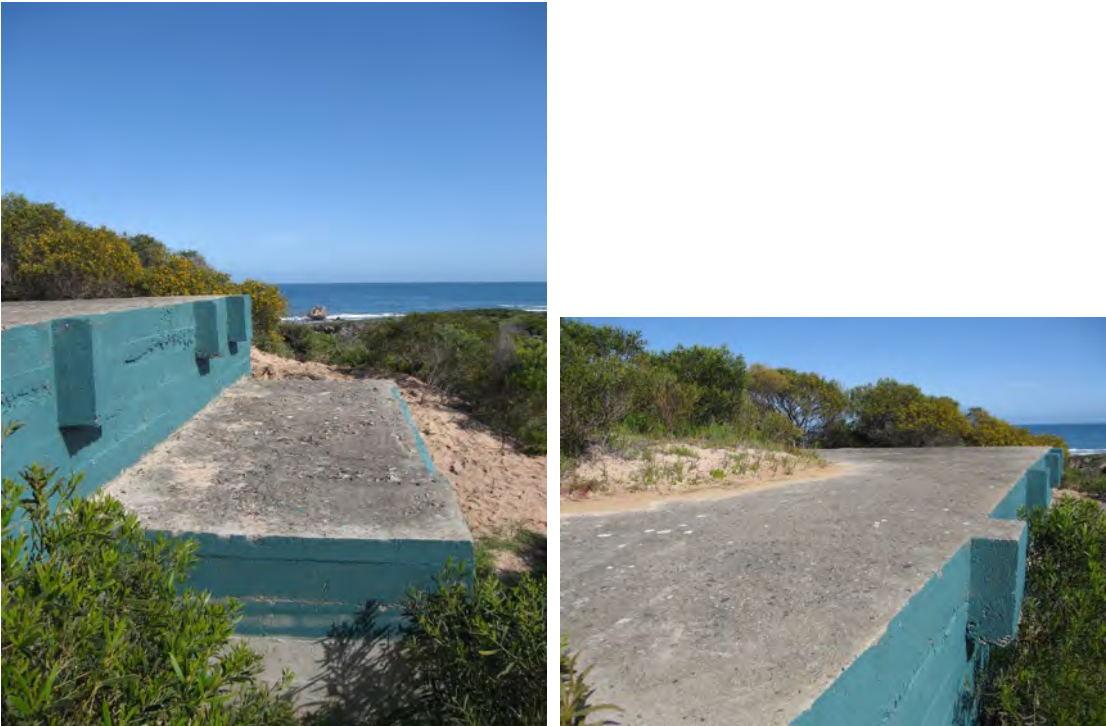
<p>Repair concrete around the air vent. To prevent further damage the air vent shaft should be reconstructed based on the design of extant air shafts. Protection of the opening will safeguard the vulnerable fabric around the opening and also prevent water ingress into the building.</p>	2
Roof	C	<p>Appears to be in sound condition with only hairline cracking. Water drainage issues causing some damage to the air vent shafts and edge of the concrete roof. Sand build up on the roof with subsequent vegetation growth.</p>

<p>Consideration to be given to adding a new top screed, angled to allow run off for rain water. Roof to be coated with waterproof breathable membrane or other coating to reduce water penetration into the fabric and subsequent damage.</p> <p>Sand removal from the roof is required if full roof inspection to be undertaken.</p>	2

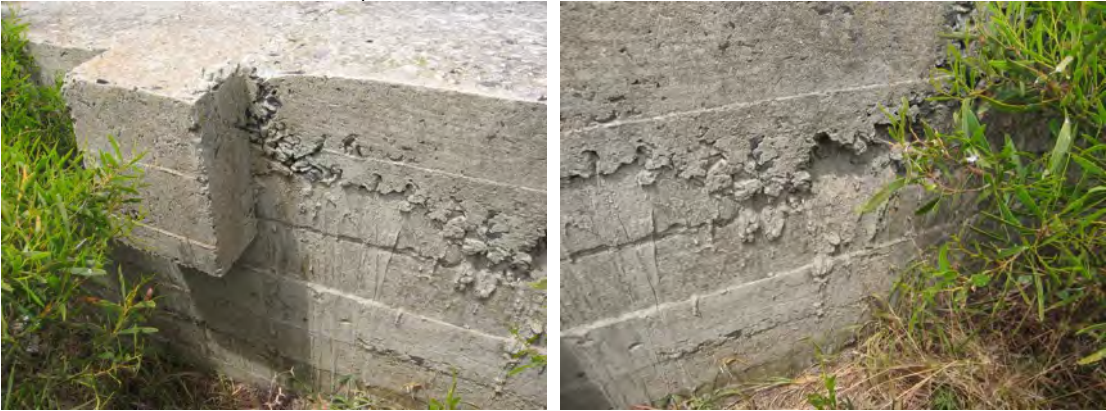
Building Name	Condition Rating	Defect and Location	Work to Rectify Defect	Priority Ranking
West Elevation		<p>Much of the west elevation is obscured by vegetation. The elevation is partially submerged. Projecting air shafts extending from the roof level down approximately three block courses. The underside of the vents showing signs of concrete cancer and erosion in some instances. This elevation has not been painted.</p>

<p>Full inspection of elevation is required to determine condition. This may require the removal of some vegetation.</p> <p>Monitor condition of elevation. Patch repairs to the air shaft vents to reduce further deterioration.</p>	<p>1 3</p>
Roof	C	<p>Slight cracking , especially at the edges of the roof, resulting in water ingress into the interior. If left unchecked this will result in eventual concrete cancer. Generally in good condition.</p>

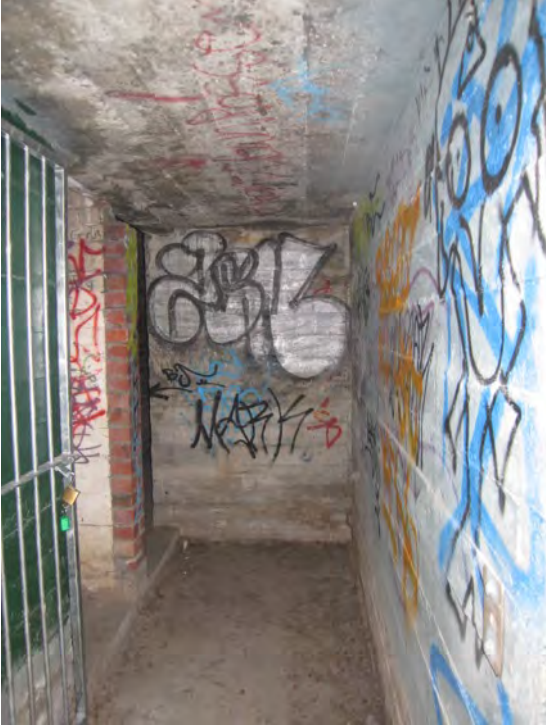
Building Name	Condition Rating	Defect and Location	Work to Rectify Defect	Priority Ranking
Interior				
Entry Passage	C	<p>Concrete walls and ceiling painted in a white paint finish which is beginning to show signs of wear. Walls and ceiling subjected to graffiti. Sand accumulation causing early signs of damp at low level.</p>

<p>Remove paint from entire elevation as this can contribute to the deterioration of the fabric. Paint removal should not unduly damage the substrate and mortar and test panels in discrete locations should be established prior to embarking on the full removal. Non-caustic solvent based methods or low pressure steam removal can be tried. Peelaway paint removal system can be used or Westox's DeLam which applies a poultice to the paint and will be ready to be removed within a few days. Not all paint traces will be removed due to the texture of the bricks and concrete.</p> <p>Graffiti to be removed. An anti-graffiti coating is not required.</p> <p>Ensure sand levels are maintained implementing regular removal.</p>	3

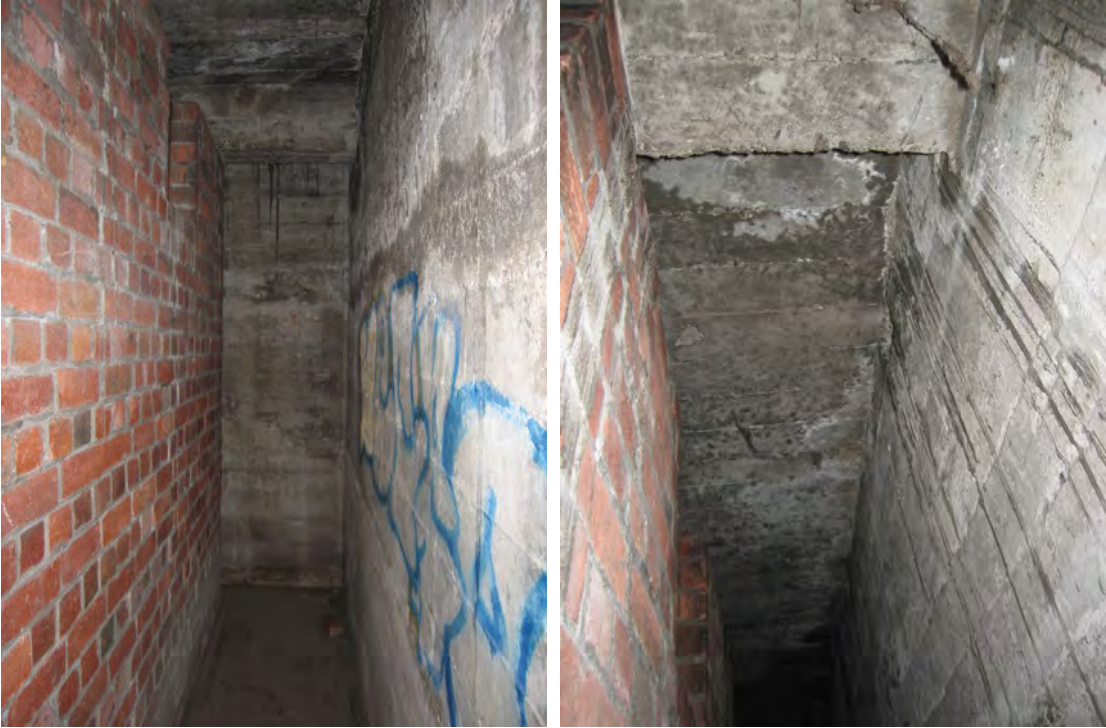
<p>Room 2 plus blast corridor</p> <p>Concrete outer walls and brick inner walls, concrete ceiling and floor</p>	<p>C</p>	<p>Brick work to the internal walls is generally in sound condition, with some graffiti. Dusted white painted finish wearing off from the walls. Some slight signs of damp at the junction between the wall and ceiling, likely to be in line with the roof cracks. Evidence of recent sand removal from both the main room and the blast corridor. Signs of early concrete cancer to the roof with some of the enforcement bars rusting and breaking through the concrete.</p>

<p>Remove paint from entire elevation as this can contribute to the deterioration of the fabric. Paint removal should not unduly damage the substrate and mortar and test panels in discrete locations should be established prior to embarking on the full removal. Non-caustic solvent based methods or low pressure steam removal can be tried. Peelaway paint removal system can be used or Westox's DeLam which applies a poultice to the paint and will be ready to be removed within a few days. Not all paint traces will be removed due to the texture of the bricks and concrete.</p> <p>Remove graffiti. An anti-graffiti coating is not required.</p> <p>Ensure sand levels are monitored, removing any sand build up on a regular basis.</p>	<p>2</p> <p>2</p> <p>1</p>

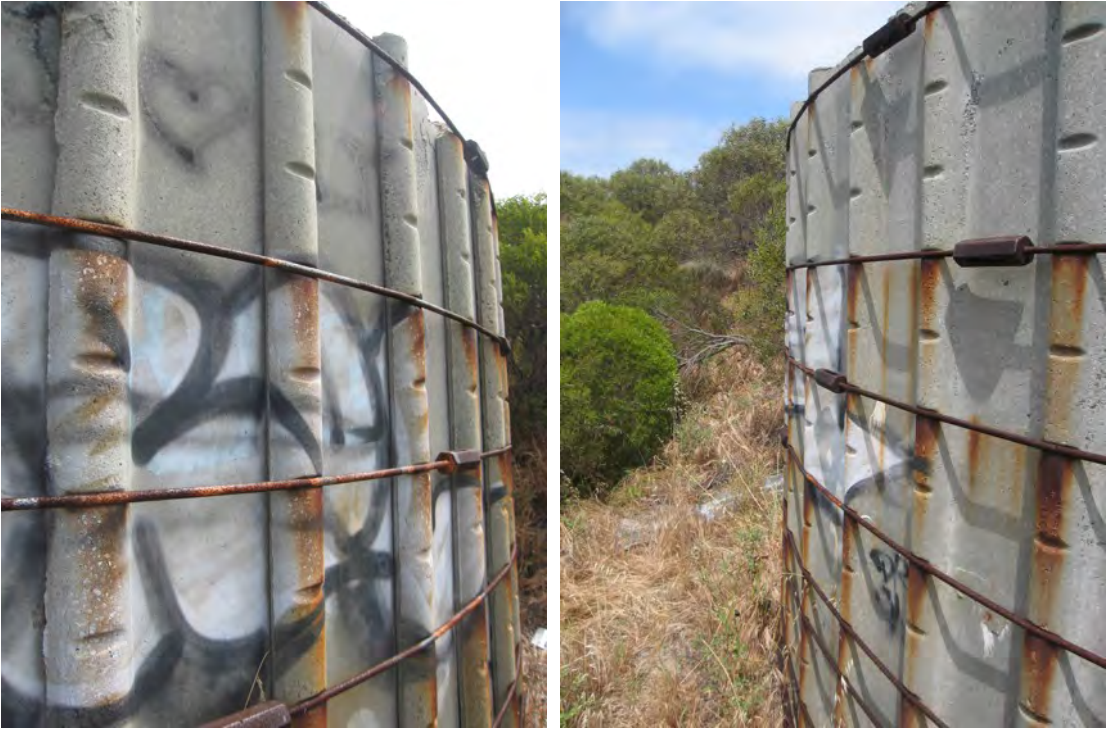
<p>Water Tank</p> <p>Reinforced concrete, corrugated iron roof no longer extant but possible remnant roofing material lays in and around the tank</p>	<p>C</p>	<p>Slight signs of concrete cancer, rusted steel tension bands and substantial graffiti to the interior. Roof no longer extant but remnant fabric may exist in the foot of the tank and around the structure.</p>

<p>Retention or removal is a decision for the owners of the site. Concrete cancer is beginning to occur which will require remediation if the structure is to be retained for interpretation purposes.</p> <p>There is no requirement to reinstate the corrugated iron roof.</p> <p>Removal of graffiti from the interior of the tank is recommended and consideration should be given to coating the structure with an anti-graffiti coating ensuring that this does not cause harm to the underlying fabric.</p>	<p>2</p>
