Point Peron "K" Battery Conservation Management Plan

South West Corridor Development Foundation Inc.

March 2016

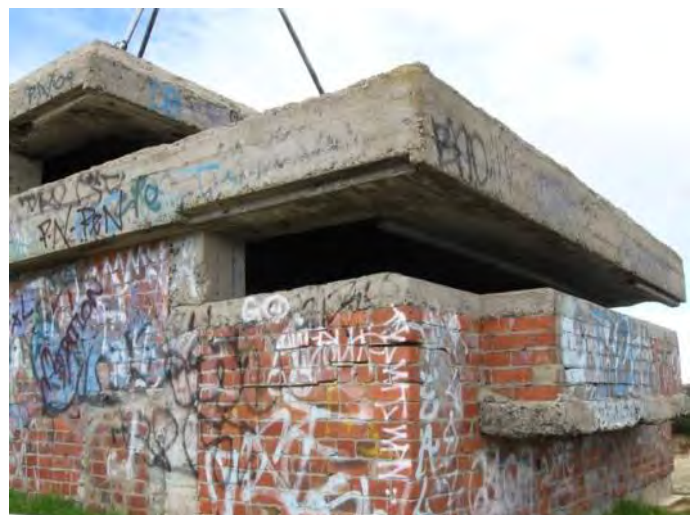
The Observation Post is essentially a simple square building with a flat roof of brick and concrete construction. Originally the structure presented in its more natural form of unpainted finish as illustrated in the photographs below but has been subjected to graffiti on a regular basis which was harming the brick and concrete finish and has since been painted to try and reduce the impacts of graffiti.

Figure 52: Observation Post before being painted, c.2009
Courtesy: <http://perthurbex.livejournal.com/2393.html>

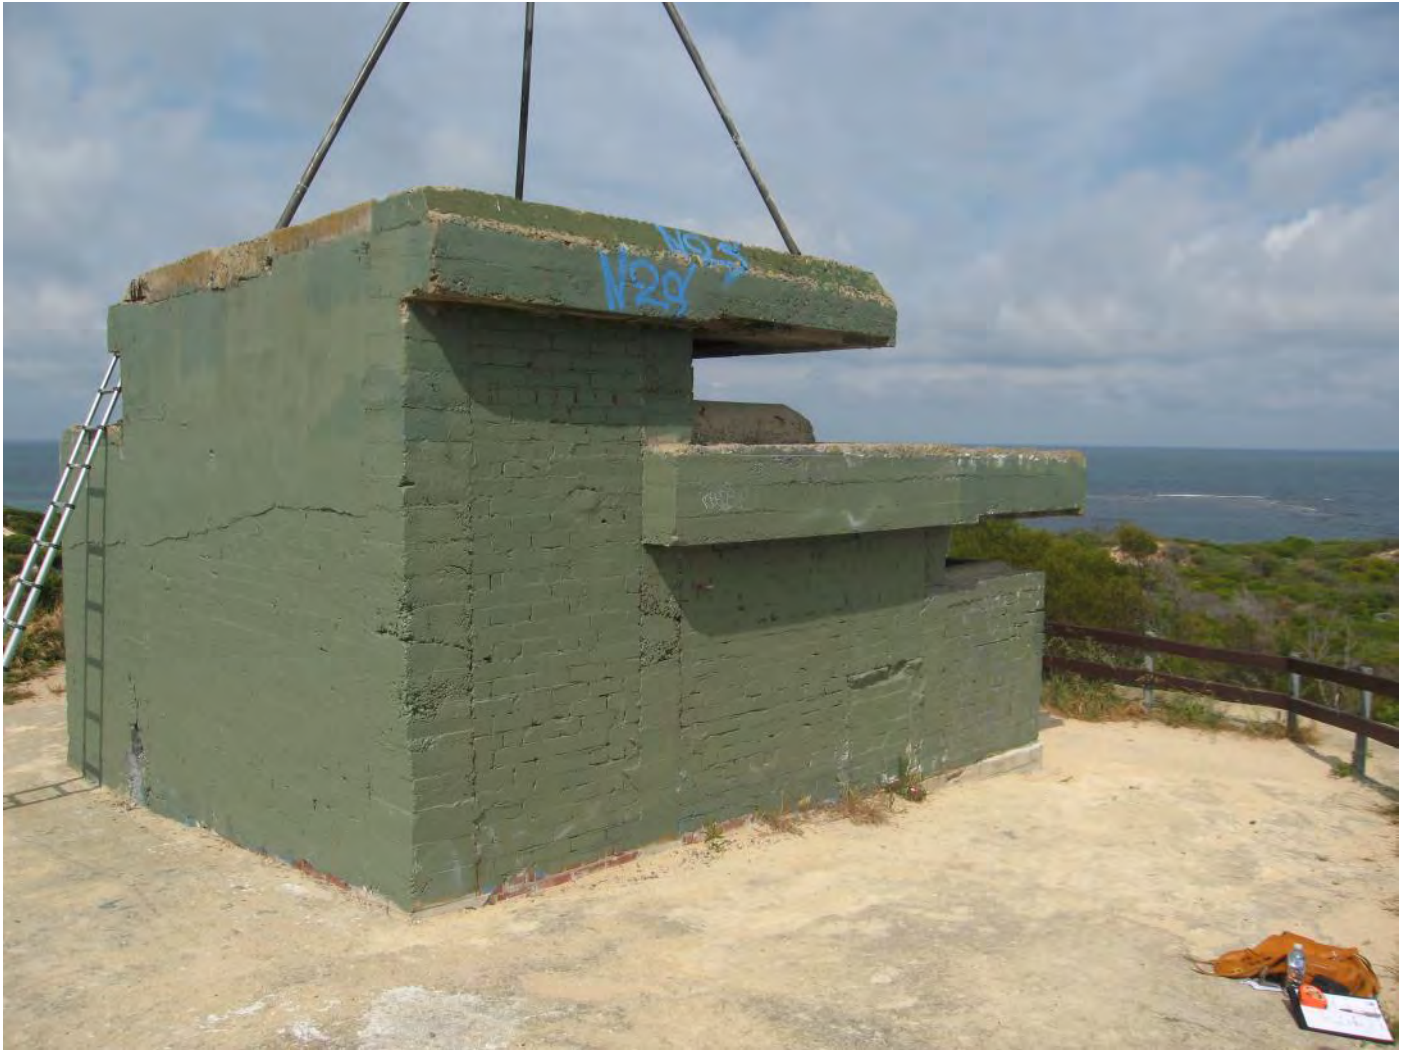
Figure 62: North Elevation

The north elevation is similar to the south elevation in terms of construction and presentation albeit with no entrance door. Again the concrete framework is visible with brick infill panels. A low level section towards the western end of the elevation has also been in filled. As the structures were decommissioned all the military equipment and installations were removed resulting in brick infill.

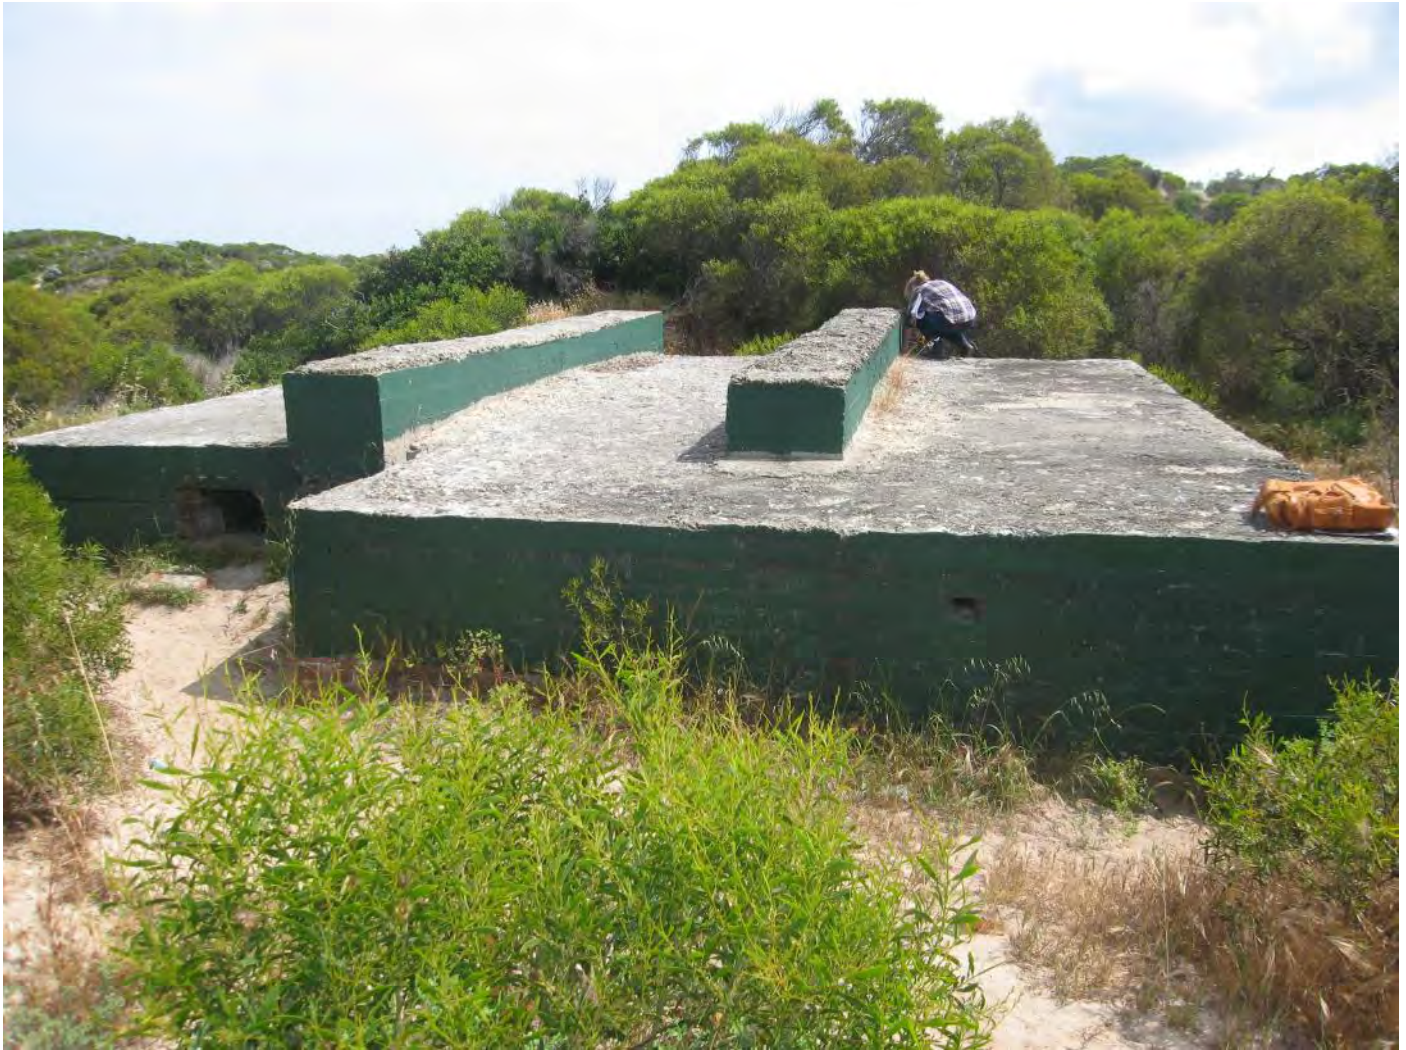
Figure 79: Operations Bunker – Roof plan

The roof of the Operations Bunker is reinforced concrete slab with raised reinforced concrete beams extending across the roof in a north-south direction, across the main structure only.

The layered blocks of the concrete are visible in the reinforced beams, each being three slabs high with a roughcast concrete top layer. Sand accumulation around the base of the beams is allowing for grass growth along the beams.

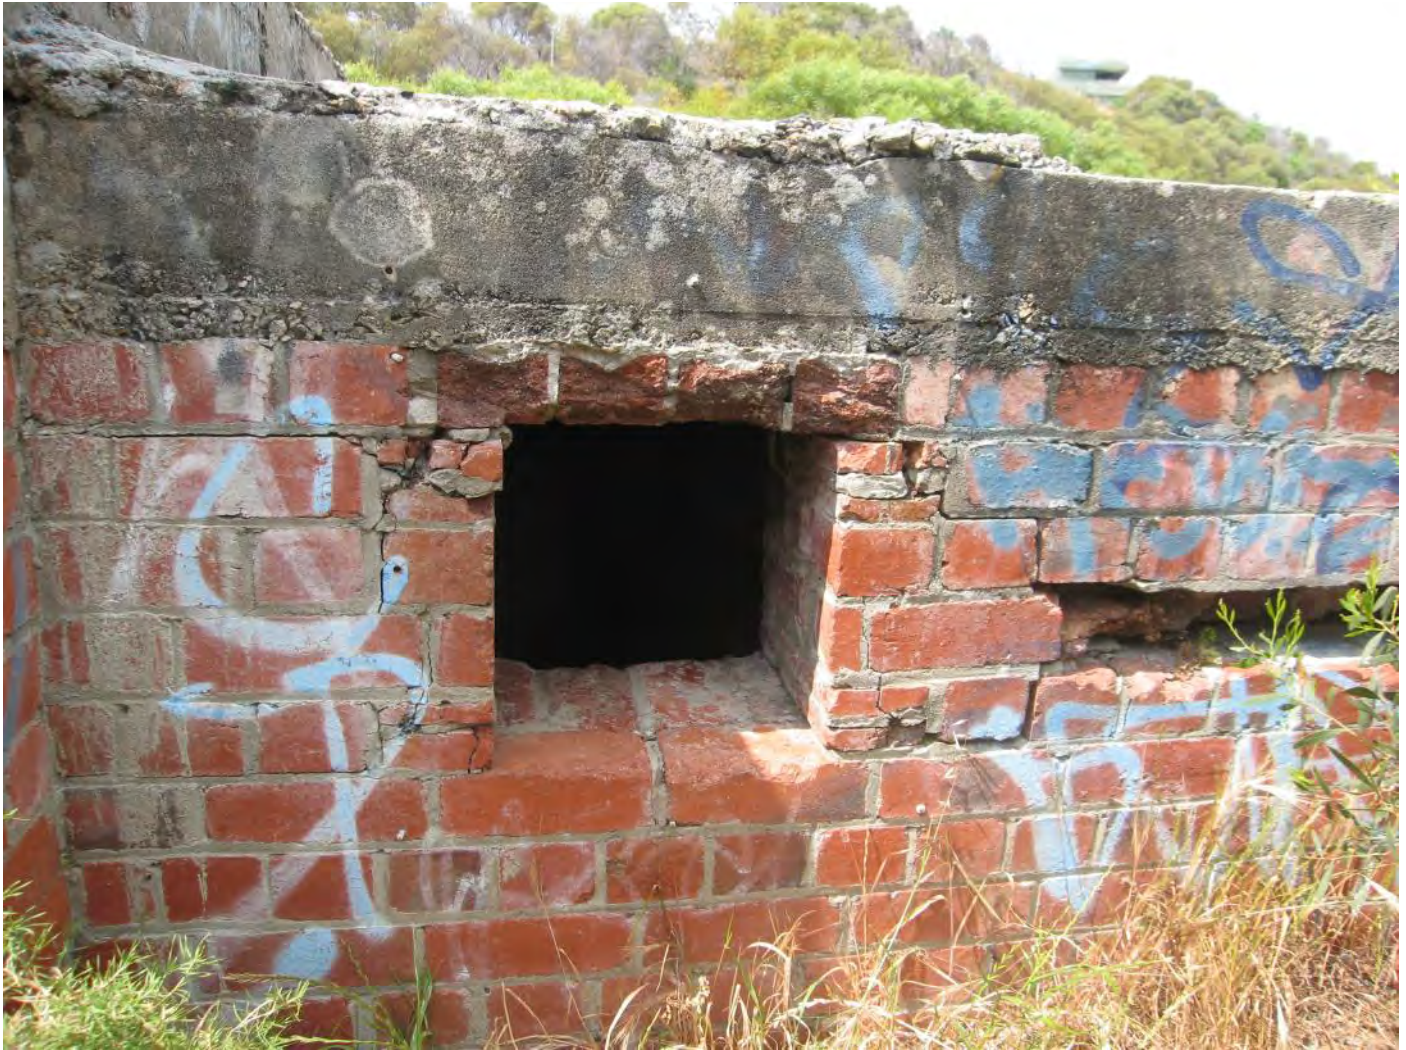
Figure 85: Operations Bunker – Openings in north wall

Small openings have been incorporated into the north wall, positioned one brick course below the concrete slab and are four bricks deep and approximately 1.5 bricks wide. Such holes often had a dual purpose of providing ventilation into the space but also to provide low level observations.

The brickwork immediately to the west of the opening, closest to the west elevation, is deteriorating. Bricks are missing with much of the damage being caused by the rusting and failing reinforcing steel. Previous repairs have been carried out with some evidence of localised repointing.

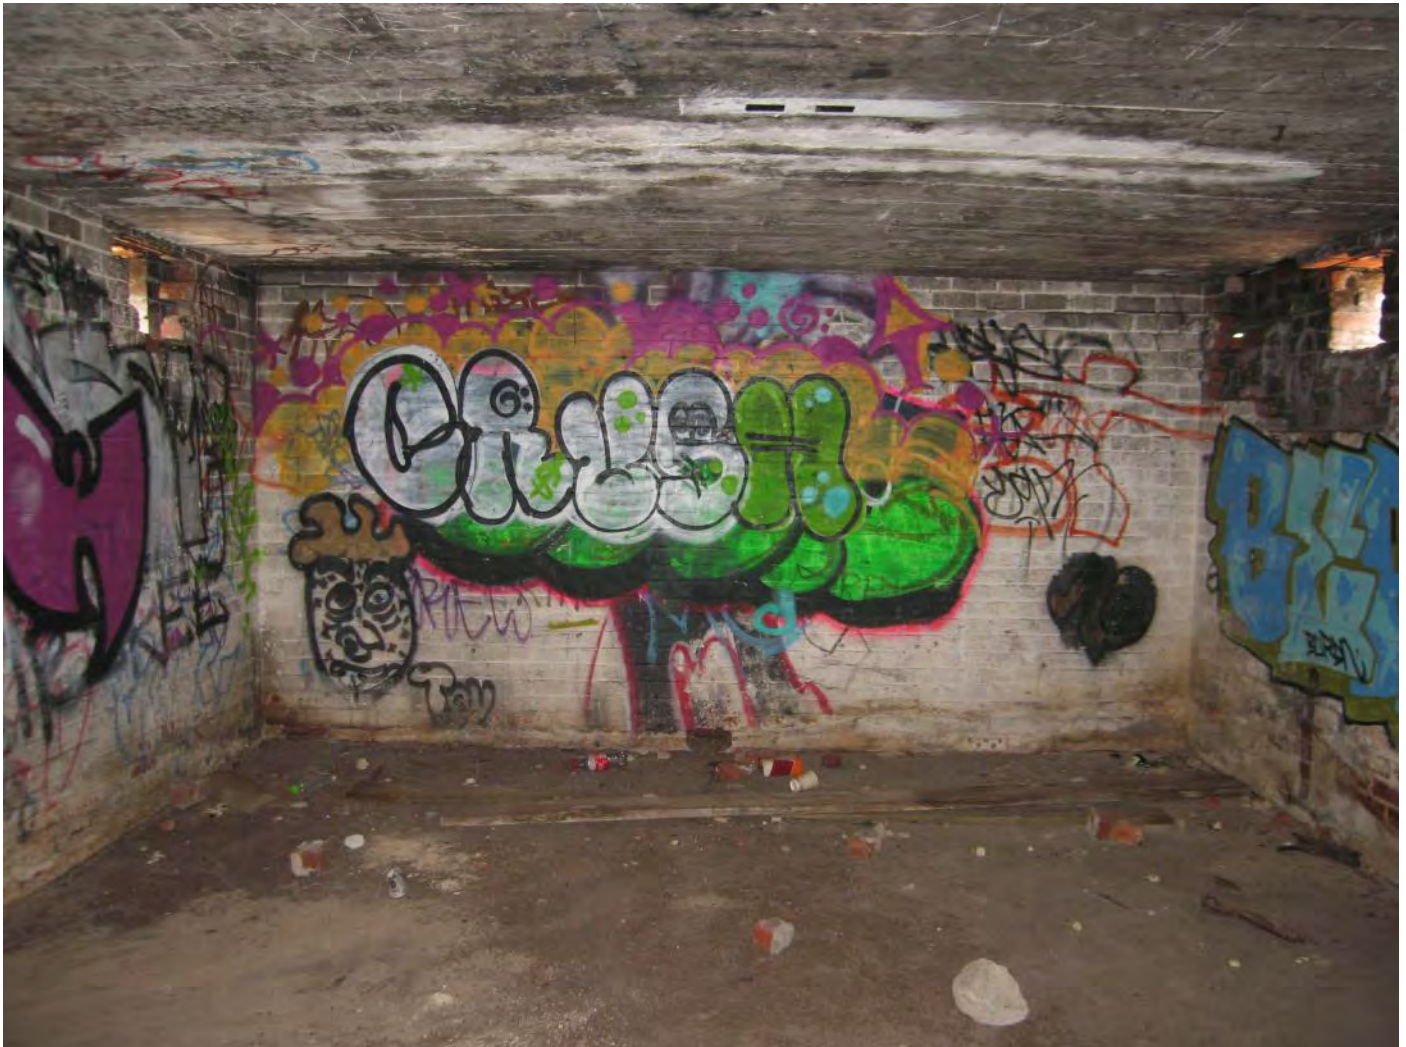
Figure 90: Operations Bunker – Interior (west wall)

The internal space consists of one rectangular shaped room of simple presentation. The brick walls are the internal leaf of the cavity wall which have been painted white at an earlier stage and are now covered in graffiti.

Loose bricks have collected on the concrete slab floor from the north west opening.

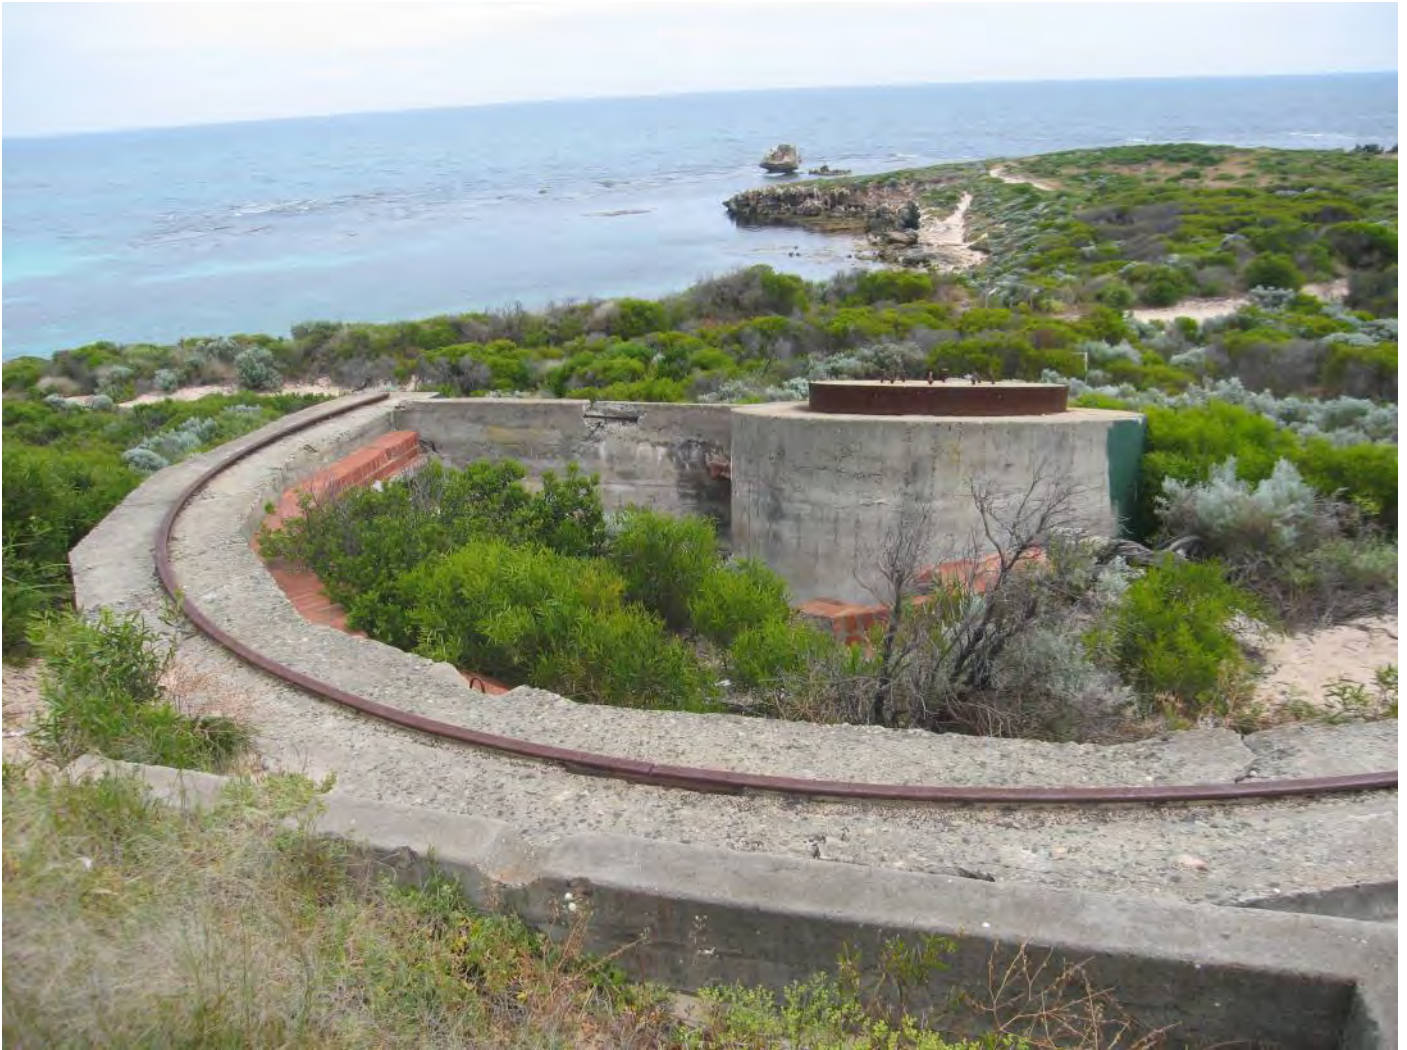
Figure 99: Gun Emplacement

The gun emplacement is principally a $\frac{3}{4}$ circular reinforced concrete structure that was originally submerged. The external and internal sides of the concrete wall consist of 13 straight sided segments. The sunken nature of the emplacements allowed the central concrete gun mount to have clear view over the waters the gun was protecting. A steel rail extends around the top of the concrete walls as part of the remnant fabric.

Brick steps extend around the internal side of the concrete structure, leading to a brick paved floor and to the central gun mount. The brick elements have become displaced and no longer full extend around the internal space of the gun emplacement. Sand has accumulated and bushes grown in the internal area, further obscuring the planning of the gun emplacement.

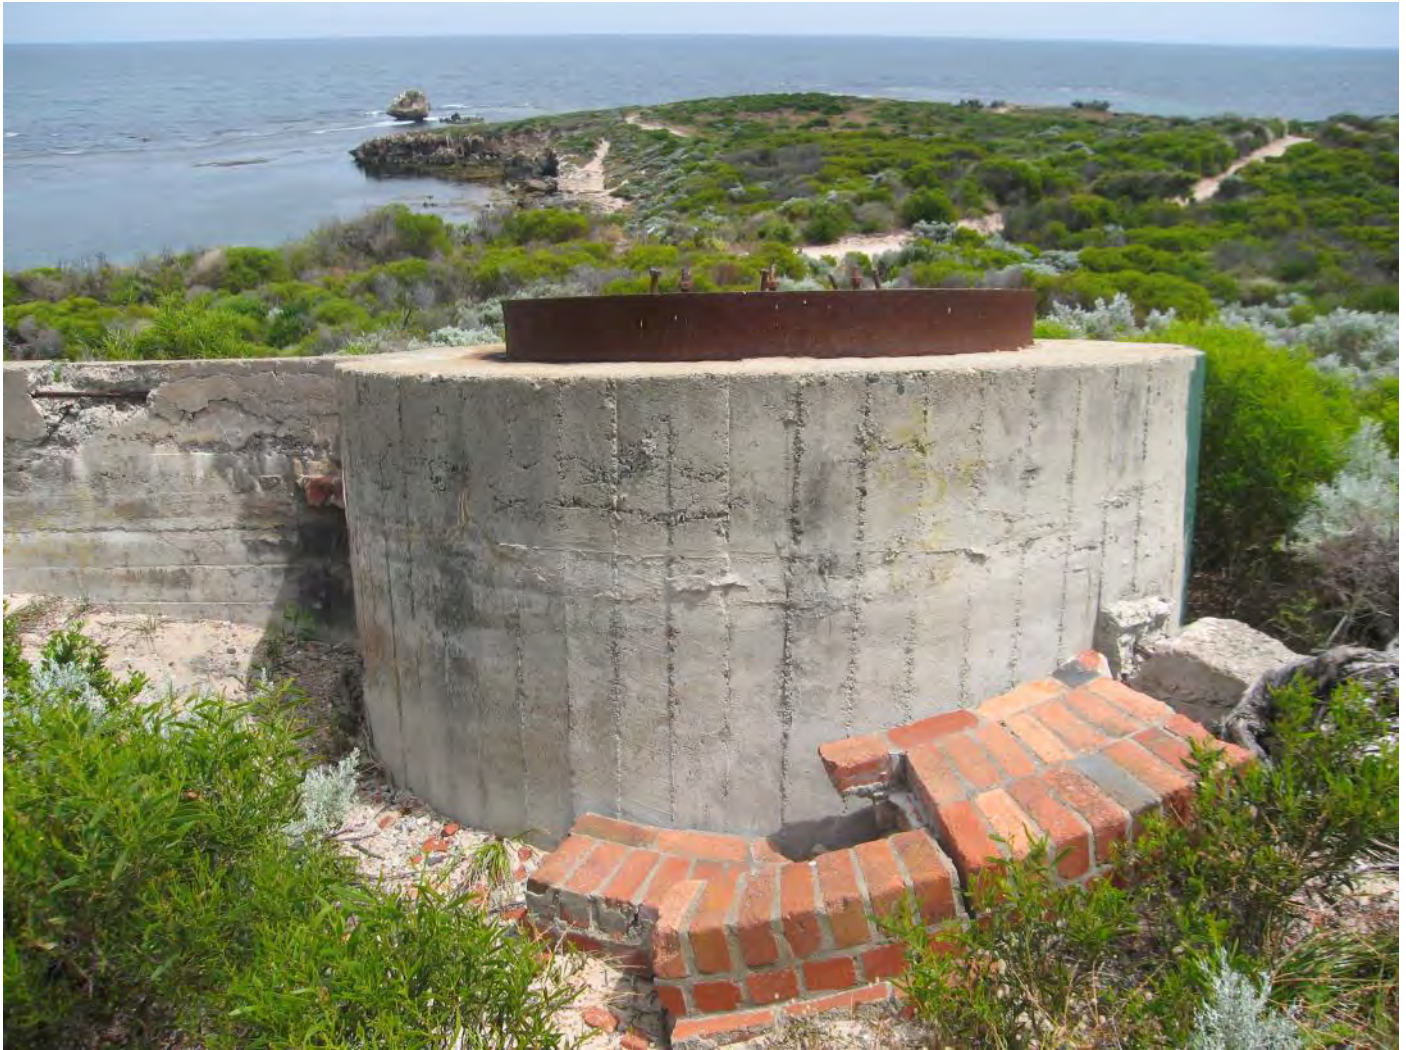
Figure 100: Gun Emplacement

The central gun mount and the concrete walls are all constructed from reinforced concrete. Sections of the concrete have blown due to the rusting of the reinforcements displacing chunks of concrete.

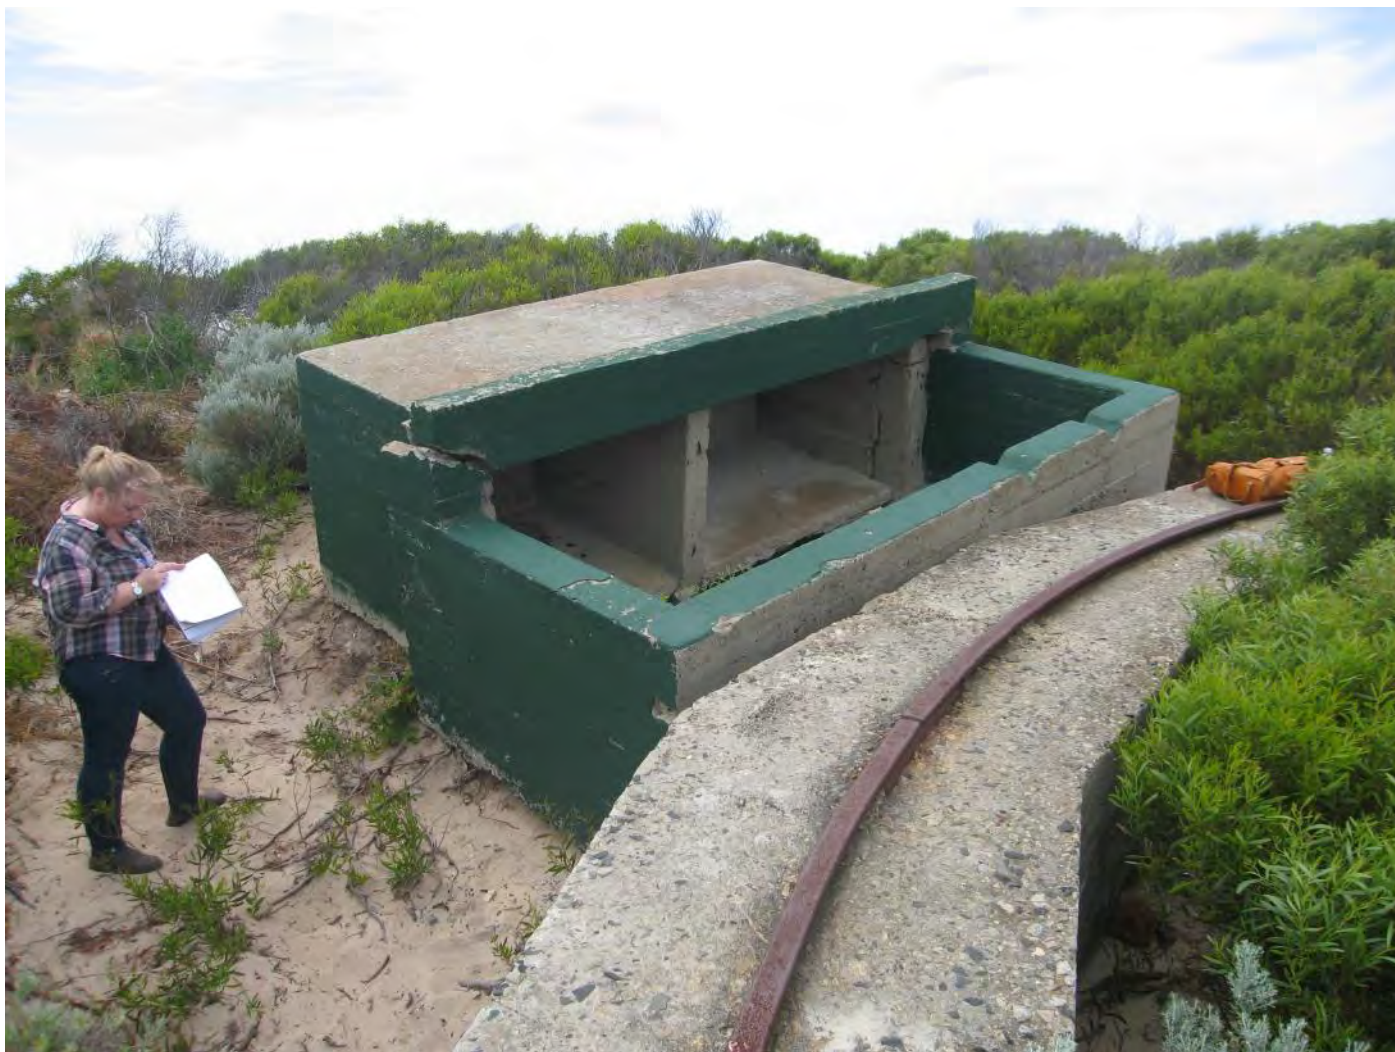
Figure 106: Gun Emplacement - Ammunition Store No. 1

The two ammunition stores are located to the north east and south east of the gun emplacement and are identical in form and construction, though both are in varying states of deterioration. As with the main gun emplacement structures, the two ammunition stores have also suffered as a consequence of the ground shifting. Store No. 1 which is located to the north east of the gun emplacement has moved forward and slipped into the retaining wall of the gun emplacement.

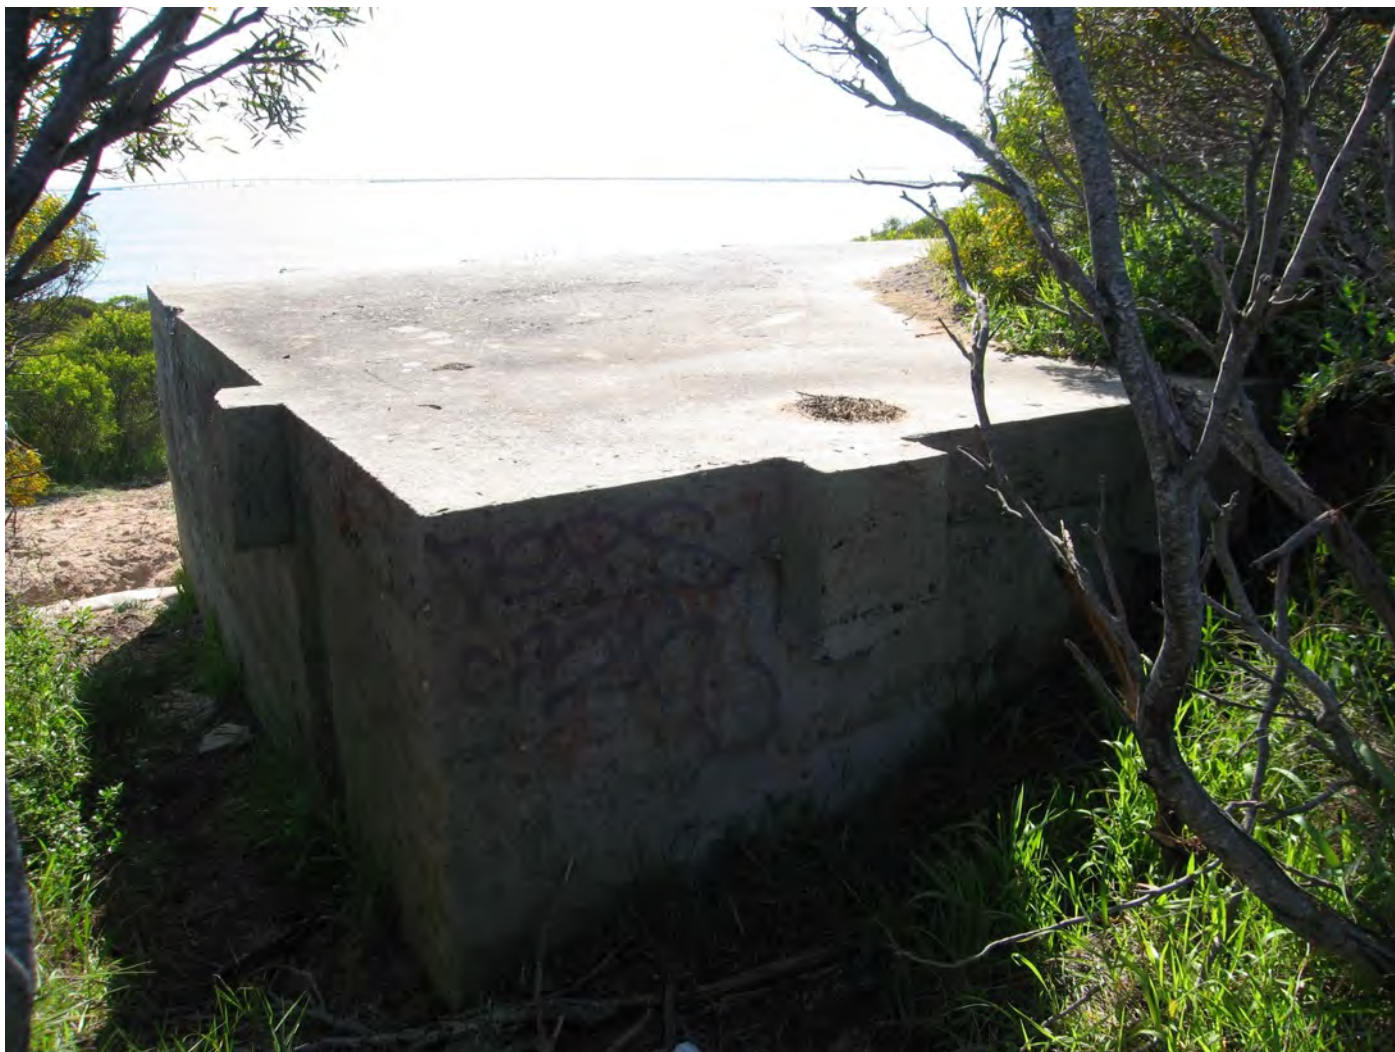
Figure 118: Ammunition Bunker – view across the roof

The Ammunition Bunker is a simple structure bearing similarities to the plan form and construction method of the other structures around the site. The external walls are of reinforced concrete construction with the roof being a reinforced concrete slab. Projecting vent shafts are placed at regular intervals around the building, level with the roof and extending down to approximately two concrete slab courses. One of the shafts on the north elevation has fallen off revealing a small opening in the wall.

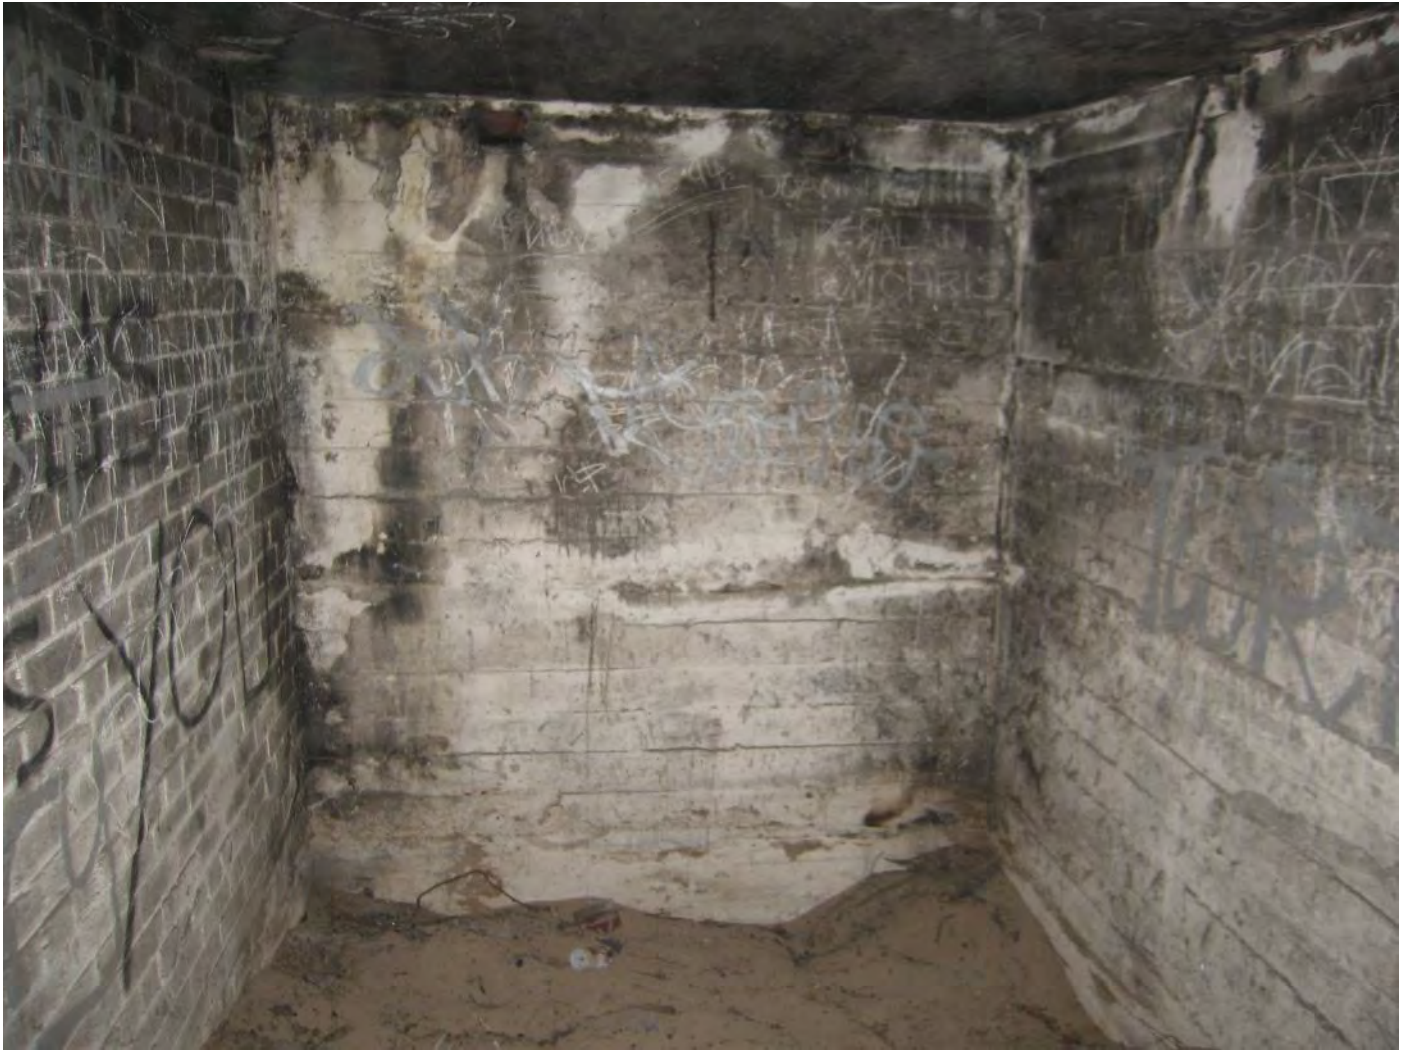
Figure 122: Ammunition Bunker – Room 1

The first room is a small rectangular space with no natural light flowing into the room. The three external walls are of concrete construction, the floor (under the cover of sand at the time of writing) is concrete and the roof is also reinforced concrete. The fourth wall, the west wall, is a double leaf brick load bearing wall.

The walls are a dusty white with graffiti with damp staining and possible fire scorch marks.

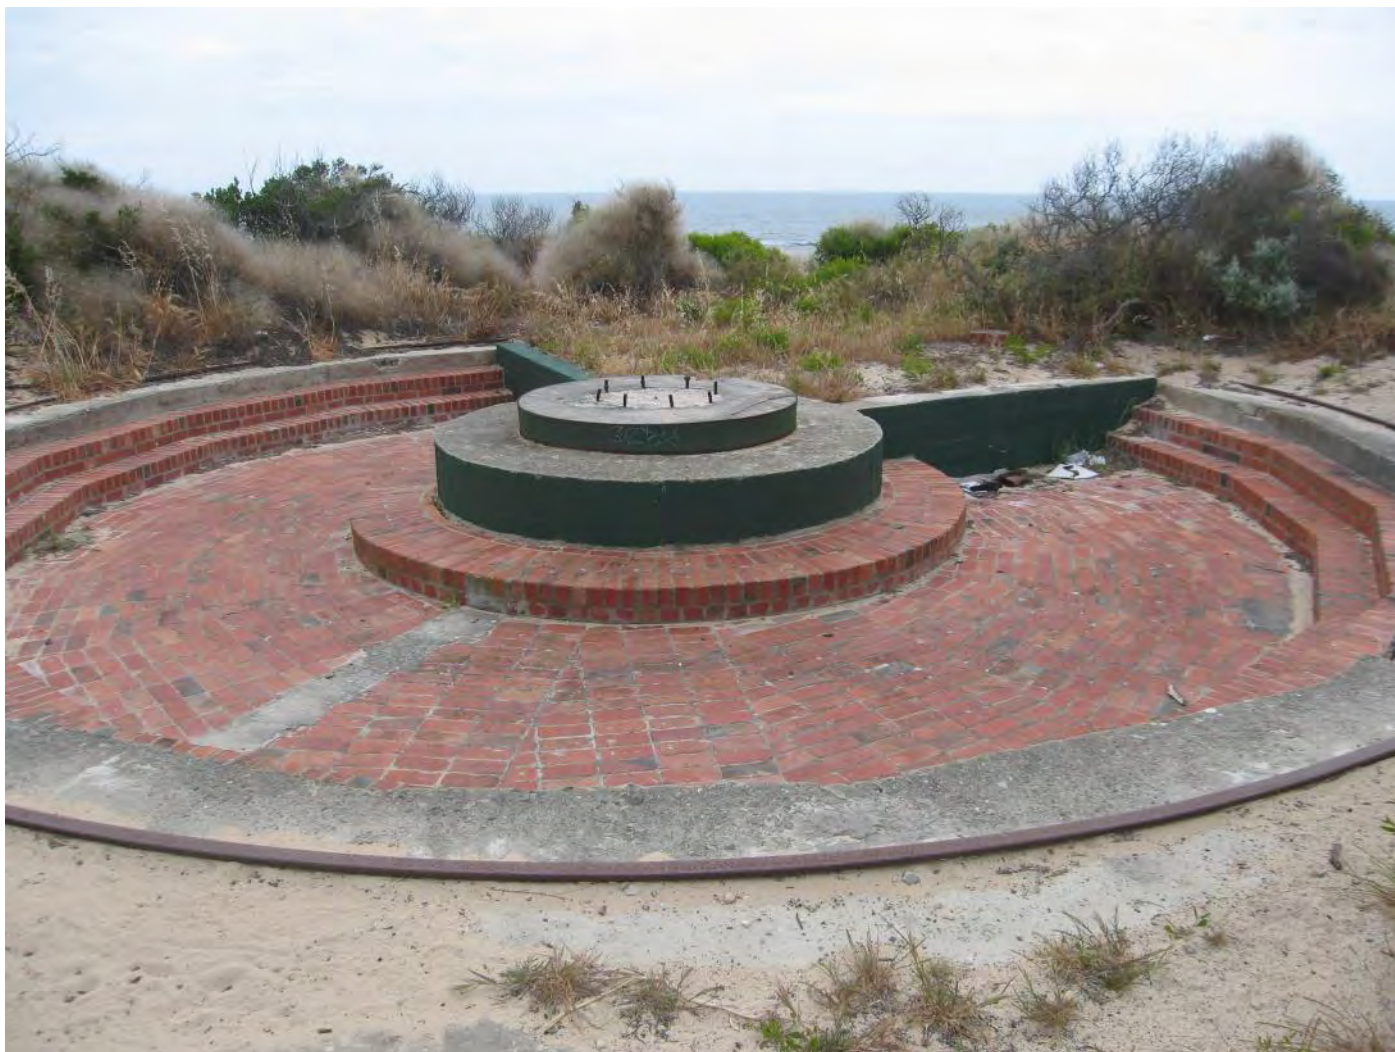
Figure 129: Gun Emplacement No. 2

Gun Emplacement No.2 is exactly the same as the Emplacement No. 1 apart from its condition. Gun Emplacement No. 2 is intact and presents as originally constructed which aids understanding of the form and function of the structure.

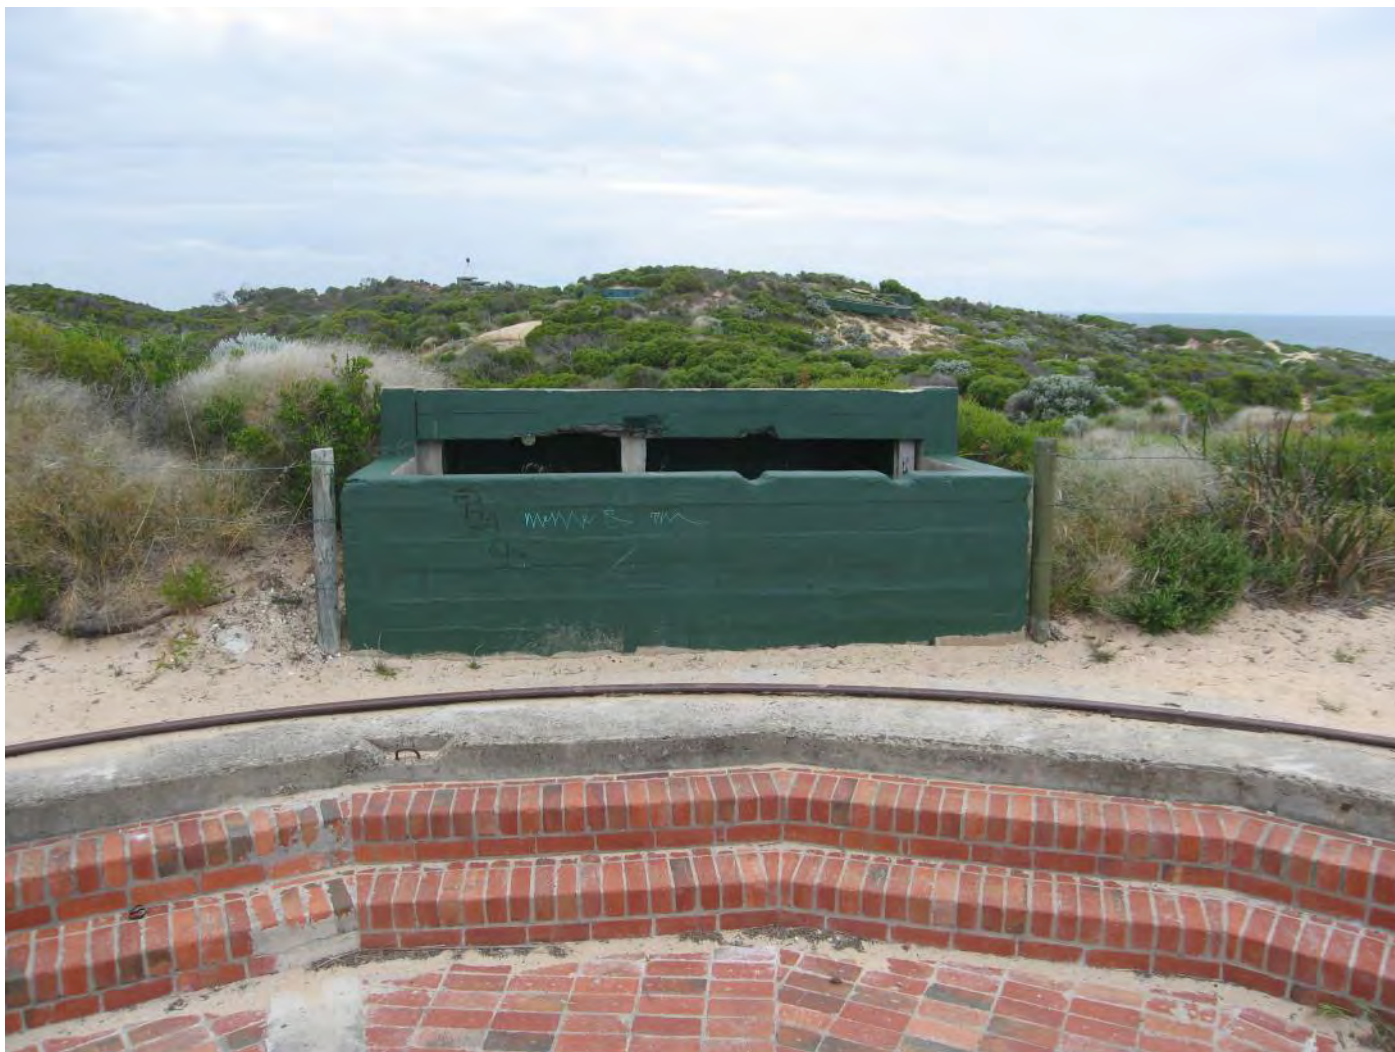
Figure 134: Gun Emplacement No. 2 – Ammunition Store 1

The associated ammunition stores are located to the east and south of the gun emplacement. Both are in their original positions and look down into the gun emplacement.

Both are in good condition and clearly demonstrate the plan form of the structures. Both are partially obscured by the sand around the sides and the rear of the structures but not to any great detrimental effect.

Though generally in good condition, the concrete is beginning to show early signs of concrete cancer in places, especially to the edge of the roof slab where chunks of concrete have broken away and the rusted reinforcing steel is visible.

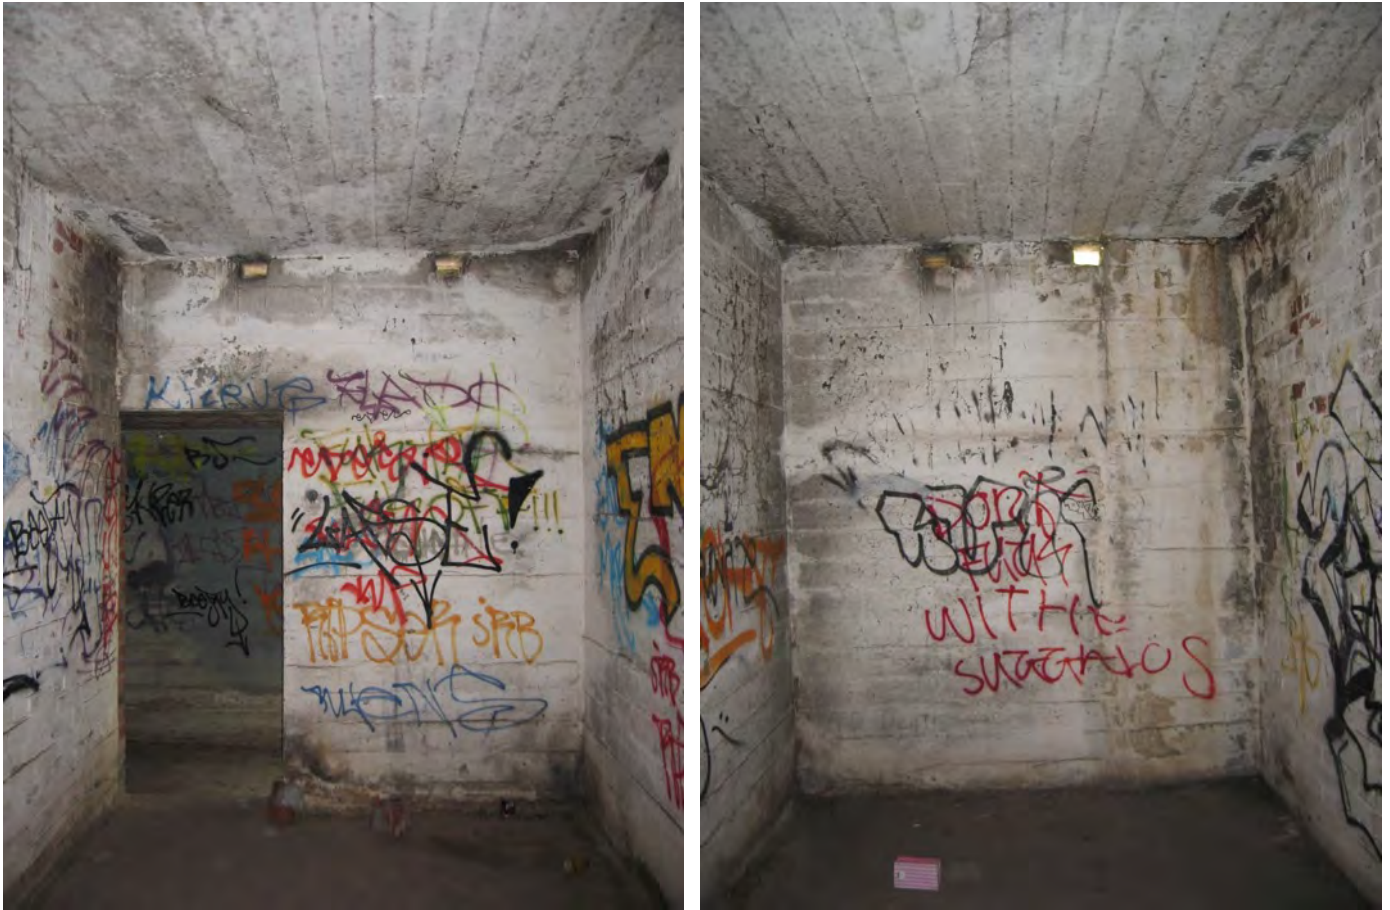
Figure 146: Ammunition Bunker - Room 1

Internally, the bunker has the same plan form as Bunker 1 with the main space divided into two rooms plus an entry tunnel. The smaller room, Room 1, has three external concrete walls with a fourth double leaf loading bearing brick wall dividing Room 1 from Room 2. The concrete to Room 1 has been painted white which is wearing off and has been covered in graffiti. Small ventilation holes are positioned directly below the ceiling. The sand has been removed but the walls are showing slight signs damp at lower level which may dry out now the sand has been cleared.

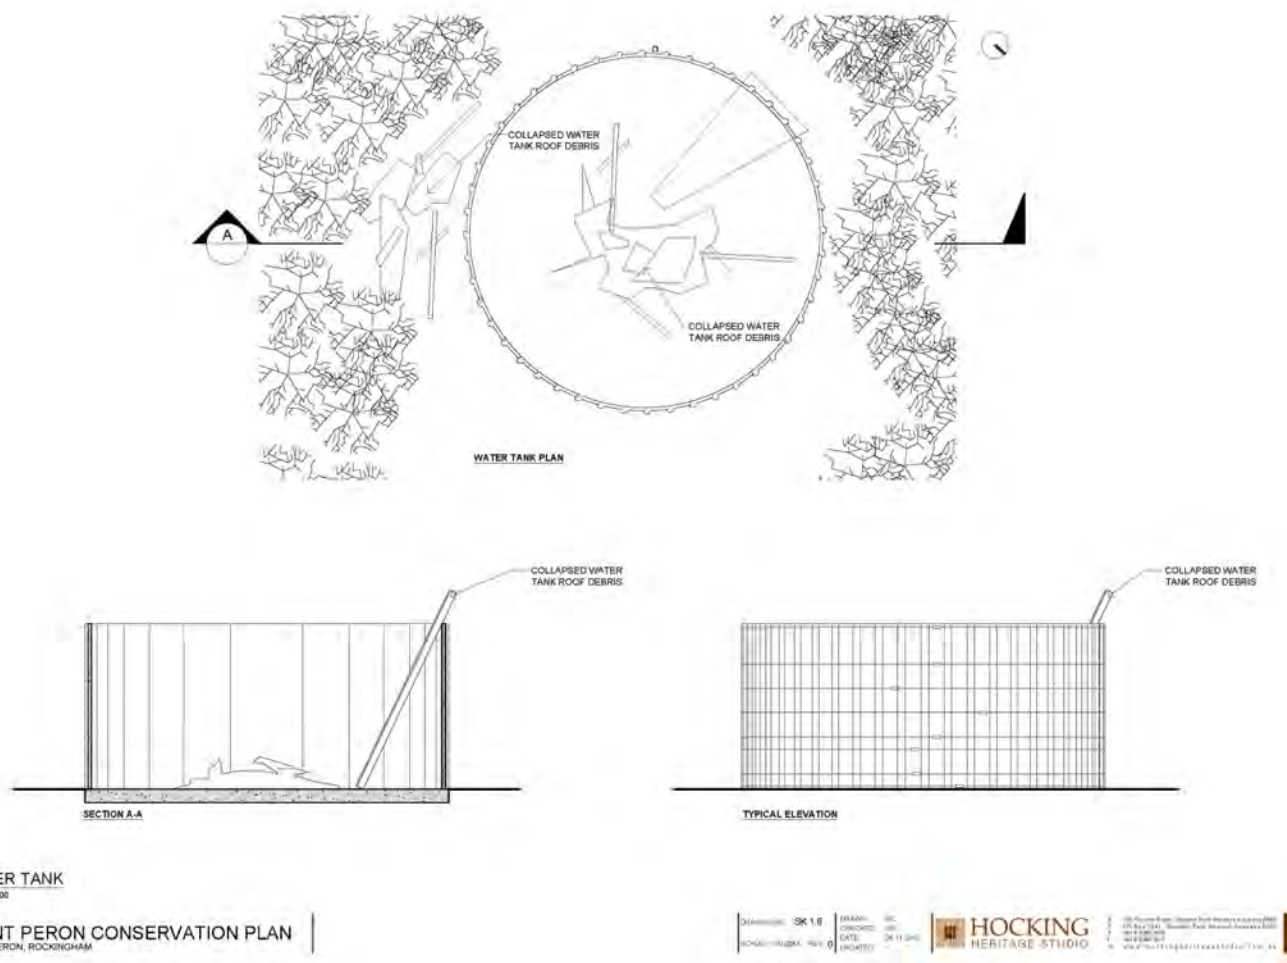
Figure 151: Water Tank – Plan and Elevation

The roof is no longer extant with remnant corrugated iron and timber laying in the bottom of the tank and around the edges.

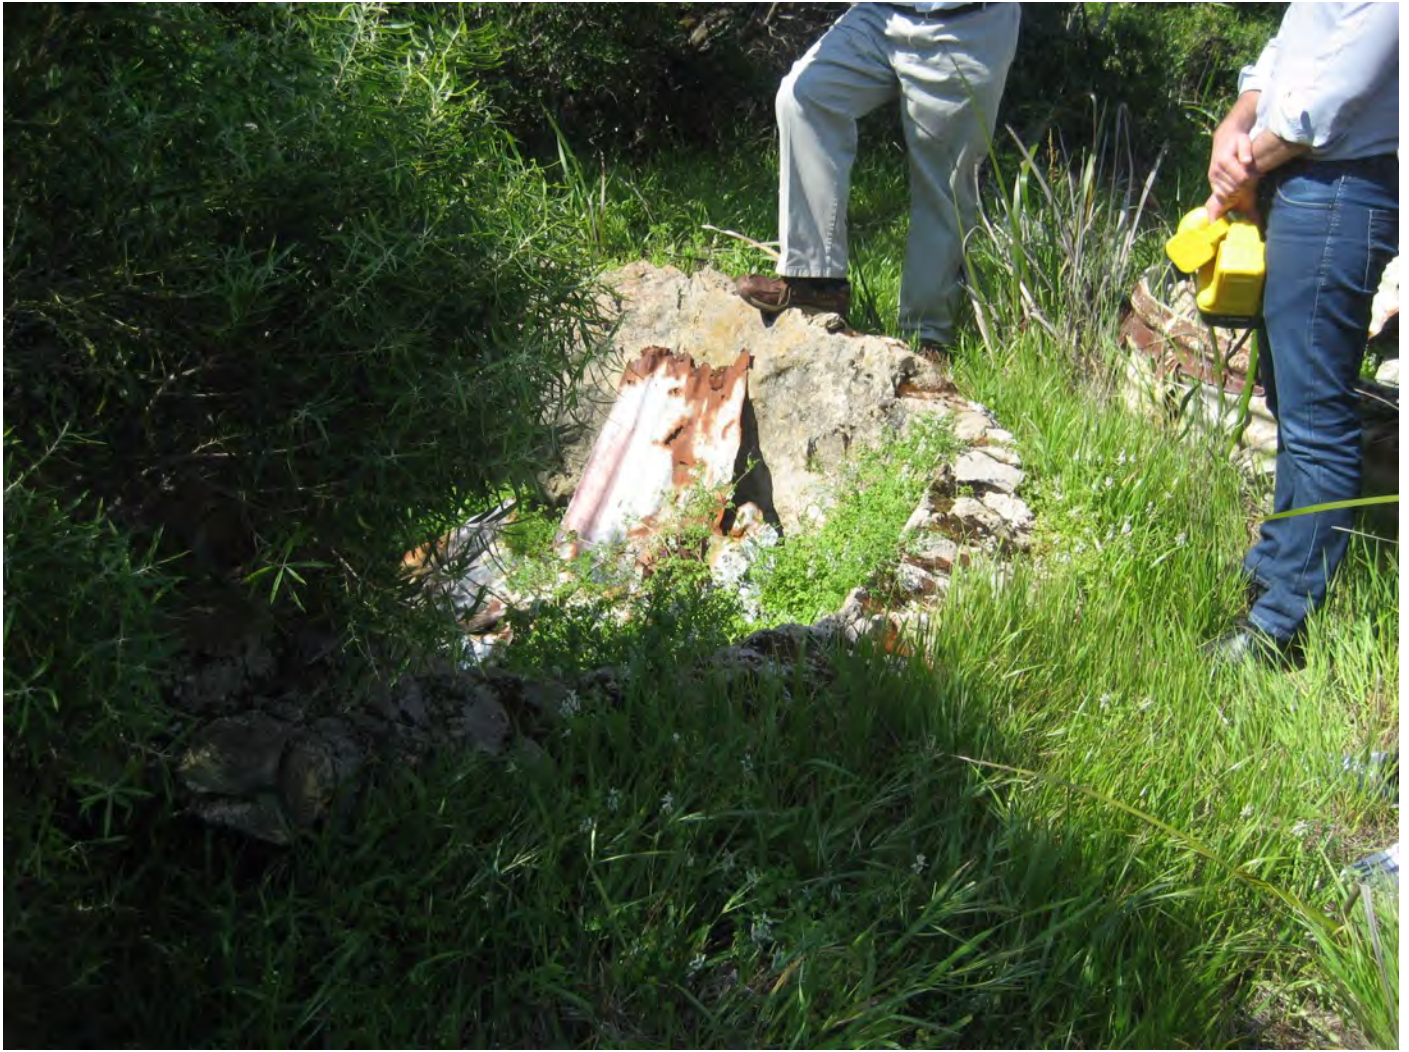
Figure 159: Well

The remnants of the well consist of a circular stone lined void of indeterminable depth. Remnant corrugated iron sheets are laying in the well which may have formed part of the well lid. The well is now full of building debris, sand and weeds.
