Point Peron "K" Battery Conservation Management Plan

South West Corridor Development Foundation Inc.

March 2016

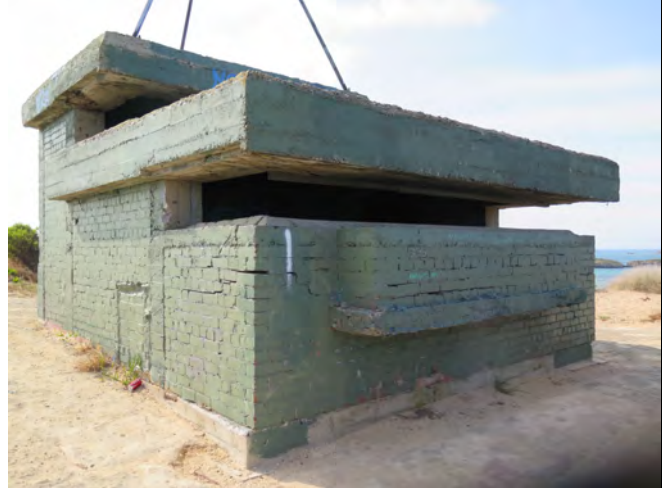
3.1 Observation Tower

The overall condition of the building is good given the original quality and speed of construction, its intended design life at outset, its atmospheric exposure and the levels of maintenance seen since decommissioning.

From the experience of similar sites it is most likely that the rapid acceleration of concrete cancer is not far away. With the cost and invasiveness of concrete repairs, the large scale concrete repair of such structures is likely to be both financially prohibitive and undesirable from a heritage viewpoint due to the scale of fabric loss. A more realistic approach to adopt is that of a managed ruin whereby efforts are focused on measures to slow down the onset of cancer as much as possible. Ultimately cancer will develop but with appropriate measures put in place, particularly those against water ingress and those promoting local and global drainage of surfaces, the timing of such can be slowed down significantly. The building's life is consequently extended significantly as a result.

- i) Re-screeding of concrete roof tops to good falls and with waterproof membrane or acrylic barrier.
- ii) Covers to look out openings at each levels.
- iii) Cover to entrance door opening.
- iv) Possible local concrete patch repairs and/or 'benching' of local surface to improve drainage.
- v) Corrosion inhibitor and epoxy/acrylic barrier coatings to exposed external concrete surfaces.
- vi) Carbonation barrier and corrosion inhibitor coatings to all internal concrete surfaces.

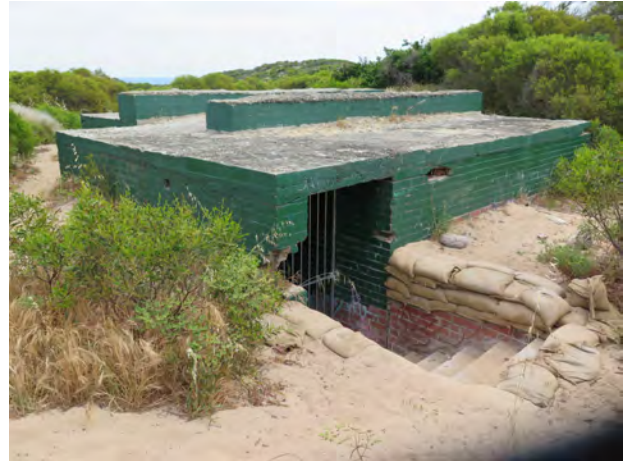
As for the Observation Tower, the structure has fared well given its history. The most vulnerable element on the face of it, the concrete roof slab, is in good condition without widespread cancer damage. Consistent damage has occurred however in the high level courses of the perimeter brickwork onto which the slab immediately drains. Horizontal steel bar bed reinforcement has been used at one course down in the two leafs of brickwork. These have corroded and expanded significantly in locations, particularly at the building corners. Here corrosion forces have been high, sufficient to jack up slab corners and push local brickwork off the building both externally and internally. This is both the most important condition issue and most important safety issue facing the building.

Shifting external ground levels has clearly occurred over time with erosion appearing to dominate the West side and deposition the East. This has not affected the structure much except to increase exposure to lateral moisture penetration on the East side and block the entry (now cleared). Additional lateral pressure is exerted on the brick retaining walls of the entry approach but to no effect as yet since entry clearing work. There has been undermining of the small brick vent shafts on the north side, these have consequently fallen away.

The subject steel causing the high level problems in the brick walls was and remains in fact of little use structurally and is best removed from the structure for the long term good. A systematic approach to raking out joints and removing bars can be used in conjunction with brick and crack repairs.

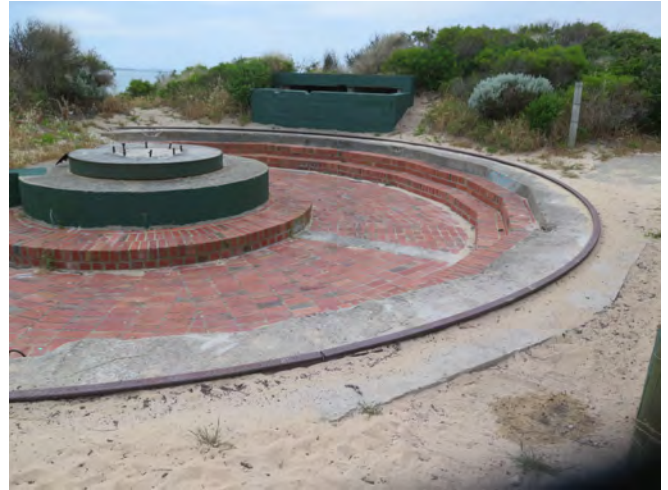
The emplacement remains are in good general structural condition. Shifting soil issues do not appear to have adversely affected stability of this site unlike the Emplacement 1 site. Concrete cancer is evident on the soffits of the munitions stores' roof slabs but the gun mount is relatively unaffected.

The steel perimeter belt around the upstand of the central gun hold down has corroded through on the far side of the upstand and presents a hazard to users. Potentially loose cover concrete to the munitions stores' roof soffits is another hazard is users who may enter the store space.

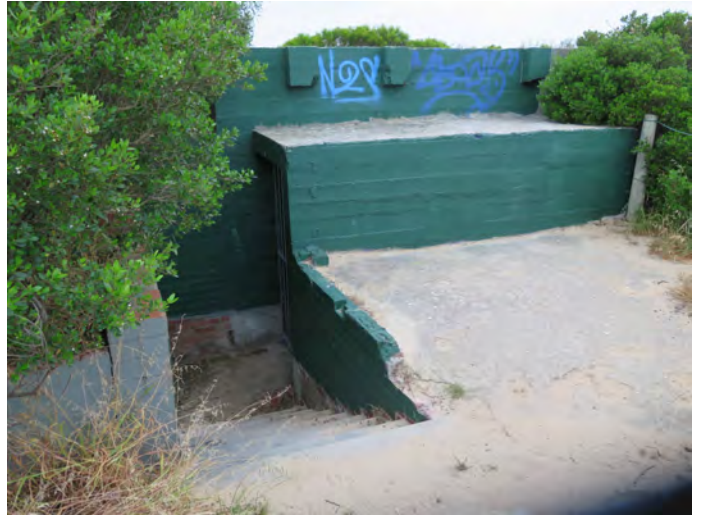
The building is similar in construction and condition to the bunker at Gun Emplacement 1.

Internally, brickwork is in good condition. The floor slabs are obscured by sand build up but are expected also to be in good condition.

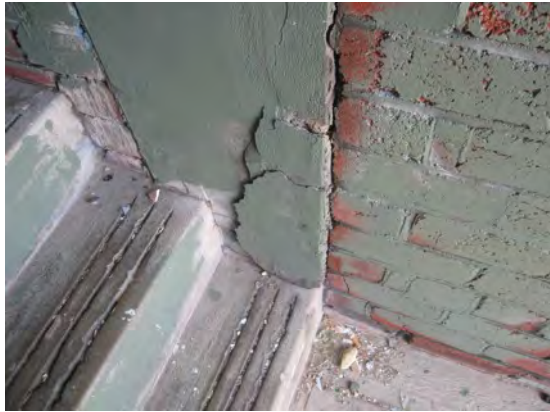
Underside of roof slab forming the ceiling is showing early signs of concrete cancer. Render to concrete column at foot of stairs is drummy, cracking and falling off.

Painted finish with graffiti	Patch repairs to reinforced concrete as outlined above. Monitor condition of ceiling for further deterioration. Remove paint from all elevations as this can contribute to the deterioration of the fabric. Paint removal should not unduly damage the substrate and mortar and test panels in discrete locations should be established prior to embarking on the full removal. Non-caustic solvent based methods or low pressure steam removal can be tried. Peelaway paint removal system can be used or Westox's DeLam which applies a poultice to the paint and will be ready to be removed within a few days. Not all paint traces will be removed due to the texture of the bricks and concrete. Remove drummy render from the concrete column at the foot of the stairs, ensuring that all retained render is in a sound condition. Patch repair in a render mix to match existing. If the structure is to be secured by the metal grille gate graffiti should not be an ongoing issue for the internal space and once all paint and graffiti has been removed, there should not be a requirement to coat the internal fabric with an anti-graffiti coating.	2 2 2

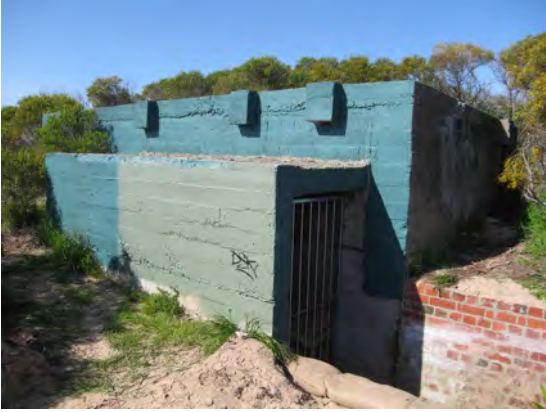
<p>North Elevation</p>	<p>B</p>	<p>The north elevation is the principal façade and is the only elevation that is clearly visible. The key elements being the entrance and the projecting air vents positioned along the roof line of the elevation.</p> <p>Minimal signs of concrete cancer.</p> <p>Painted finish.</p>	<p>Remove paint from entire elevation as this can contribute to the deterioration of the fabric. Paint removal should not unduly damage the substrate and mortar and test panels in discrete locations should be established prior to embarking on the full removal. Non-caustic solvent based methods or low pressure steam removal can be tried.</p> <p>Peelaway paint removal system can be used or Westox's DeLam which applies a poultice to the paint and will be ready to be removed within a few days. Not all paint traces will be removed due to the texture of the bricks and concrete.</p>	<p>2</p>

Building Name	Condition Rating	Defect and Location	Work to Rectify Defect	Priority Ranking
		 	<p>Monitor the rate of deterioration to the air vents. The undersides have corroded due to water ingress and will require remedial action in the future to prevent the entire element being lost. The method of patch repairs outlined above can be utilised.</p>	2
East Elevation		<p>The east elevation is obscured by sand dune and vegetation. It is unpainted and is likely to be in good condition.</p>	<p>Full inspection of the elevation is required to determine condition. Small scale concrete patch repairs re likely.</p>	1
South Elevation	B	<p>Partially submerged into sand dune and partially obscured by vegetation. Full inspection not possible. Concrete deterioration to base of air vent shaft.</p>  	<p>Full inspection of the elevation is required to determine condition.</p> <p>Concrete patch repairs required to base of air vent shaft.</p>	<p>1</p> <p>2</p>

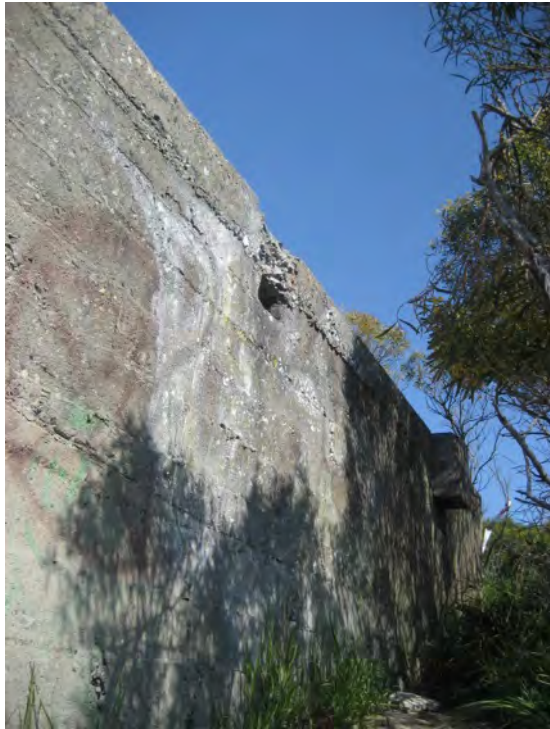
Building Name	Condition Rating	Defect and Location	Work to Rectify Defect	Priority Ranking
West Elevation	C	Slight concrete damage. Loss of ventilation shaft and deterioration to underlying concrete. Water drainage issues from roof causing some of the deterioration.

Repair concrete around the air vent. To prevent further damage the air vent shaft should be reconstructed based on the design of extant air shafts. Protection of the opening will safeguard the vulnerable fabric around the opening and also prevent water ingress into the building.	2
Roof	C	Appears to be in sound condition with only hairline cracking. Water drainage issues causing some damage to the air vent shafts and edge of the concrete roof. Sand build up on the roof with subsequent vegetation growth.

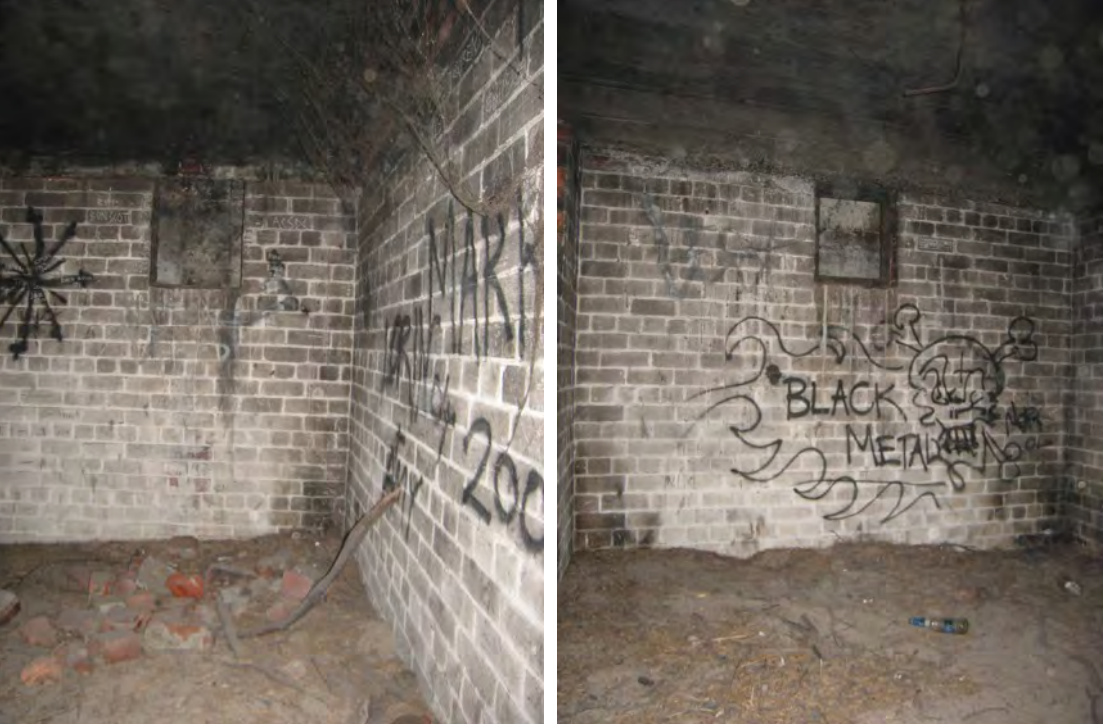
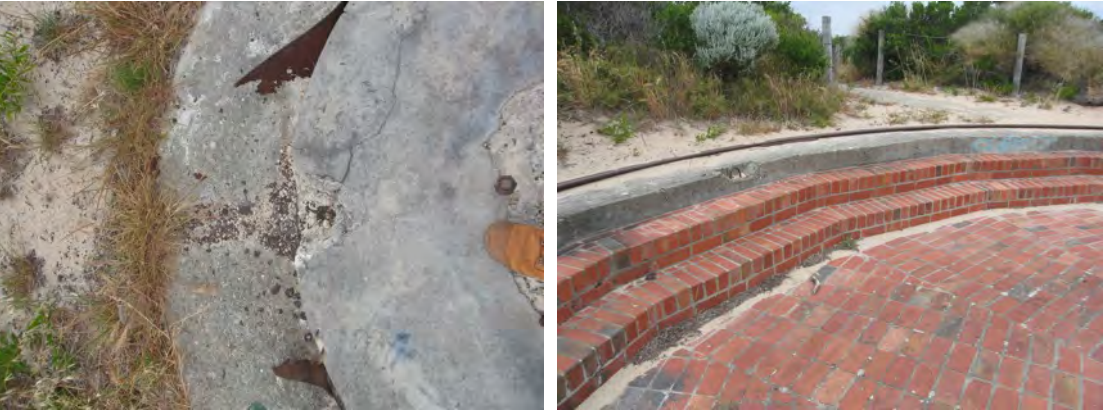
Building Name	Condition Rating	Defect and Location	Work to Rectify Defect	Priority Ranking
Room 2 plus blast corridor	C	<p>Brick internal walls with concrete outer walls. Clouded paint finish to walls with graffiti. Sand accumulation.</p>

<p>Remove graffiti. There is no requirement for an anti-graffiti coating to be applied if public access is going to be controlled. Removal of graffiti should not damage the underlying brick and concrete.</p> <p>Remove painted finish to the walls as per specifications above or other suitable alternative conservation method.</p> <p>Slight signs of concrete deterioration to the ceiling. Further deterioration to be monitored.</p> <p>Sand accumulation to be monitored and removed prior to substantial build-up.</p>	<p>2</p> <p>2</p>
<p>Gun Emplacement No. 2</p> <p>Reinforced concrete retaining wall, brick steps and paving, central reinforced concrete gun mount</p>	B	<p>Gun Emplacement No. 2 is in good condition and has not suffered from the same fate as its counterpart Gun Emplacement No. 1. Shifting sand and ground conditions do not appear to be impacting on the structural condition of this structure.</p> <p>There is some concrete damage to the top of the gun mount and the steel perimeter edging around the top of the mount has rusted in places, springing loose from the concrete it is encasing.</p> <p>Sand accumulation in places.</p> <p>Non-original painted surfaces.</p>	<p>Conservation works are limited to replacing the steel edge to the gun mount and regularly removing the sand. The paint should be removed from the gun mount as per the methodology specified elsewhere in this report.</p> <p>The concrete elements should be regularly monitored as they will be susceptible to the harsh coastal environmental conditions.</p> <p>As this element is to be the main focus of the site and potentially the site for a memorial, the visitor numbers will be higher. The paving and brick steps should be regularly inspected to ensure they are not loose and creating trip hazards.</p>	2

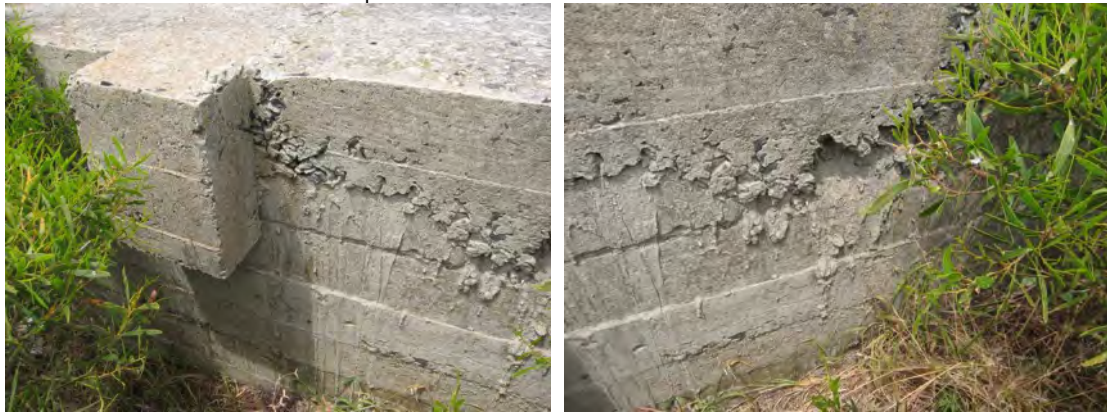
Building Name	Condition Rating	Defect and Location	Work to Rectify Defect	Priority Ranking
West Elevation		<p>Much of the west elevation is obscured by vegetation. The elevation is partially submerged. Projecting air shafts extending from the roof level down approximately three block courses. The underside of the vents showing signs of concrete cancer and erosion in some instances. This elevation has not been painted.</p>

<p>Full inspection of elevation is required to determine condition. This may require the removal of some vegetation.</p> <p>Monitor condition of elevation. Patch repairs to the air shaft vents to reduce further deterioration.</p>	<p>1 3</p>
Roof	C	<p>Slight cracking , especially at the edges of the roof, resulting in water ingress into the interior. If left unchecked this will result in eventual concrete cancer. Generally in good condition.</p>

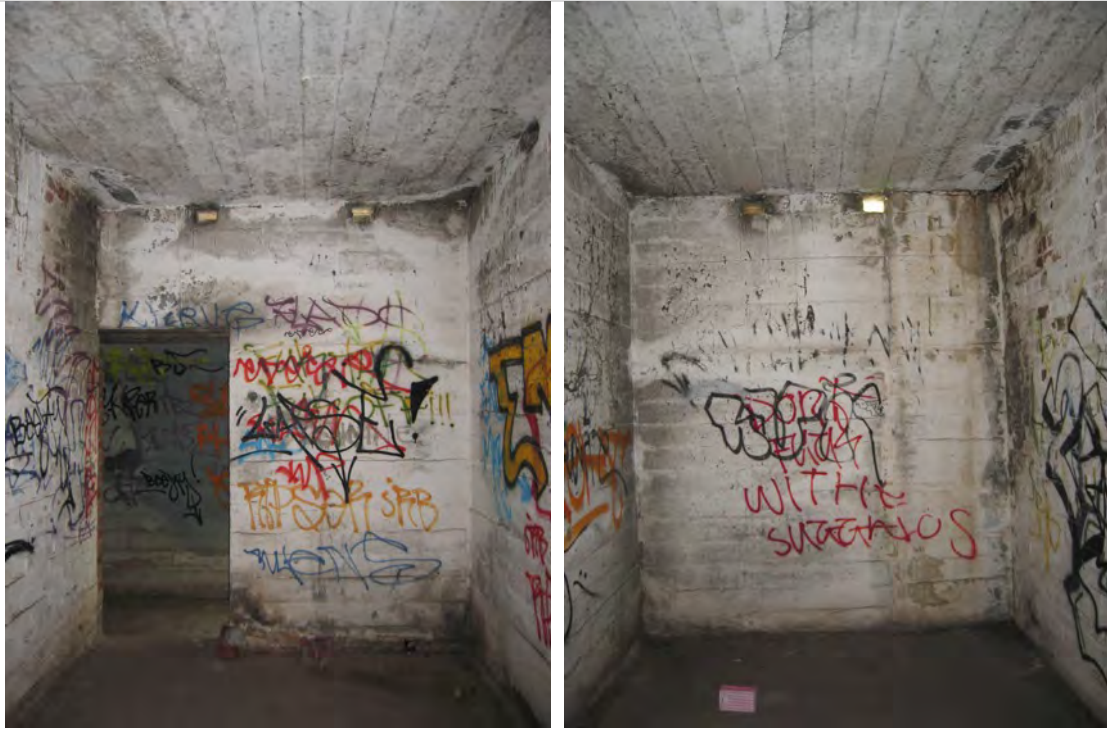
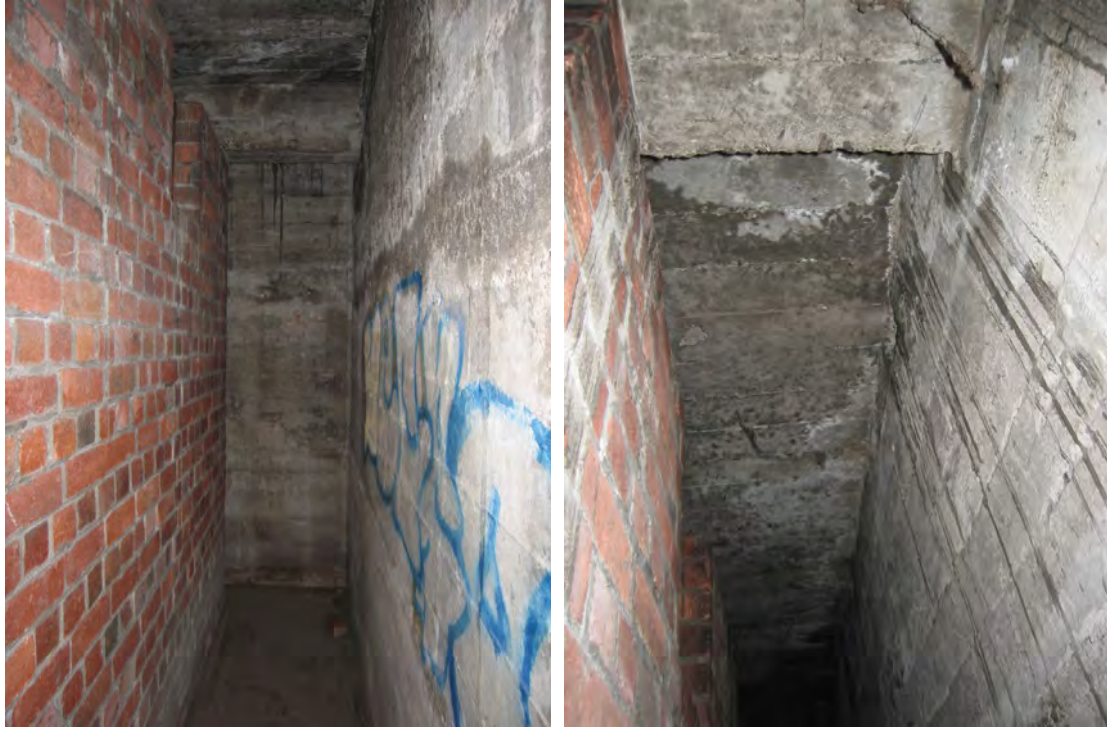
<p>Room 2 plus blast corridor</p> <p>Concrete outer walls and brick inner walls, concrete ceiling and floor</p>	<p>C</p>	<p>Brick work to the internal walls is generally in sound condition, with some graffiti. Dusted white painted finish wearing off from the walls. Some slight signs of damp at the junction between the wall and ceiling, likely to be in line with the roof cracks. Evidence of recent sand removal from both the main room and the blast corridor. Signs of early concrete cancer to the roof with some of the enforcement bars rusting and breaking through the concrete.</p>

<p>Remove paint from entire elevation as this can contribute to the deterioration of the fabric. Paint removal should not unduly damage the substrate and mortar and test panels in discrete locations should be established prior to embarking on the full removal. Non-caustic solvent based methods or low pressure steam removal can be tried. Peelaway paint removal system can be used or Westox's DeLam which applies a poultice to the paint and will be ready to be removed within a few days. Not all paint traces will be removed due to the texture of the bricks and concrete.</p> <p>Remove graffiti. An anti-graffiti coating is not required.</p> <p>Ensure sand levels are monitored, removing any sand build up on a regular basis.</p>	<p>2</p> <p>2</p> <p>1</p>

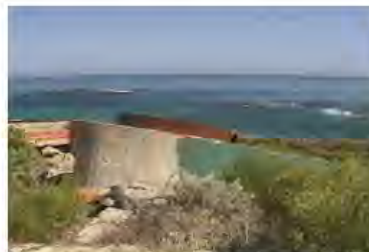
PHOTO: The coastal defence battery at Point Peron has fallen into disrepair. (ABC News)
